December 31, 2018
Revised: January 29, 2019

Re: Infiltration and Inflow Investigation
296 Main Street Project
296 Main Street
City of Beacon, New York
Tax ID: 5954-27-869916 (\pm 0.09 acres)

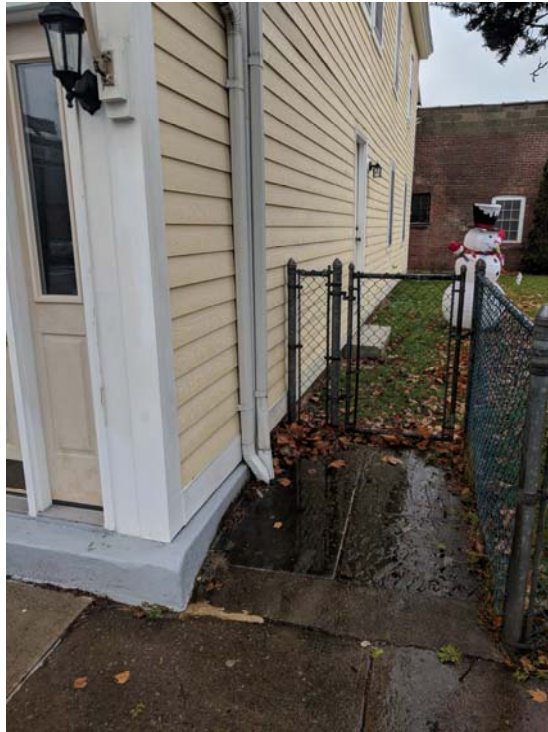
The first phase of the study consisted of an exterior inspection of the building to determine the location of roof leader discharge points. There were two roof leaders observed on the southeast corner of the exterior of the building on the Main Street side that are connected to underground piping. The discharge location of these underground pipes could not be determined by visual inspection (see Figure 1 at the end of this report).

On January 28, 2019, a dye test was conducted with Beacon Sewer Department personnel. In addition, an endoscope was lowered into the ground pipe that the roof leaders discharge into. A blockage was discovered in one of the pipes. The other roof leader discharges into a horizontal cast iron pipe that is directed toward main street. It is believed that this pipe is the sewer lateral pipe from the rear building. There is no storm system in Main Street in the vicinity of this pipe. Dye was administered into the drain

line that discharges from the rear building along the exterior of the east wall of the front building; The results of the dye test confirmed that this pipe discharges to the sewer main within Main Street. It is assumed that since there is no stormwater infrastructure in this location, the two roof leaders located in the southeast corner of the building discharge to this sewer line. Per City of Beacon requirements, these two roof leader pipes will need to be disconnected from the sewer line from the rear building. The Site Plan set currently before the planning board has been updated to show design for re-routing these roof leader pipes to the storm system.

Figure 1 – View of Roof Leader Pipes Located in the Southwest Corner of the Front Building

All roof leaders and the sump pump discharge line will be disconnected from the sewer and re-routed to the City stormwater system. The two roof leaders shown in Figure 1 at the end of this report will be re-routed to storm system by installing a 6” SDR 35 PVC header pipe from this location and directed toward the rear building along the east building wall of the front building. The sump pump discharge line will exit the east building wall and connect directly to this line within an ADS polyethylene catch basin. The 6” SDR 35 PVC continues into the rear building where it will intercept both roof leaders within the rear building below the concrete slab. The sewer line will increase to 8” SDR 35 PVC after intercepting the two roof leader pipes. From there, the 8” pipe is directed toward North Cedar Street.

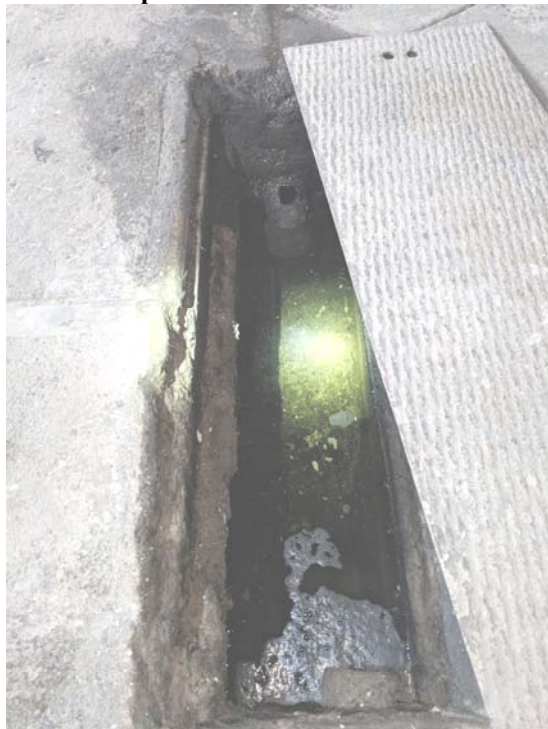
The second phase of the investigation consisted of an interior investigation of the front and rear buildings. The rear building is single-story on slab with no basement. There are two roof leaders within the rear building that are piped below the slab – one on the north wall and one on the south wall (Figures 3 & 4). The north roof leader pipe continues below the slab into a 90° elbow where it travels toward the south into a sump with metal cover within the center of the slab floor (Figure 2). The sump has an open bottom to ground where the roof leader discharge is allowed to infiltrate into the subsoils. There is a downward facing 90° elbow overflow outlet on the south side of the sump. It is believed that this overflow pipe is connected to the south roof leader.

Figure 2 - View of Sump Within Floor of Rear Building

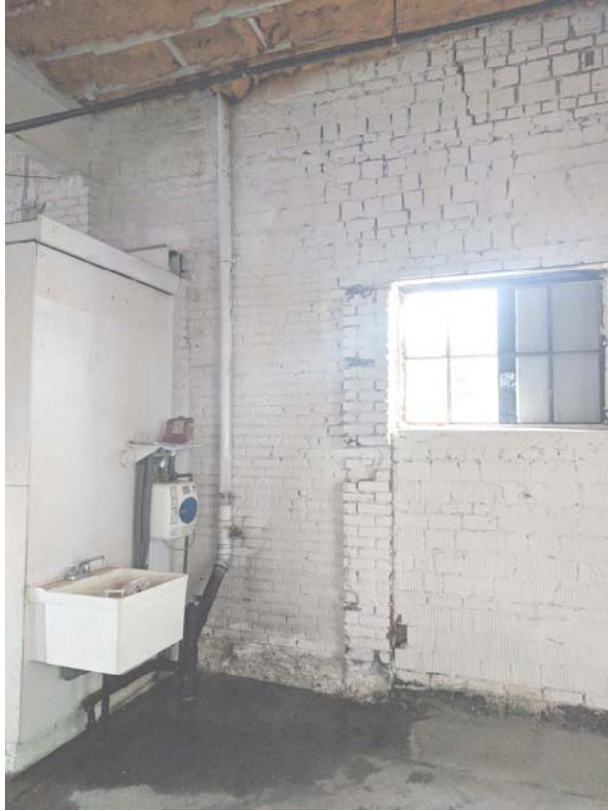
Dye was introduced into a sink located adjacent to the south roof leader (Figure 3). The sink drain and the roof leader drain both are directed into a common sewer line. The dye test was conducted to determine where this drain line is directed toward. Manholes were opened on Main Street, and North Cedar Street after the dye was introduced. Dye was observed in a sewer manhole within Main Street; therefore, it has been confirmed that the 4" cast iron sewer line from the rear building discharges toward Main Street along the east exterior wall of the front building into the City sewer system. These roof drains will need to be disconnected from the sewer pipe and re-directed to the storm system. The Site Plan set currently before the planning board has been updated to show design for re-routing these roof leader pipes to the storm system.

Figure 3 - View of Roof Leader on South Side of Rear Building

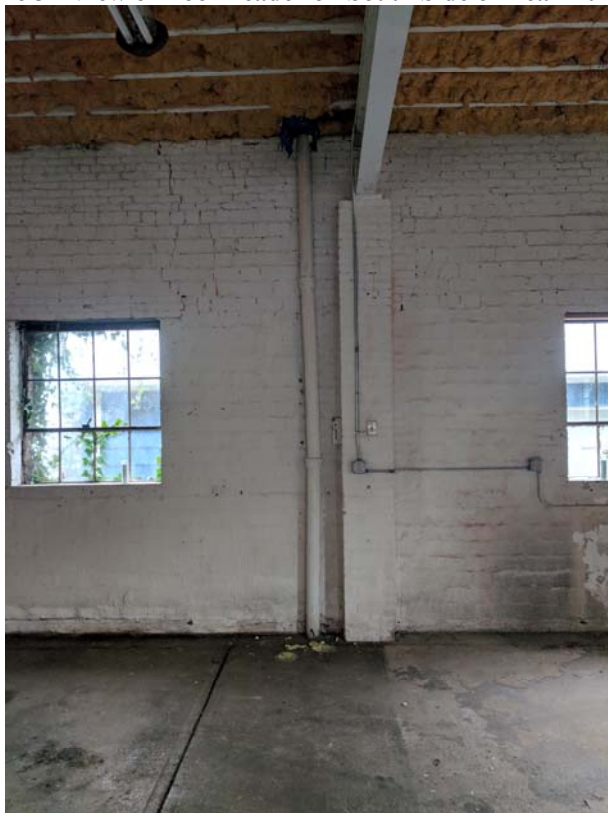
Figure 4 - View of Roof Leader on North Side of Rear Building

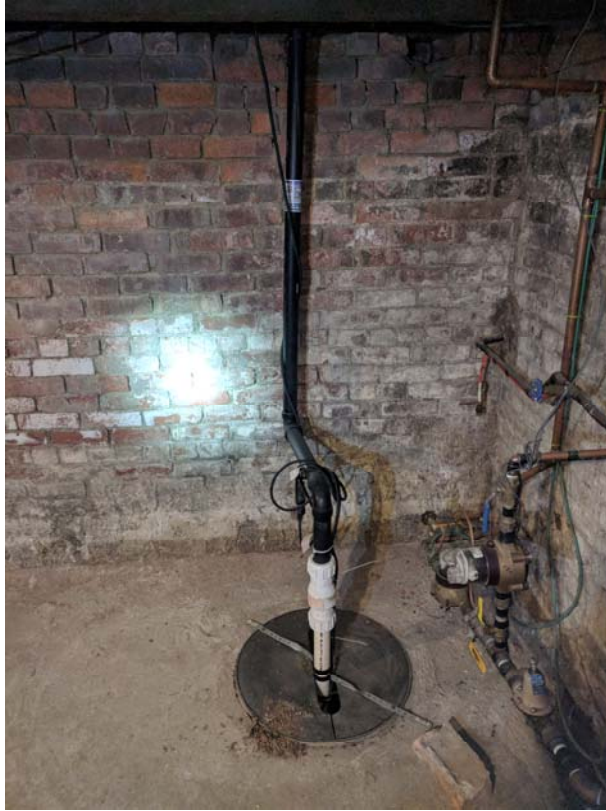
The front portion of the building has a basement. The basement was investigated for any interior roof leaders, floor drains or sump pumps that could be connected to the building sewer. A sump pump was observed in the northeast corner of the front building's basement (Figure 5). It was confirmed that the discharge line from the sump pump is connected to the building sewer line. The building sewer line travels along the

Figure 5 - View of Sump Pump in Basement of Front Building

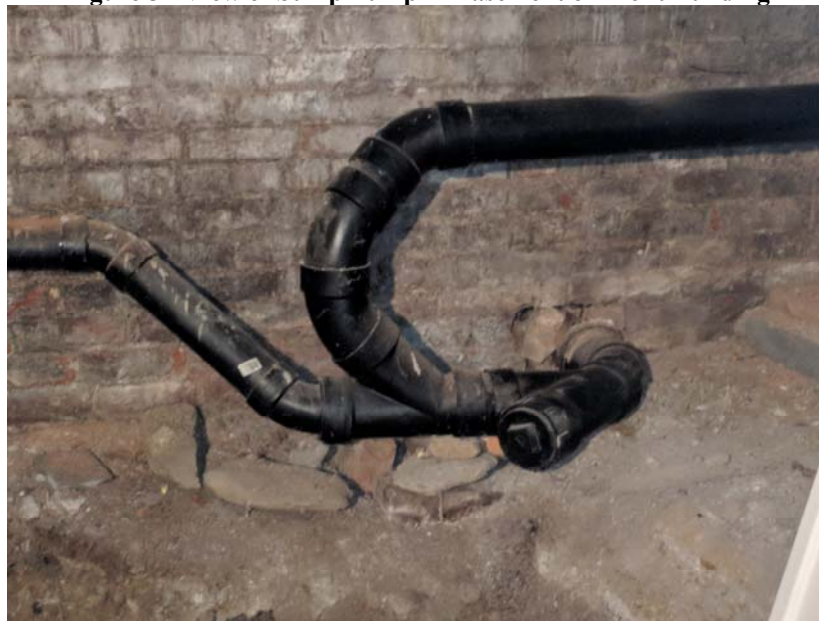
westerly wall of the front building and exists the building out of the west wall toward North Cedar Street (Figure 6). There is a sewer manhole within N. Cedar Street that is located just upstream of the sewer lateral coming from the building. The sewer manhole was inspected on January 28, 2019 with the Beacon Sewer Department. It was confirmed that the sewer lateral from the front building is connected to the 8” sewer main within North Cedar Street. The sump pump will need to be disconnected from the sewer pipe and re-routed to the storm system. The Site Plan set currently before the planning board has been updated to show design for re-routing the sump pump to the storm system.

Figure 6 - View of Sewer Lateral Leaving Front Building Through the West Wall Toward North Cedar Street

North Cedar Street does not contain stormwater infrastructure in this area; however, there is a catch basin located approximately 72 feet to the north within North Cedar Street. Therefore, a new catch basin will be installed in this location with a 12” HDPE pipe directed toward the existing catch basin toward the north. The Site Plan set currently before the planning board has been updated to show design for re-routing the sump pump and roof leader pipes to the storm system.

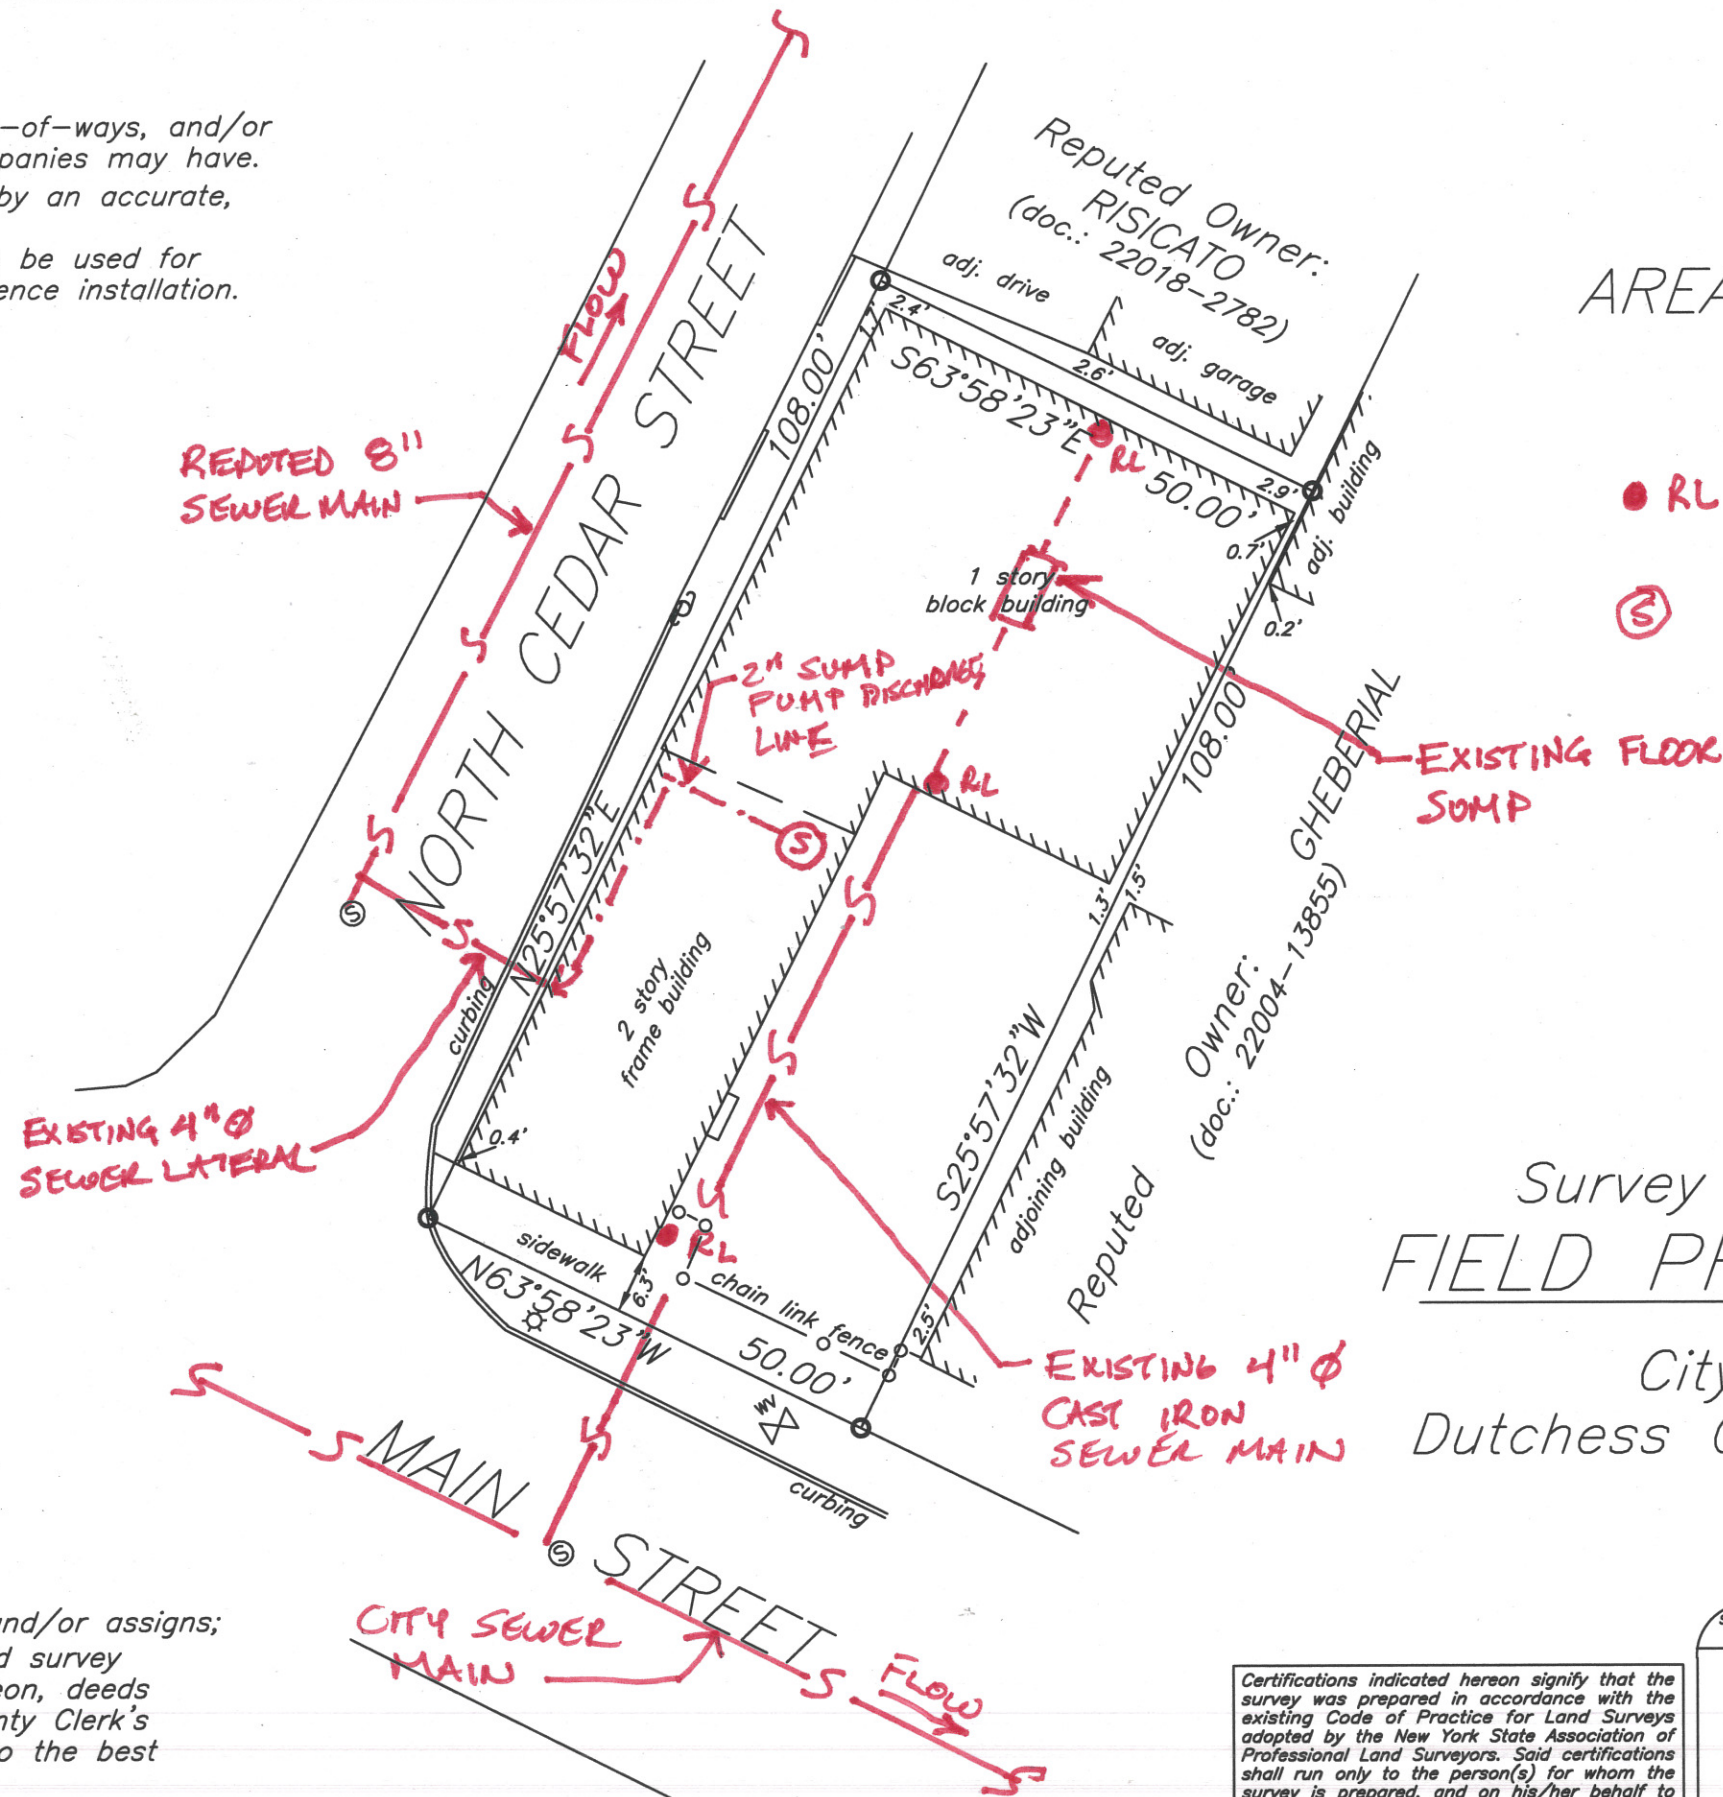
Appendix A
I&I Investigation Sketch

The rear portion of the gabled roof drains to a lower shed roof that is also pitched toward the rear building. Both of these roofs discharge to the rear building roof which is pitched toward two interior roof leaders located within the rear building. See the attached sketch with Appendix A that shows the locations of the roof leaders and gutters.
