July 26, 2018
Revised April 30, 2019

Re: Infiltration and Inflow Investigation
208 Main Street Site Plan
City of Beacon, New York
Tax ID: 6054-39-349638

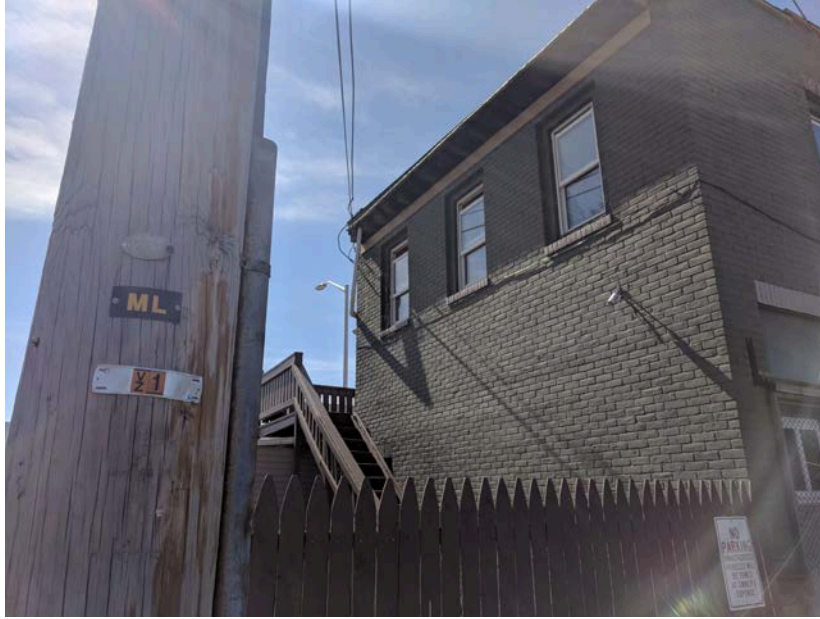
View of roof gutter and roof leader on rear of left portion of the building

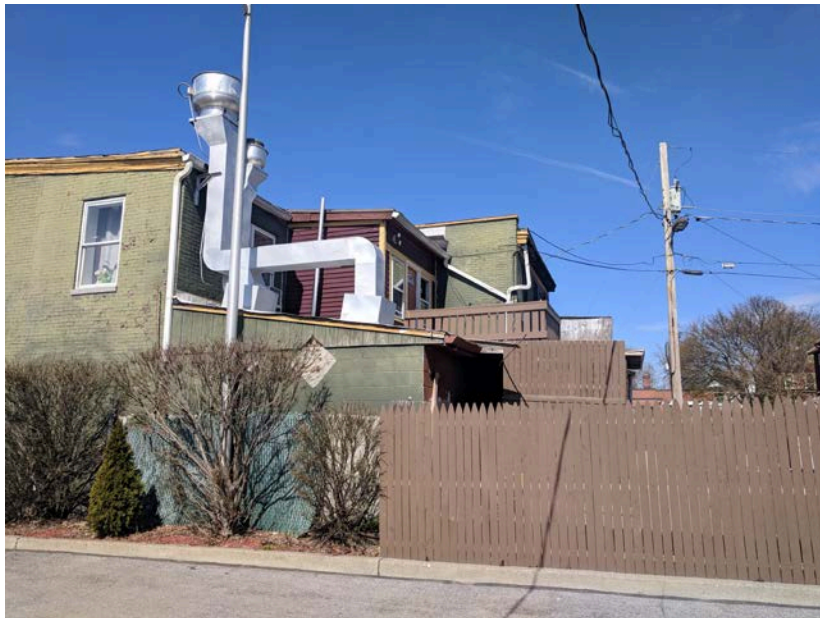
View of roof gutter and roof leaders on the rear of right portion of the building

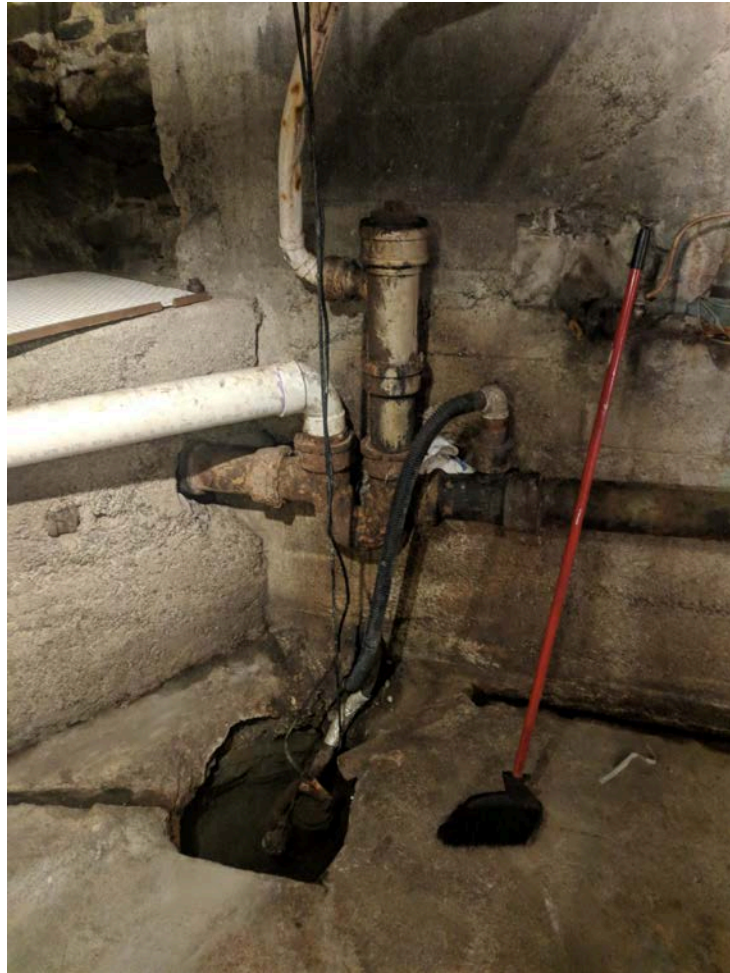
A single sump pump was observed in the southwest corner of the basement of the existing building adjacent to the building sewer lateral. It was observed that the sump

pump discharges directly into the sewer lateral, and ultimately to the City of Beacon's sanitary sewer system. The photo below shows the sump pump and force main pipe discharging to the sanitary sewer lateral.

On an average day, during a 1-year storm event, it is assumed that the existing sump pump will cycle approximately 20 times, discharging 120 gallons of water to the City of Beacon's sanitary sewer system.

Based on our observations, HLD believes that there are illicit stormwater connections from the building located at 208 Main Street to the City of Beacon's sanitary sewer collection system. The sump pump will be disconnected from the sanitary sewer and re-directed to discharge to the existing catch basin located at the corner of Main Street and Digger Phelps Court.
