July 25, 2019

Re: Infiltration and Inflow Investigation

Early Terrible Wine Bar 305 Main Street Site Plan City of Beacon, New York Tax ID: 5954-36-908866

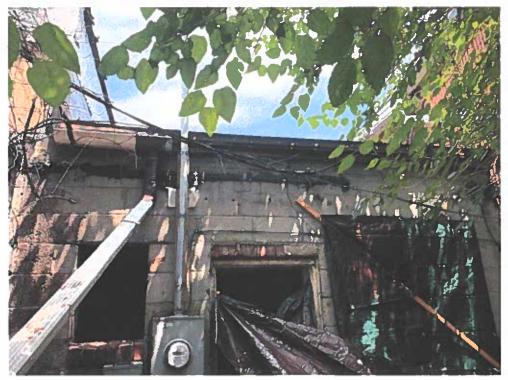
View of roof gutter and roof leader on rear of the building

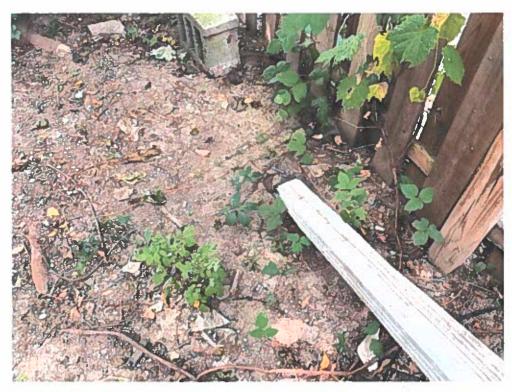
View of roof leader discharge point

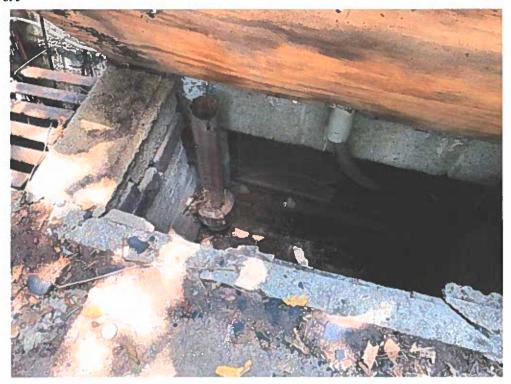
The first phase of the study consisted of an exterior inspection of the building on July 11, 2019 to determine the location of roof leader discharge points. The building has a gentle sloping roof from front to back. There is evidence that the roof leader was previously connected to sanitary sewer system, but it is currently disconnected and discharges to the ground to the rear of the building. The past connection to the sanitary sewer system is below grade and covered with plywood. Based on these observations, none of the rooftop runoff is connected to the sanitary sewer system. The existing pipe that is connected to the sanitary sewer will be removed as part of the project.

View of past roof leader connection to the sanitary sewer

- The remaining pipe that previously served to connect to the roof leader to the sanitary sewer system will be removed.
- The sump pump will be removed and rerouted to the roof leader discharge location.

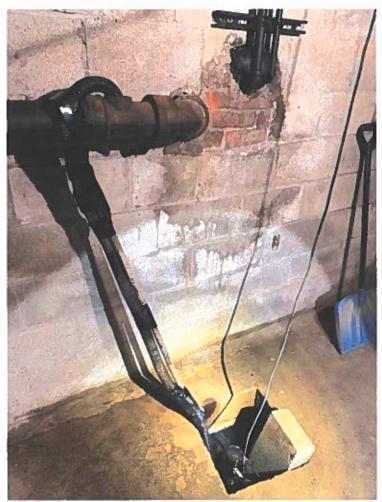
A single sump pump was observed along the northwest basement wall with a discharge to the building sewer lateral. It was observed that the sump pump discharges directly into the sewer lateral, and ultimately to the City of Beacon's sanitary sewer system. The photo on the next page shows the sump pump and force main pipe discharging to the sanitary sewer lateral.

View of basement sump pump and connection to sanitary sewer

On an average day, during a 1-year storm event, it is assumed that the existing sump pump will cycle approximately 20 times, discharging 120 gallons of water to the City of Beacon's sanitary sewer system.

Based on our observations, HLD believes that there are illicit stormwater connections from the building located at 305 Main Street to the City of Beacon's sanitary sewer collection system. The sump pump will be disconnected from the sanitary sewer and redirected to the roof leader at the rear of the building. The roof leader will also be extended to direct the discharge away from the building.
