Re: Infiltration and Inflow Investigation  
2 Cross Street Site Plan  
4 Cross Street & 172 Main Street  
City of Beacon, New York  
Tax ID: 5954-36-798971 (4 Cross Street)  
5954-36-799966 (172 Main Street)

Hudson Land Design (HLD) has completed an infiltration and inflow investigation (I&I) at the above referenced parcels as required by the City of Beacon. The investigation was conducted on August 23, 2019 at the existing buildings located at 172 Main Street and 4 Cross Street. 172 Main Street consists of a two-story masonry building that is occupied by a commercial space on the ground floor and residential apartments on the second floors. 4 Cross Street is a two-story masonry building that consists of residential apartment units.

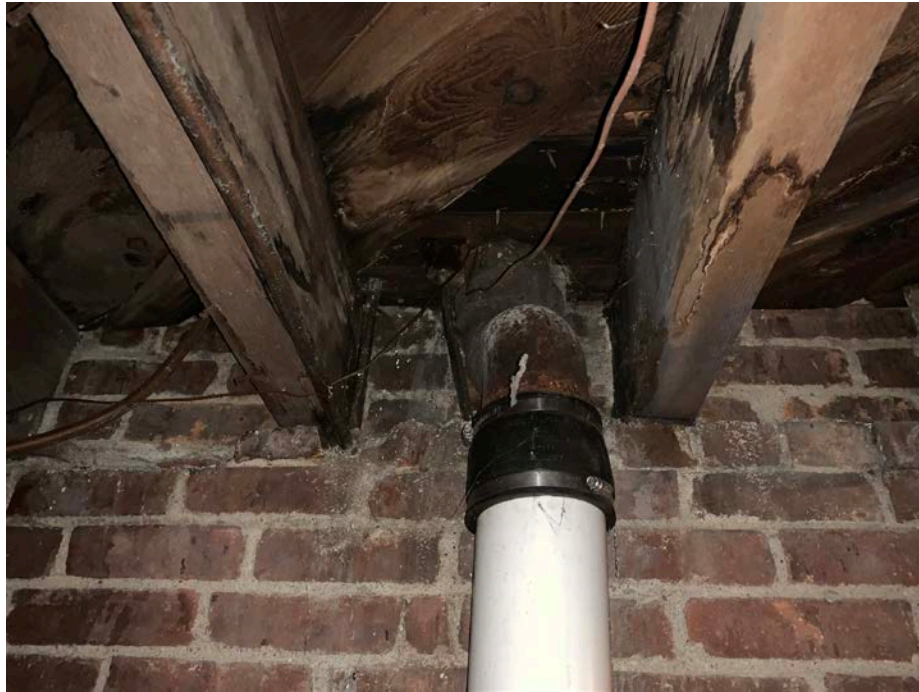
172 Main Street has a flat roof with parapet walls. Stormwater falls on the flat roof and is collected by a downspout on the eastern side of the roof which conveys the runoff through the interior of the building and connects to the sanitary sewer lateral within the building then to the sanitary sewer system located in Main Street. The existing downspout that is connected to the interior sanitary sewer lateral will be removed as part of the project. See Table 1 below for volumes of stormwater to be removed from the sanitary sewer system for the 1, 10, 25 and 100-year storm events. The hydraulic model can be found within Appendix A.

**Figure 1: View of Interior Roof Leader in 172 Main Street Basement**

- The interior roof leader at 172 Main Street will be removed from the sanitary sewer lateral and rerouted to the proposed stormwater conveyance system after design.
- The sump pump at 172 Main Street will be removed and rerouted to the proposed stormwater conveyance system after design.

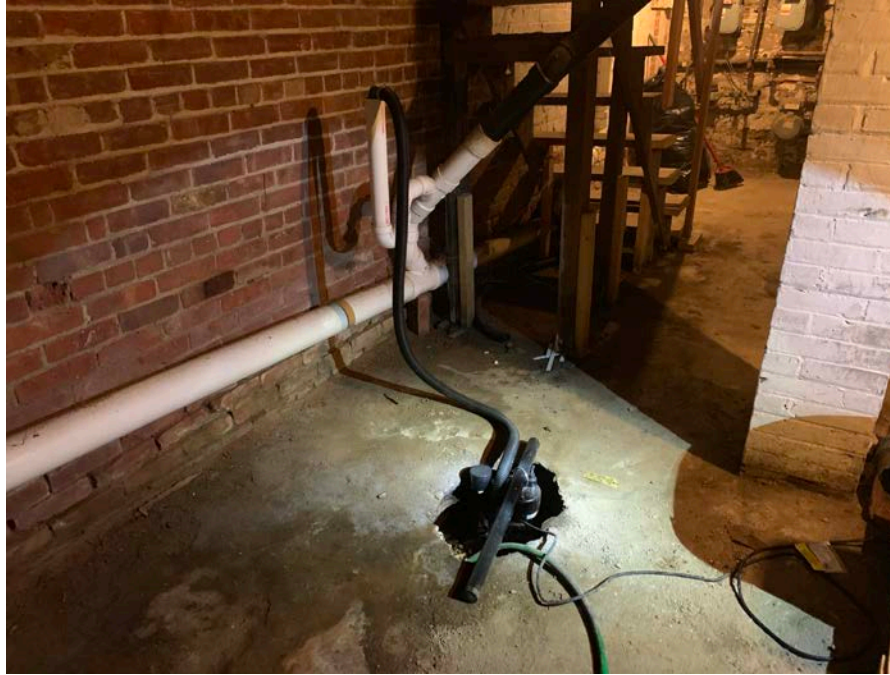
At 172 Main Street a single sump pump was observed along the eastern basement wall with a discharge to the building sewer lateral. It was observed that the sump pump discharges directly into the sewer lateral, and ultimately to the City of Beacon's sanitary sewer system. The photo on the next page shows the sump pump and force main pipe discharging to the sanitary sewer lateral.

**Figure 2: View of Basement Sump Pump and Connection to Sanitary Sewer in 172 Main Street Basement**

On an average day, during a 1-year storm event, it is assumed that the existing sump pump will cycle approximately 20 times, discharging 120 gallons of water to the City of Beacon's sanitary sewer system.

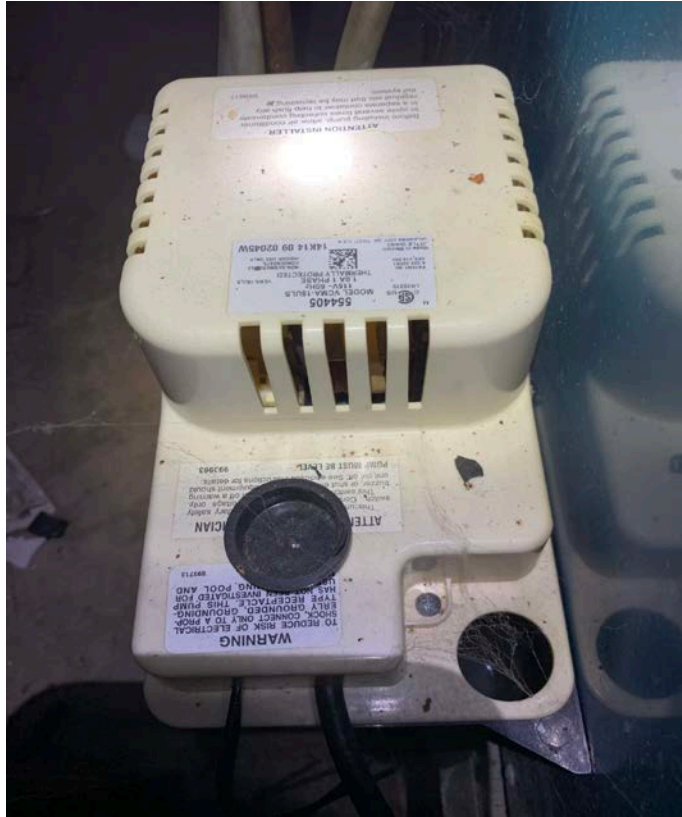
At 4 Cross Street a single furnace condensate pump was observed along the western basement wall with a discharge to the building sewer lateral. It was observed that the condensate pump discharges directly into the sewer lateral, and ultimately to the City of Beacon's sanitary sewer system. The photo below shows the condensate pump and 3/8" copper tubing discharging to the sanitary sewer lateral.

**Figure 3: Furnace Condensation Pump in 4 Cross Street**

be disconnected from the sanitary sewer and redirected to the stormwater sewer system during project construction and building renovation. The furnace condensate pump in 4 Cross Street discharges an insignificant amount of furnace condensation and is proposed to remain in the current configuration. See Appendix B for Inspection Sketch.

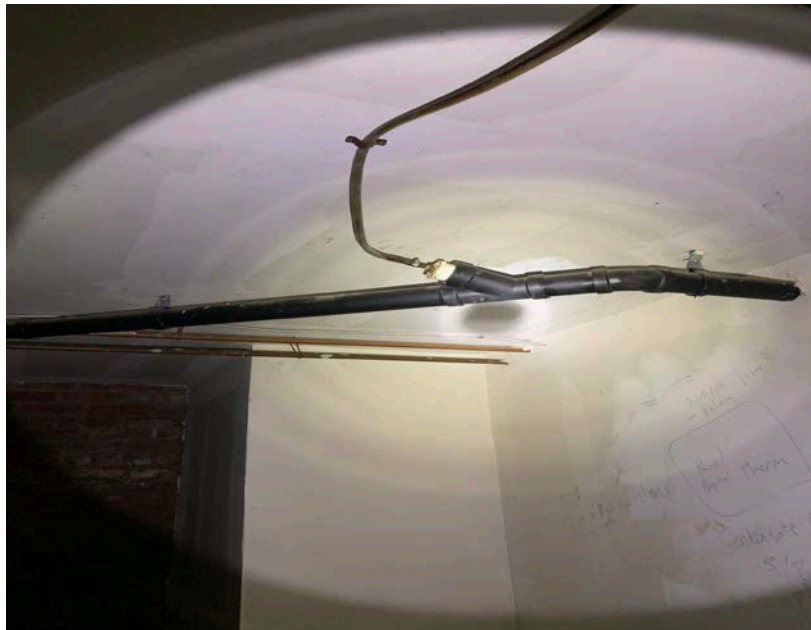
**Figure 4: 3/8" Copper Tubing from Condensate Pump to Sewer Lateral in 4 Cross Street**

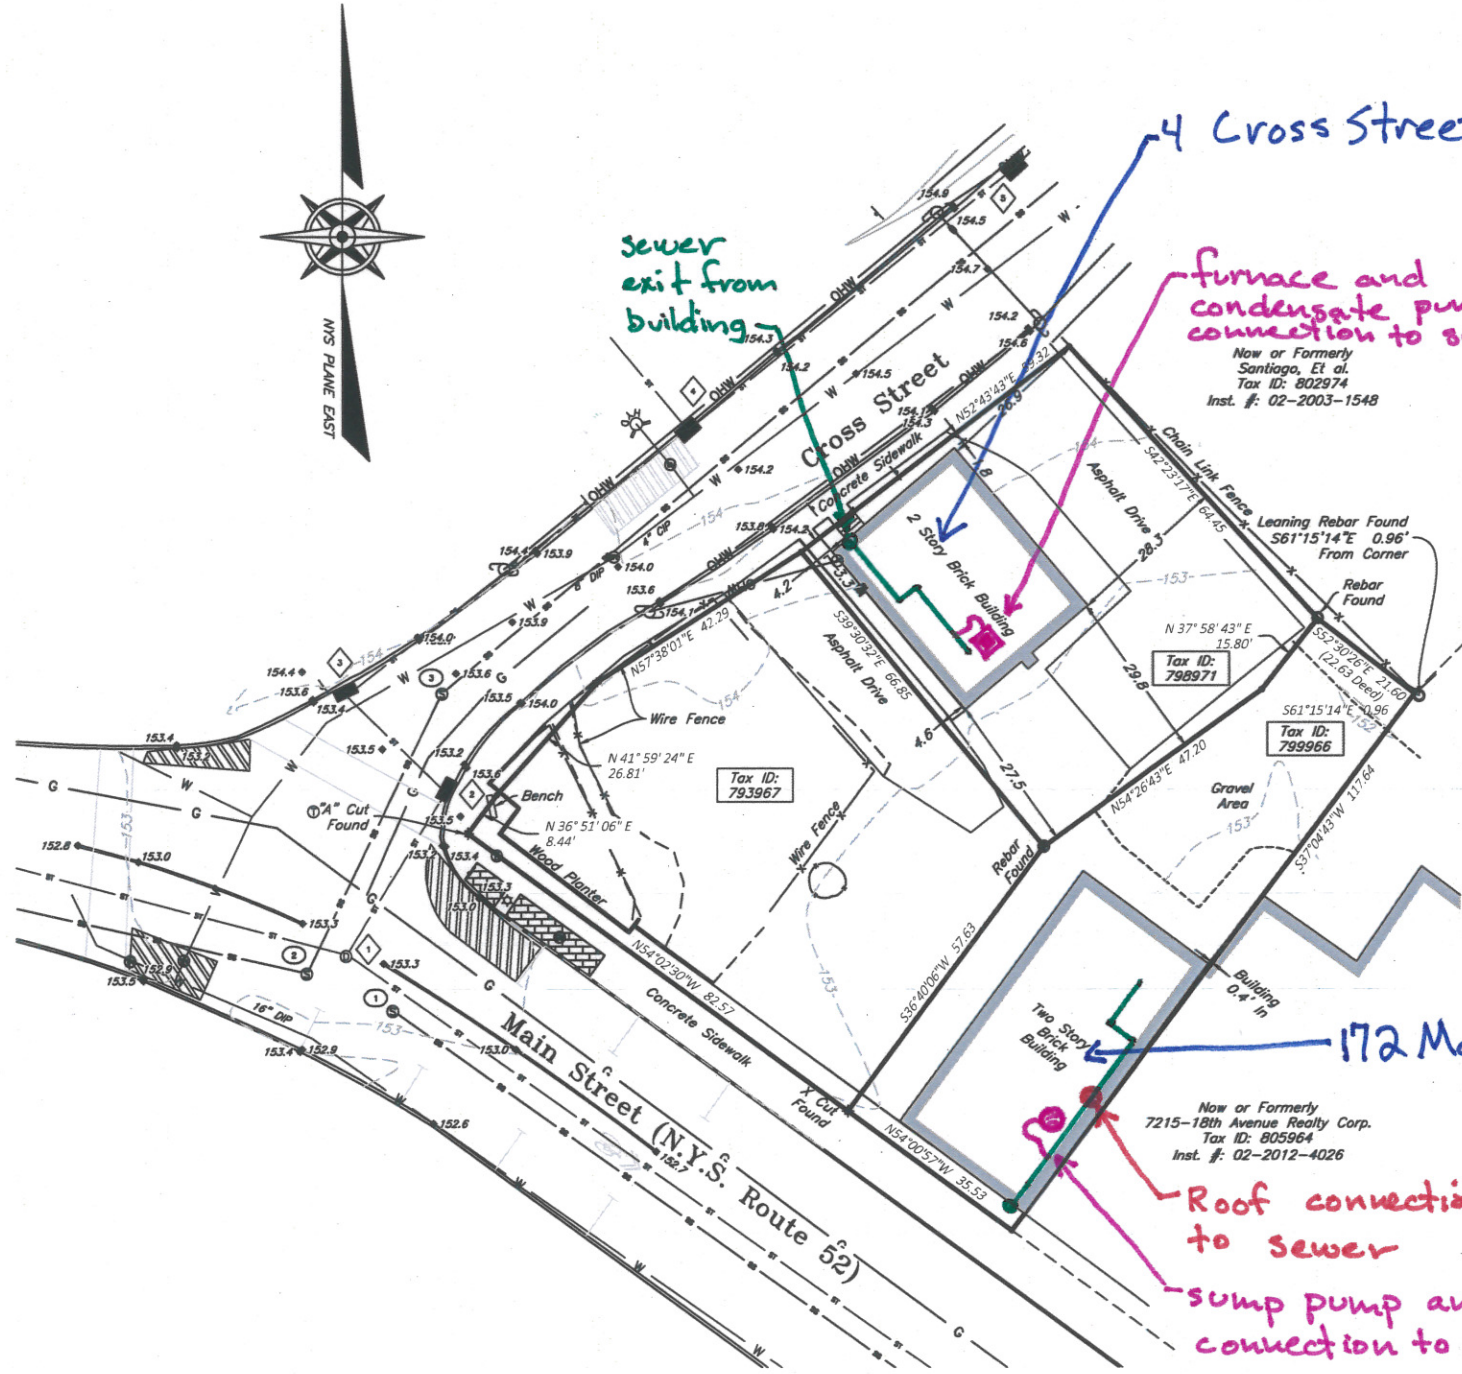
I+I observations  
8/23/19

Based on our observations, HLD believes that there are illicit connections from the buildings located at 172 Main Street and 4 Cross Street to the City of Beacon's sanitary sewer collection system. The sump pump and internal roof leader in 172 Main Street will
