# HISTORIC RESOURCE INVENTORY FORM

Address or Street Location 250 Main Street 13

Prepared by: John Clarke address 25 Beech Street, Rhinebeck, NY 12572

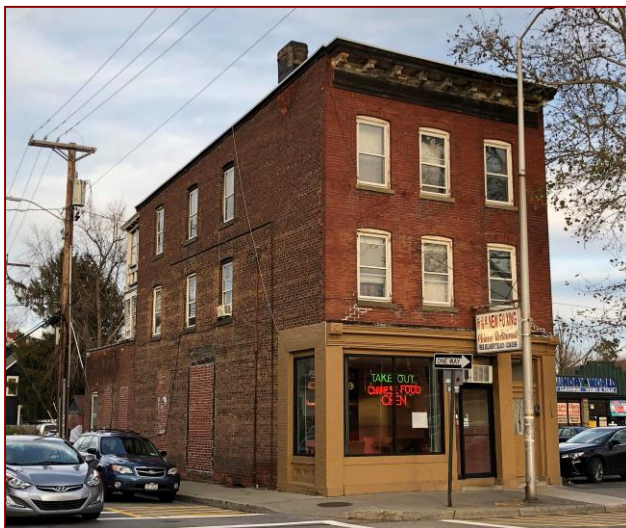
Front View

The building is located on the north side of Main Street on a narrow 0.05-acre lot. It is a three-story, three-bay brick building with a flat roof and brick chimney. The projecting cornice has regular modillions and a wide board underneath.

The windows have arched brick lintels and stone sills. The sashes appear to be modern replacements. There is a simple secondary cornice over the storefront with corner blocks. The storefront surrounds and the door to the upper floors look original, but the storefront window and door are modern.

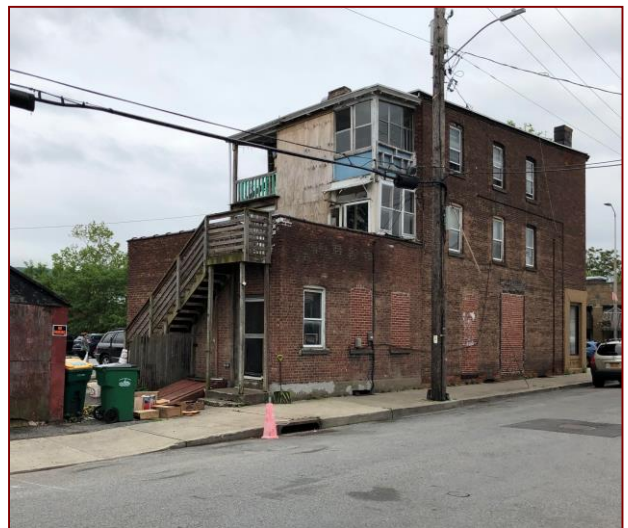
Rear View

There is a rear porch on the upper levels, one-story rear addition, and a more modern garage towards the rear of the lot. Three windows and a former doorway have been bricked-up on the west side of the building.

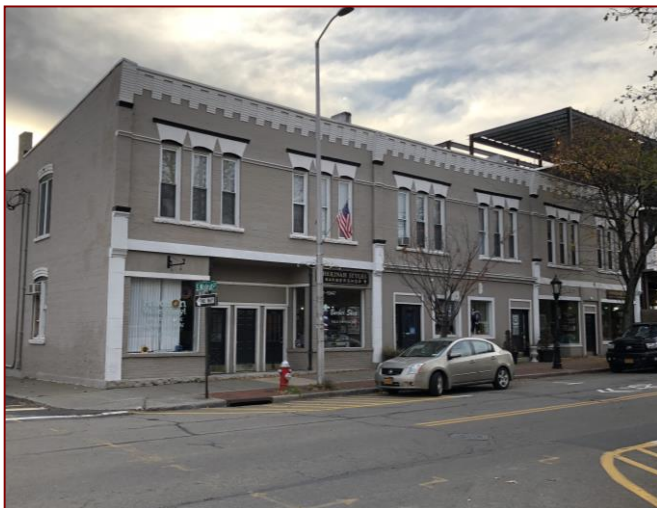
Front View

The building is located on the south side of Main Street on a 0.23-acre lot. It is a two-story painted brick building with a flat roof and three brick chimneys. The projecting cornice is formed by a regular pattern of corbeled brick.

The structure is divided into three sections by projecting piers with originally six storefronts and three separate doors to the upper floor. The tall, narrow second-floor windows are set in six groups of three with broad arching brick lintels, a drip band above, and stone sills below. There is a secondary cornice over the central section of the facade. The central storefront has been modernized, but the outer storefronts retain much of their original character.

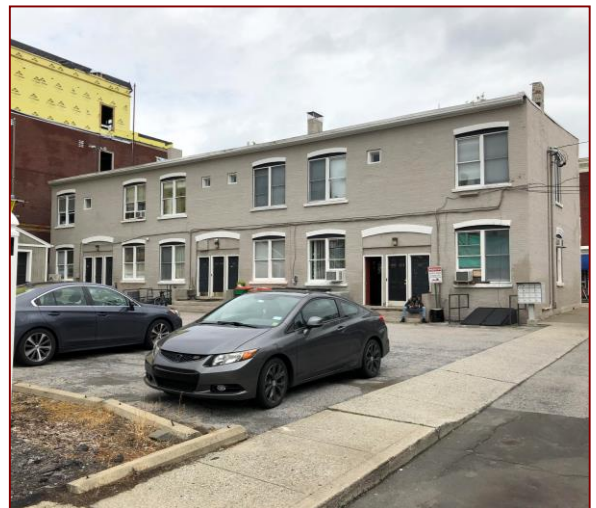
Rear View

The rear elevation features paired windows with arched brick lintels and stone sills and three doors to the three sections of the building. A modern garage sits at the far corner of the rear parking lot.

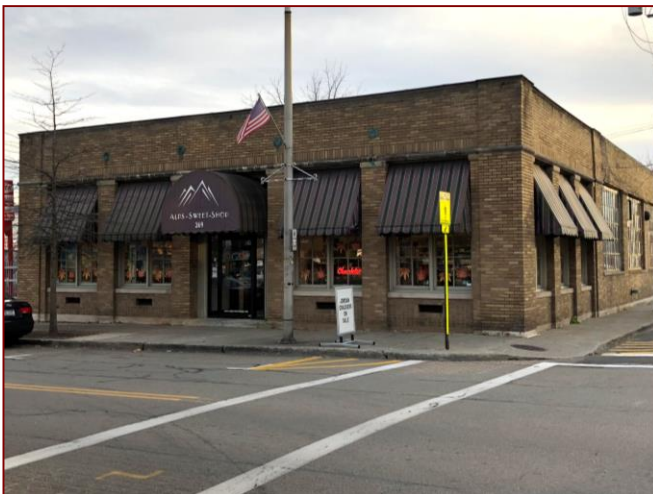
Front View

The building is located on the south side of Main Street on a 0.11-acre lot. It is a one-story brick building with a flat roof. The street-front brick walls contain multiple shades of light brown to tan, while the east and south walls are common red brick.

The Main Street facade is divided into five bays by pilasters with simple stone composite capitals and a stone string course and a soldier course of bricks above. Small metal medallions are placed over the four central pilasters. The cornice is a plain stone composite edge, as are the building's sills along the sidewalk.

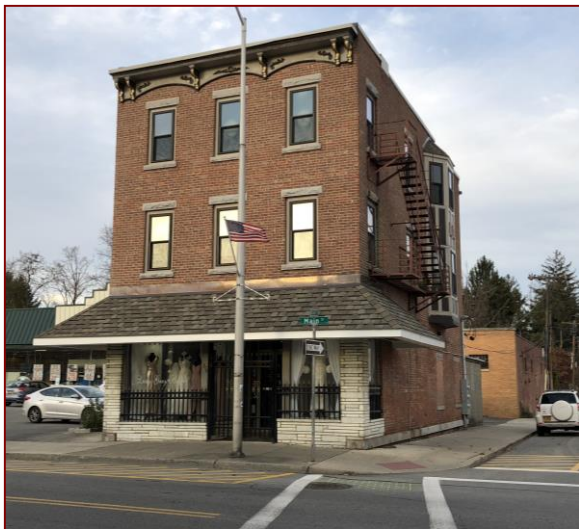
Front View

The building is located on the north side of Main Street on a narrow 0.07-acre lot. It is a three-story, three-bay brick building with a flat roof and rear brick chimney. The bracketed front cornice has paired brackets at the corners with an arching frieze board and attached scrollwork in between the brackets.

The windows have stone lintels and sills, although the sashes appear to be modern replacements. Two windows have been bricked-up on the east side first floor. The east side also has a steel fire escape and a bay window on the upper two floors, which is original to the building, but has been refaced with modern materials. The thoroughly modernized storefront features a broad asphalt shingled roof, horizontally laid white stone, and metal picket fencing in front of the windows.

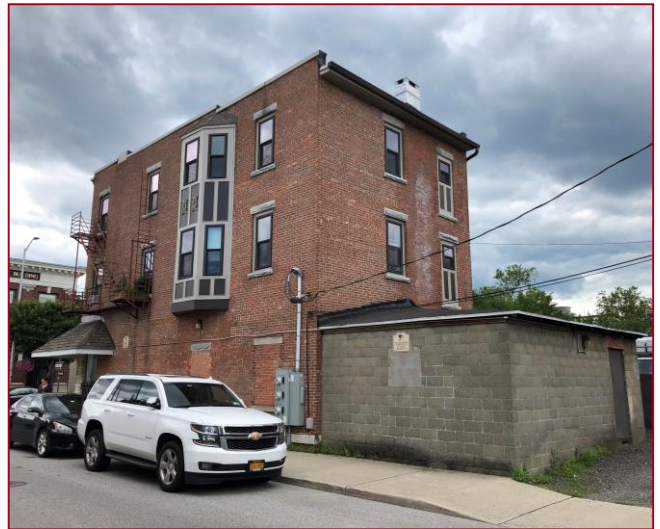
Rear View

There is a modern, cement block, one-story rear addition.

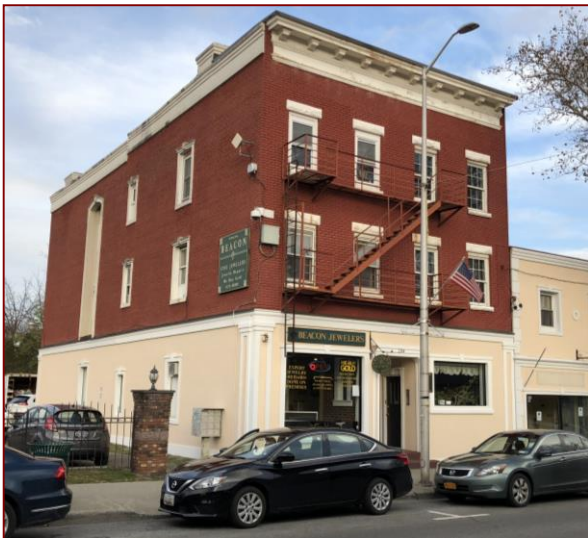
284 Main Street

The building is located on the north side of Main Street on a 0.19-acre lot. It is a three-story, four-bay painted brick building with a flat roof and four end-wall brick chimneys. The front overhanging cornice has regularly spaced modillions and a frieze board with moldings.

The south windows have stone lintels and sills, although the sashes appear to be modern replacements. On the west side the windows are wood framed with central keys above, as is the pointed arch above the recessed window well on the two upper floors.

The west side first floor and front storefront have been covered over with a modern stucco pattern with corner pilasters. The front windows and door are all modern. Steel fire escapes are also hung off the front and rear sides of the structure.

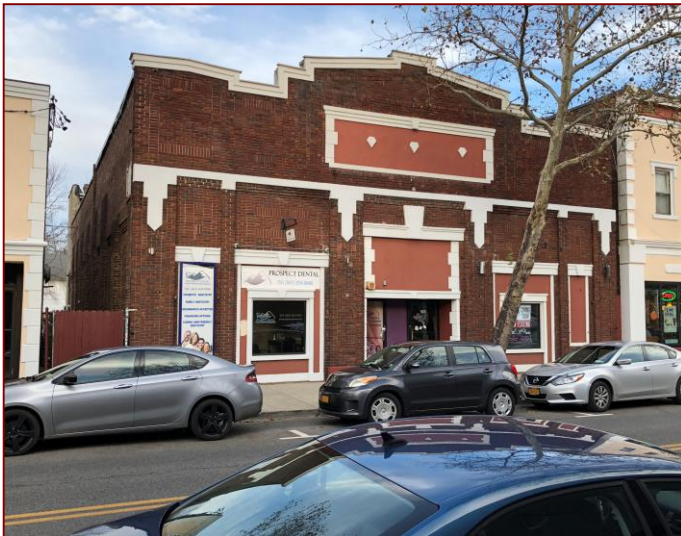
Front View

The building is located on the north side of Main Street on a 0.18-acre lot. It is a 1½-story brick building with a 2-story rear section and flat roof. The building has bold Art Deco elements, probably added in the 1930s, well after the original construction date, when it was converted into a movie theater. The original brickwork features six pilasters across the front and multiple rectangular brick patterns made from stacked and soldiered brick.

The south side windows and doors appear to be more modern replacements. The first floor doorway has keyed top and side quoins and the first-floor windows also have wide bands above with exaggerated central keys.

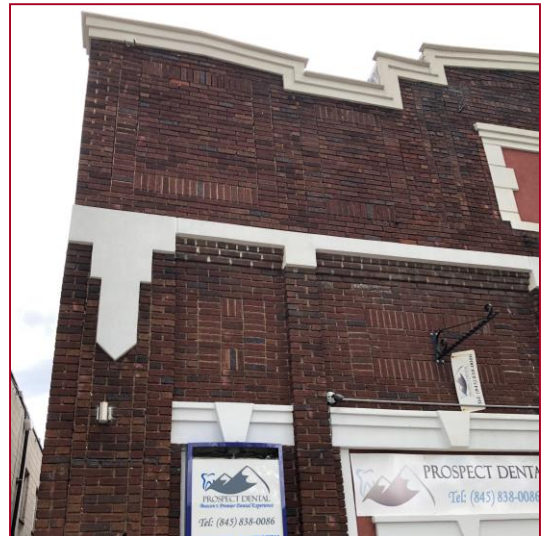
Brick Details

Contributing stylized Deco features include a shaped parapet cornice, a second level central panel, and an applied band above the first floor with dropped geometric shapes.

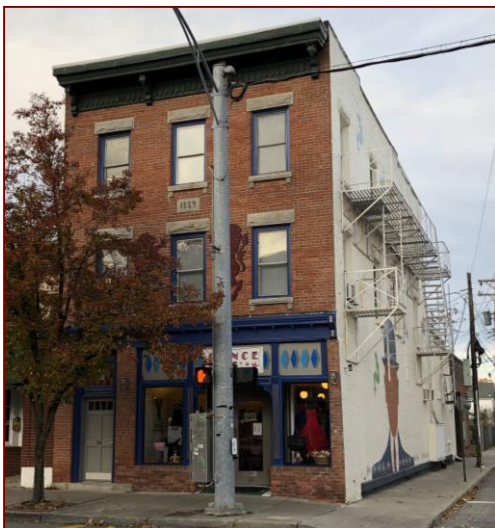
Front View

The storefront has an original secondary cornice with large end brackets and smaller central brackets. The storefront and side door with transom light have been replaced, but are historically compatible. The construction date of 1889 is carved into a central stone between the upper floor windows.

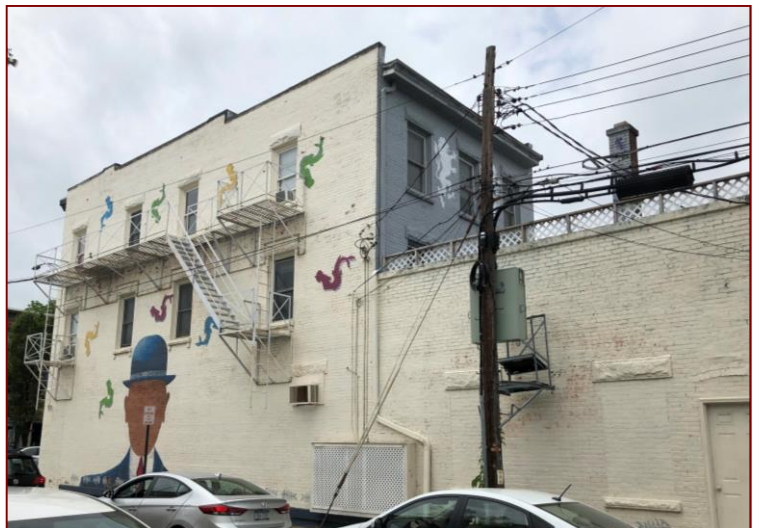
East Side View

The windows have large stone lintels and stone sills with small lower corner blocks, but the window sashes appear to be modern replacements. The side walls and one-story rear addition are painted white. The side facing South Chestnut Street has painted artwork, a steel fire escape, and several bricked-over window openings on the first floor.

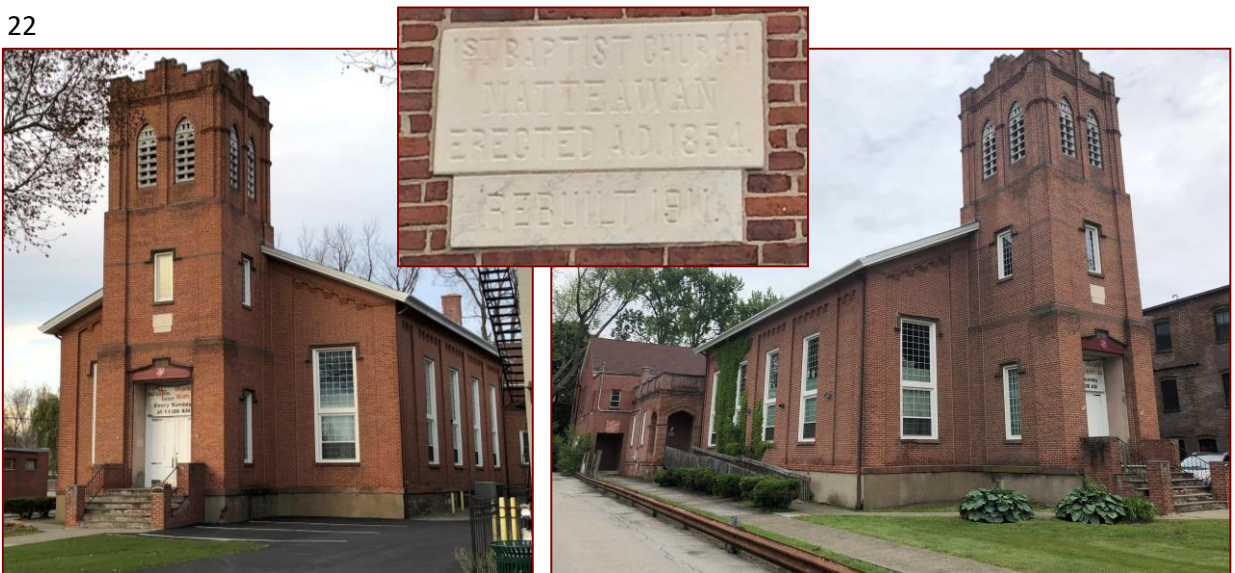
372 Main Street Front View and East Side

The brick church is located on the north side of Main Street set back from the street on a 0.6-acre lot. The main section has square brick corbelling under the eaves, and the square bell tower up front has Gothic Revival details, such as pointed arches and a crenellated top. There are stone courses along the top of the foundation and dividing the tower into three levels.

The construction dates are carved into a central stone above the double front doors, which have multi-pane transom windows. The windows are set in recessed brick panels with stone lintels and sills. The windows facing the street and on the tower have stone drip-molds over the top. The window sashes are more modern replacements.

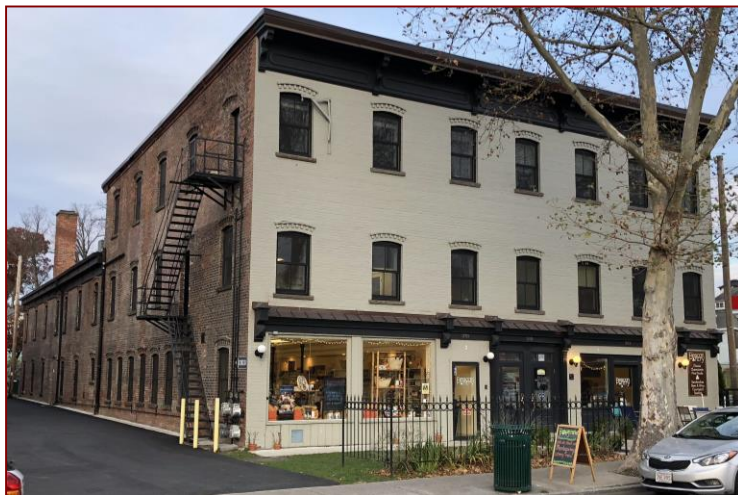
Front View

The front overhanging cornice has six regularly spaced brackets and a frieze board with a rounded raised panel pattern in between the brackets. The storefront has a contributing secondary cornice with large decorative brackets. The eastern and western storefronts have been replaced, but are historically compatible.

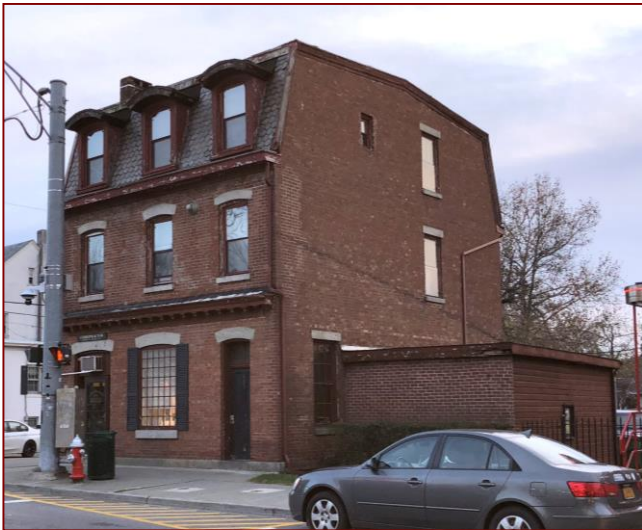
Front View

The second-floor cornices, front and rear, are simple in form, but the storefront cornice has regularly spaced modillions. The storefront features a central 48-pane window. The commercial door has side lights and the transom covered over by an air conditioner. The door to the upper floors has an original transom window.

The windows have large arched stone lintels and stone sills on the Main Street side with primarily straight stone lintels and sills on the other elevations. The window sashes appear to be a combination of original and modern replacements. There is also an original small rear porch with scroll-cut corner brackets and a modern, one-story brick addition to the east side.
