## MEMORANDUM

RE: JMC Project 18119  
Beacon Commons  
16 West Main Street  
City of Beacon, New York

SUBJECT: **Inflow & Infiltration Study**

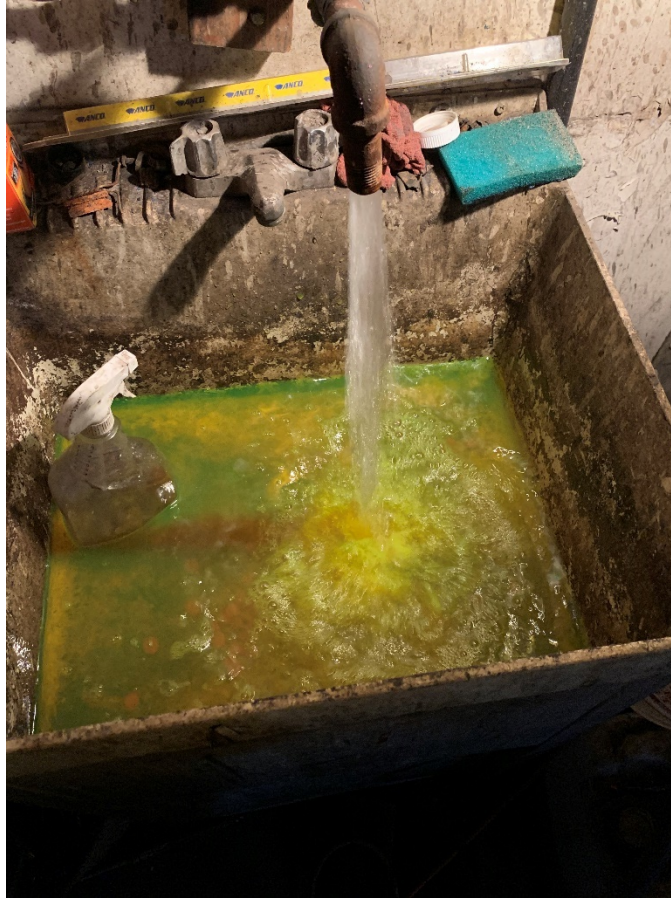
Photo 1: Dye Inserted in Sink

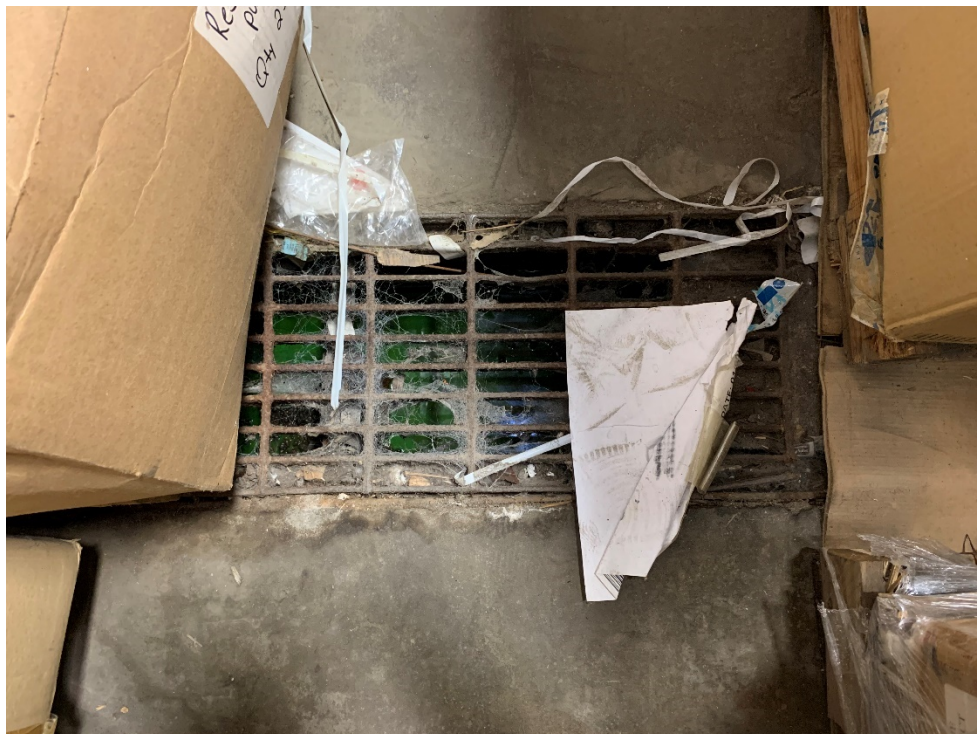
Photo 2: Dye Observed in Floor Drain inside Building

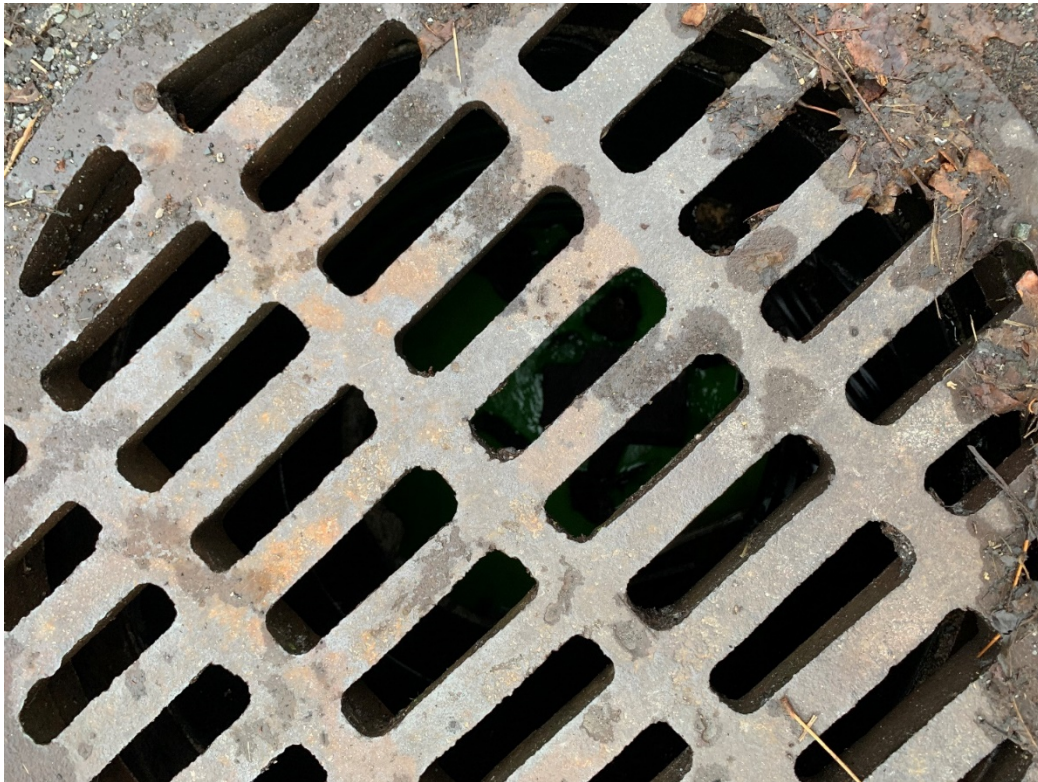
Photo 4: Dye Observed in Rear Storm Drain Inlet

It was determined that the wash sink in the rear of the building which drains into the existing floor drain through the middle of the building eventually drains to the exterior rear parking lot drainage system. There is a drain inlet in the rear parking lot drainage system that receives discharge from the interior of the building as noted on the figure. The other exterior drains at the rear of the building did not receive discharge from the interior of the building since the fluorescent dye was not observed in those structures. The existing City storm drain inlets in Bank Street and at the intersection of Bank Street and West Main Street also contained fluorescent dye which indicates that they receive flows from the rear parking area drain inlet.

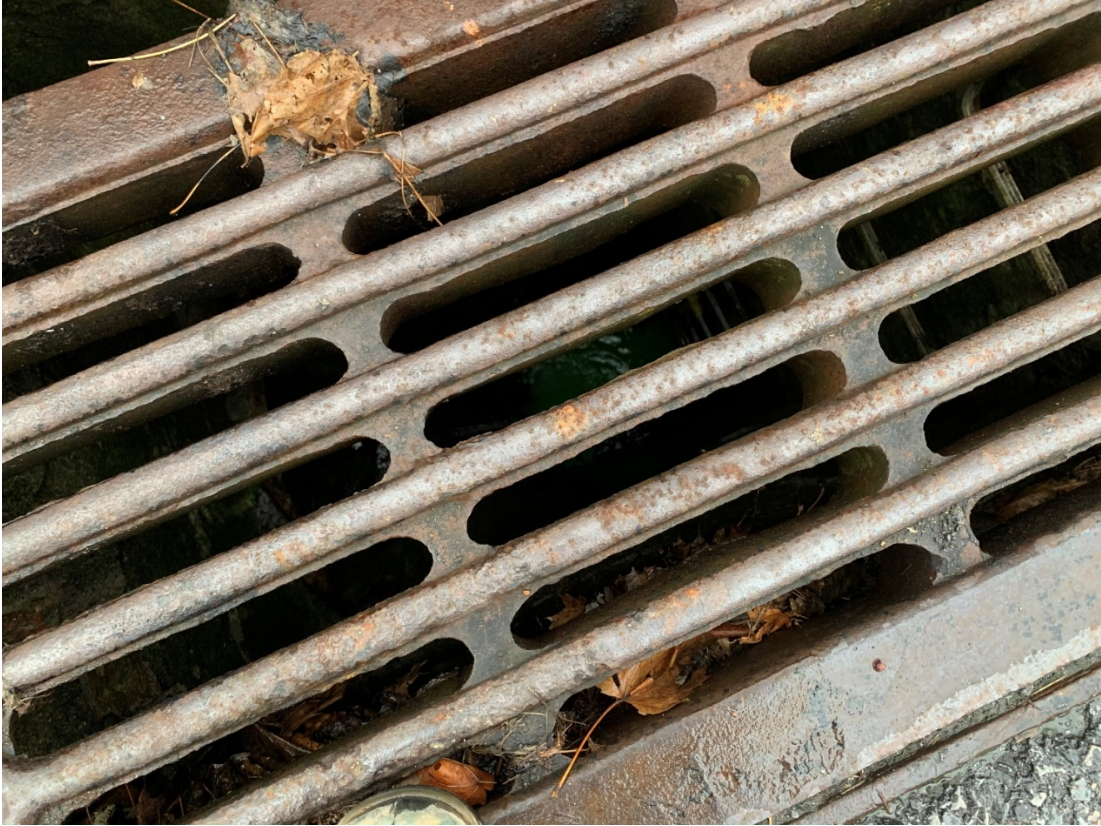
Photo 5: Dye Observed in Bank Street Upgrade Storm Drain Inlet

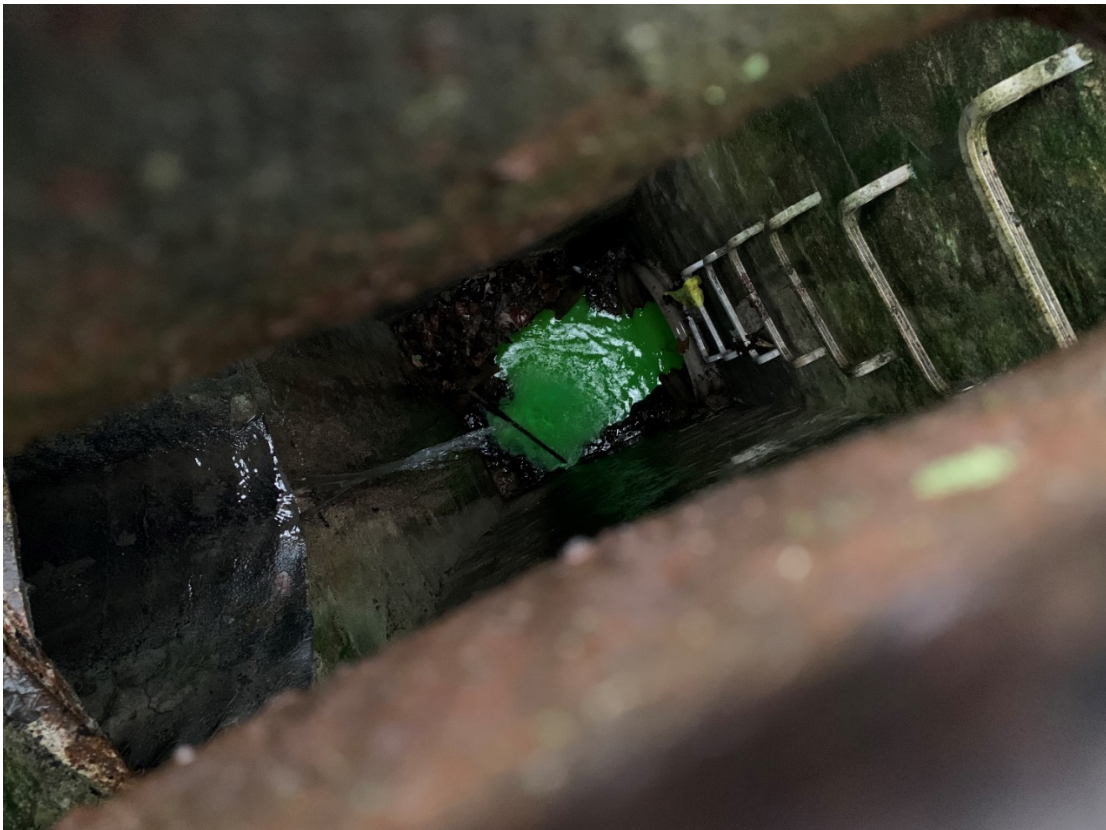
Photo 6: Close-Up of Dye Observed in Bank Street Upgrade Storm Drain Inlet

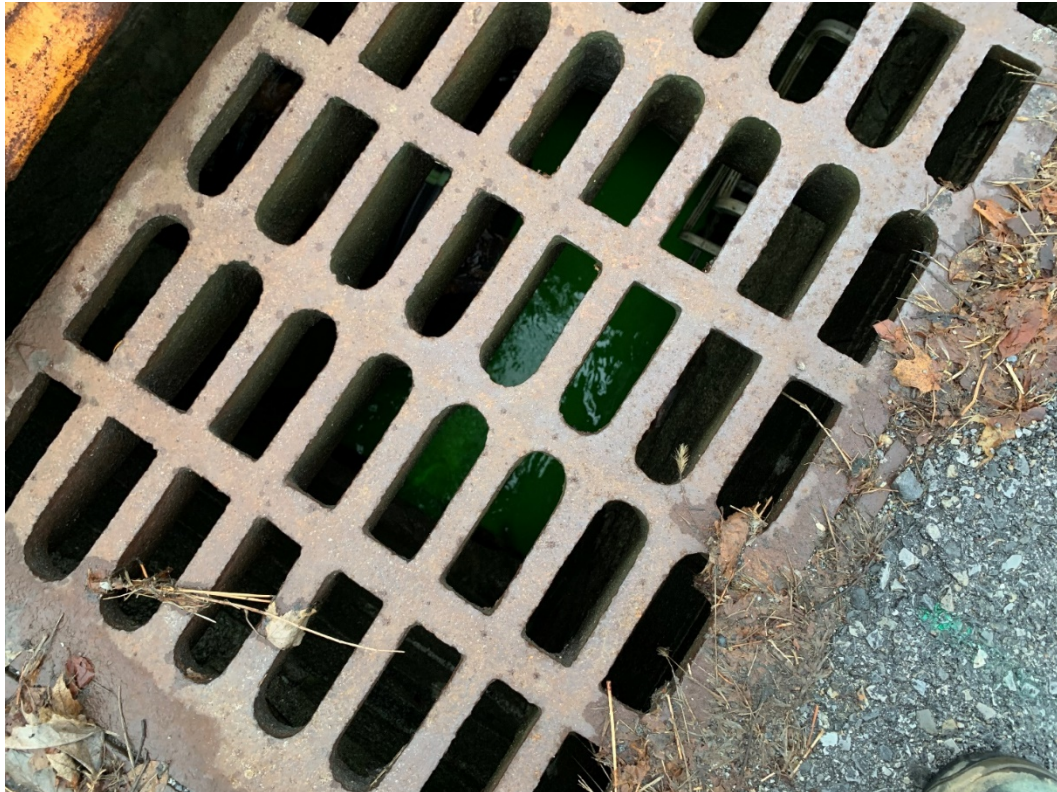
Photo 8: Dye Observed in Bank Street Downgrade Storm Curb Inlet

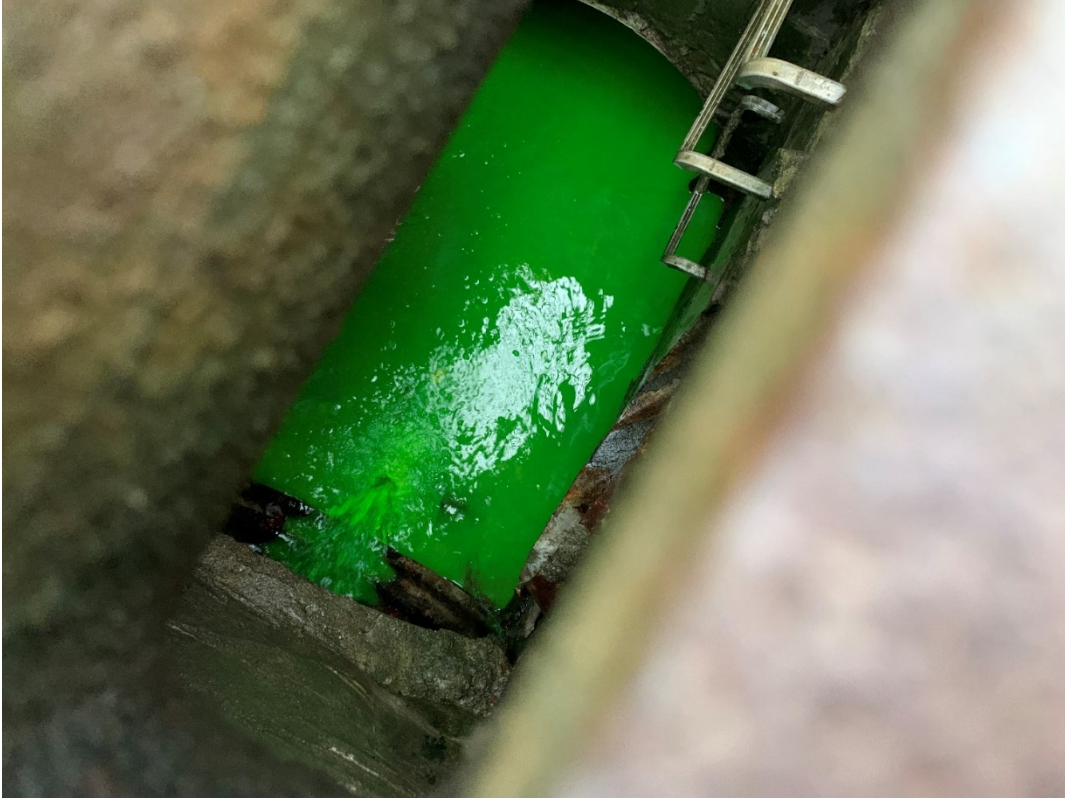
Photo 9: Close-Up of Dye Observed in Bank Street Downgrade Storm Curb Inlet

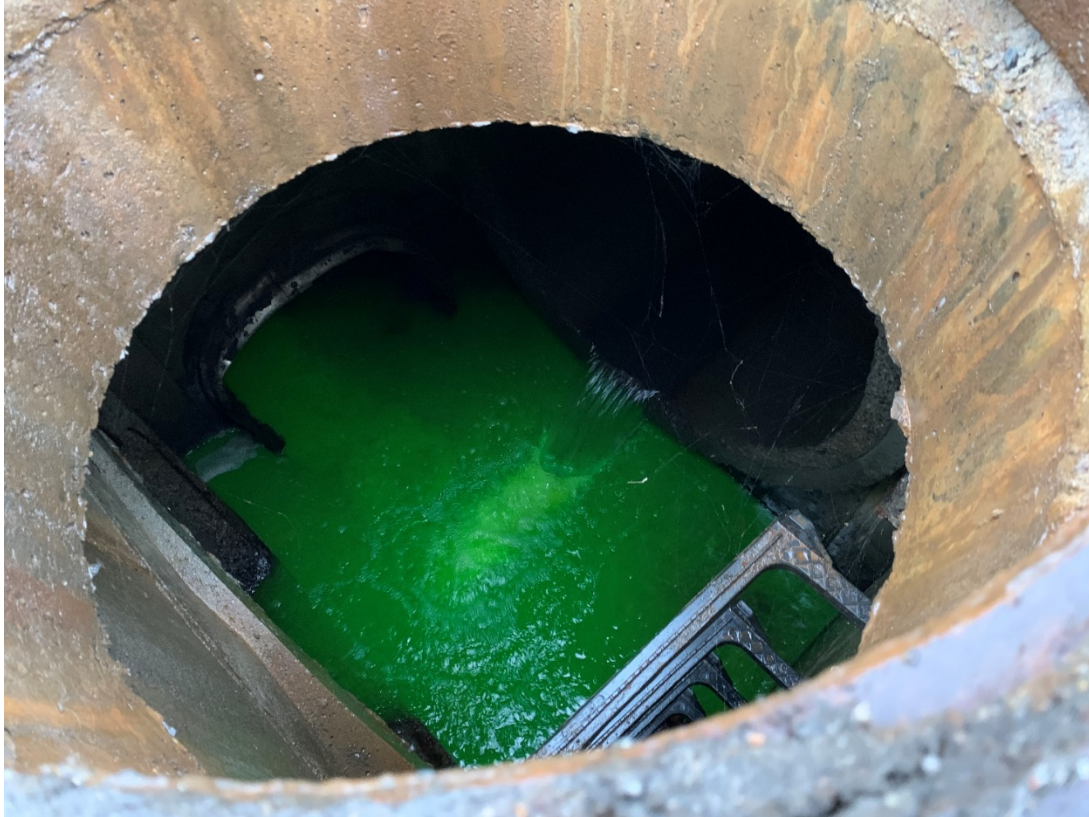
Photo 11: Dye Observed in West Main Street Storm Drain Manhole

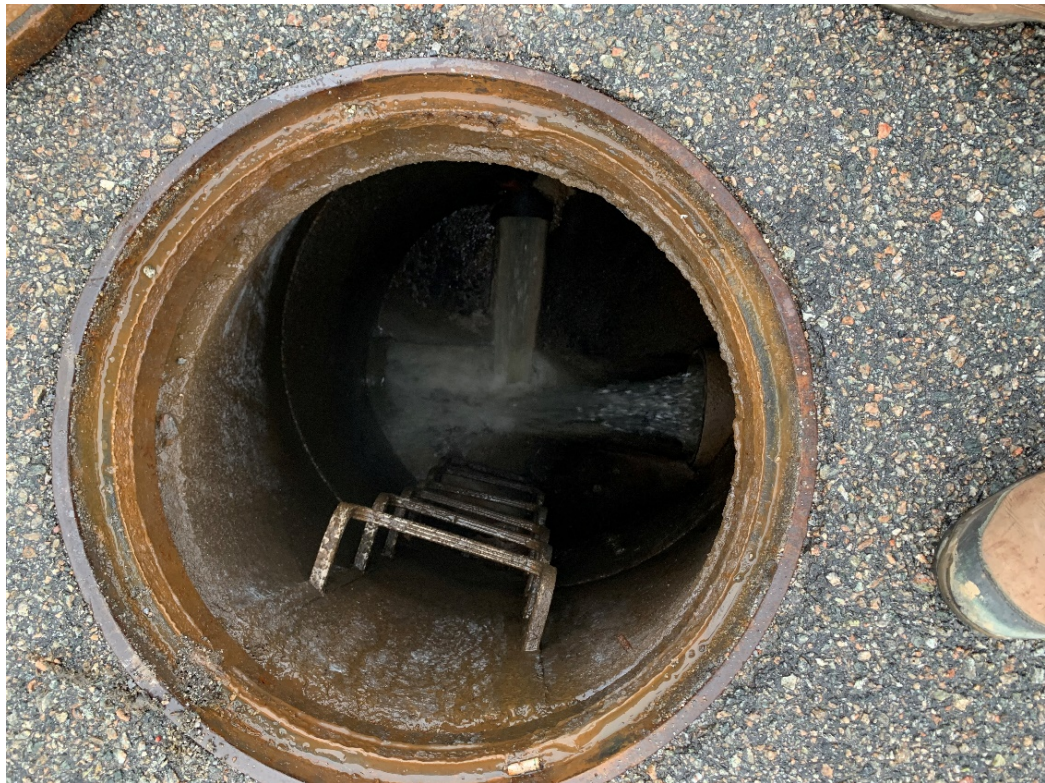
The sanitary sewer manhole in West Main Street did not receive any dye which indicates that there are no illegal or inadvertent stormwater discharges into the City sewer system. A considerable amount of stormwater from the recent storm was observed flowing through the sanitary sewer as shown in the photos below.

Photo 13: Heavy Stormwater Flow in West Main Street Sanitary Sewer Manhole  
(Dye Not Observed)
