Re: Infiltration and Inflow Investigation  
Hudson Beach Glass site  
162 Main Street  
City of Beacon, New York

Hudson Land Design (HLD) has completed an infiltration and inflow investigation at the above referenced parcel as required by the City of Beacon. The investigation was conducted on March 24, 2017 at the existing building at 162 Main Street, which consists of a three-story brick façade building with a one-story addition, which serves Hudson Beach Glass.

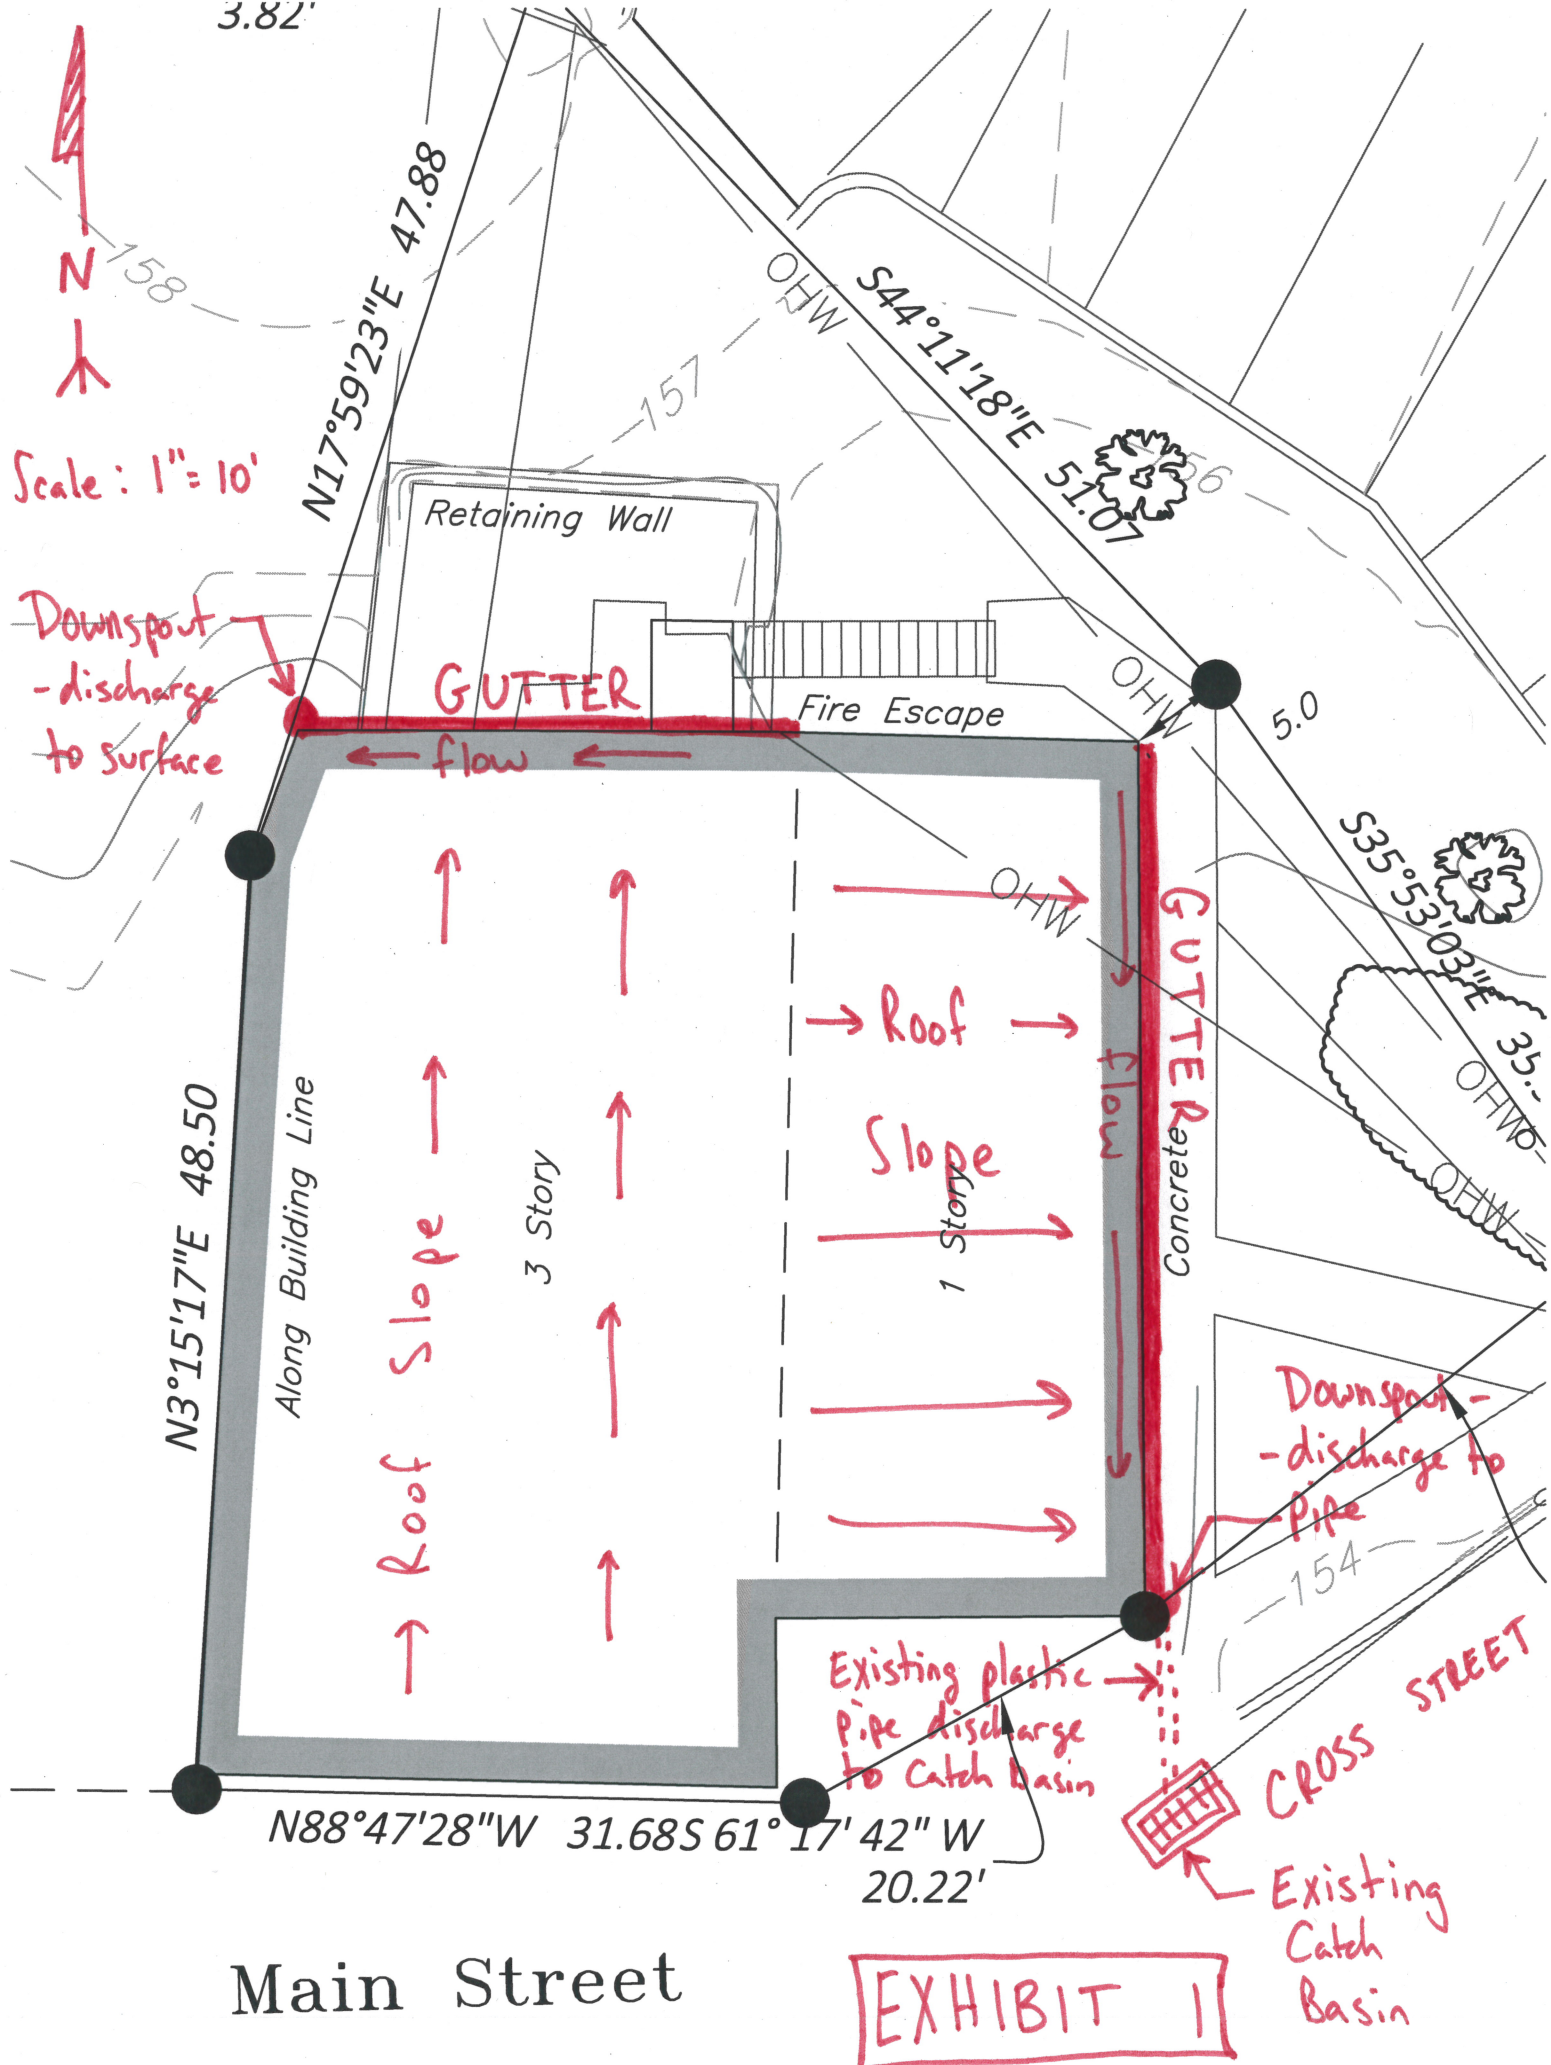
EXHIBIT 1

The first phase of the study consisted of an exterior inspection of the building to determine the location of roof leader discharge points. The three-story building has a flat roof that discharges northerly (to the rear of the building) where there is a gutter that collects and conveys the runoff westerly. At the northwest corner of the building, there is a downspout that visibly discharges to the surface. The one-story building also has a flat roof that pitches easterly toward a gutter that collects and conveys flow southerly. At the southeast corner of the building, there is a downspout that discharges into a corrugated pipe along the sidewalk/building interface. The collection pipe is a black corrugated plastic pipe that discharges directly into the catch basin at Cross Street. The same black corrugated pipe was observed in said catch basin. The attached exhibit 1 shows the general schematic of the above described roof drainage system.
