M. A. Day Engineering, PC

Re: Building #16
Beacon Lofts

I am writing this letter to state that I have inspected the building known as #16 at the Beacon Lofts project in the City of Beacon. The purpose of inspecting the building was to determine the viability of restoring the building in its current condition. Based on my review, I offer the following:

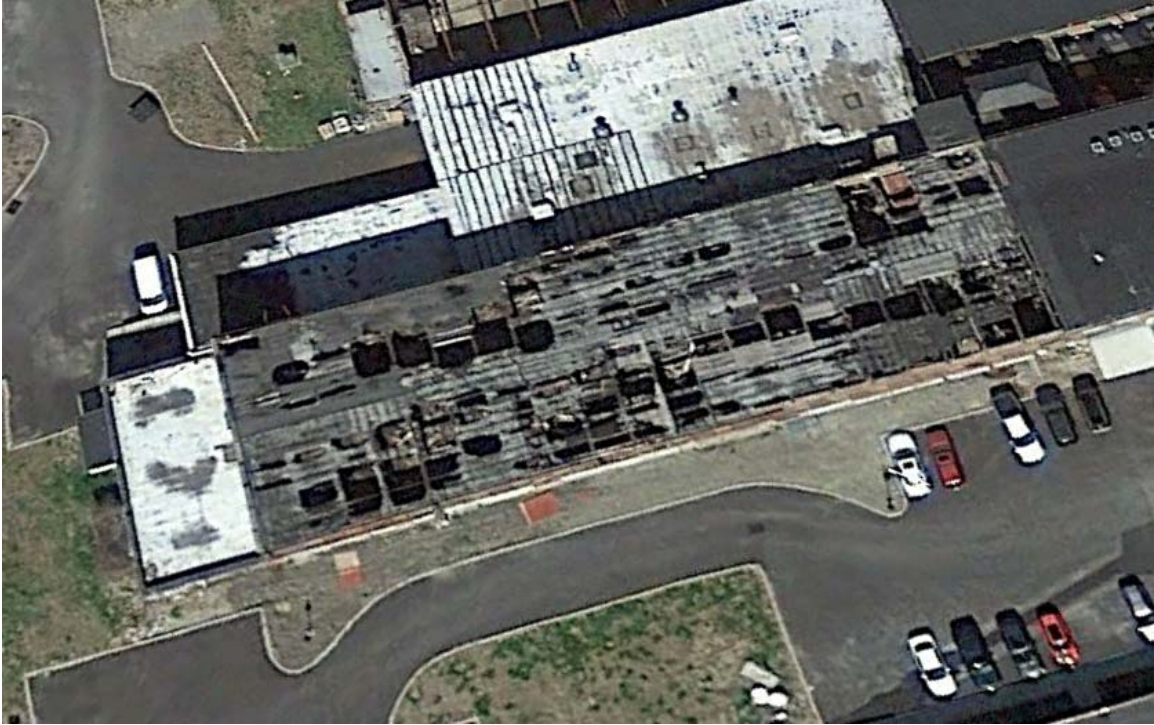
Figure 1 – Recent Excerpt from Google Earth

Currently most of the roof has deteriorated. The remaining trusses are in very poor condition and some have begun to fail. Some of the framing from the lower floors have also begun to fail.

It is my opinion that the building should be carefully razed in order to protect the attached structures.
