February 27, 2018  
Revised April 24, 2018

Re: Infiltration and Inflow Investigation  
1181 North Avenue Professional Building Subdivision and Special Use Permit  
1181 North Avenue  
City of Beacon, New York  
Tax ID: 5955-19-716048 ( $\pm 0.70$  acres)

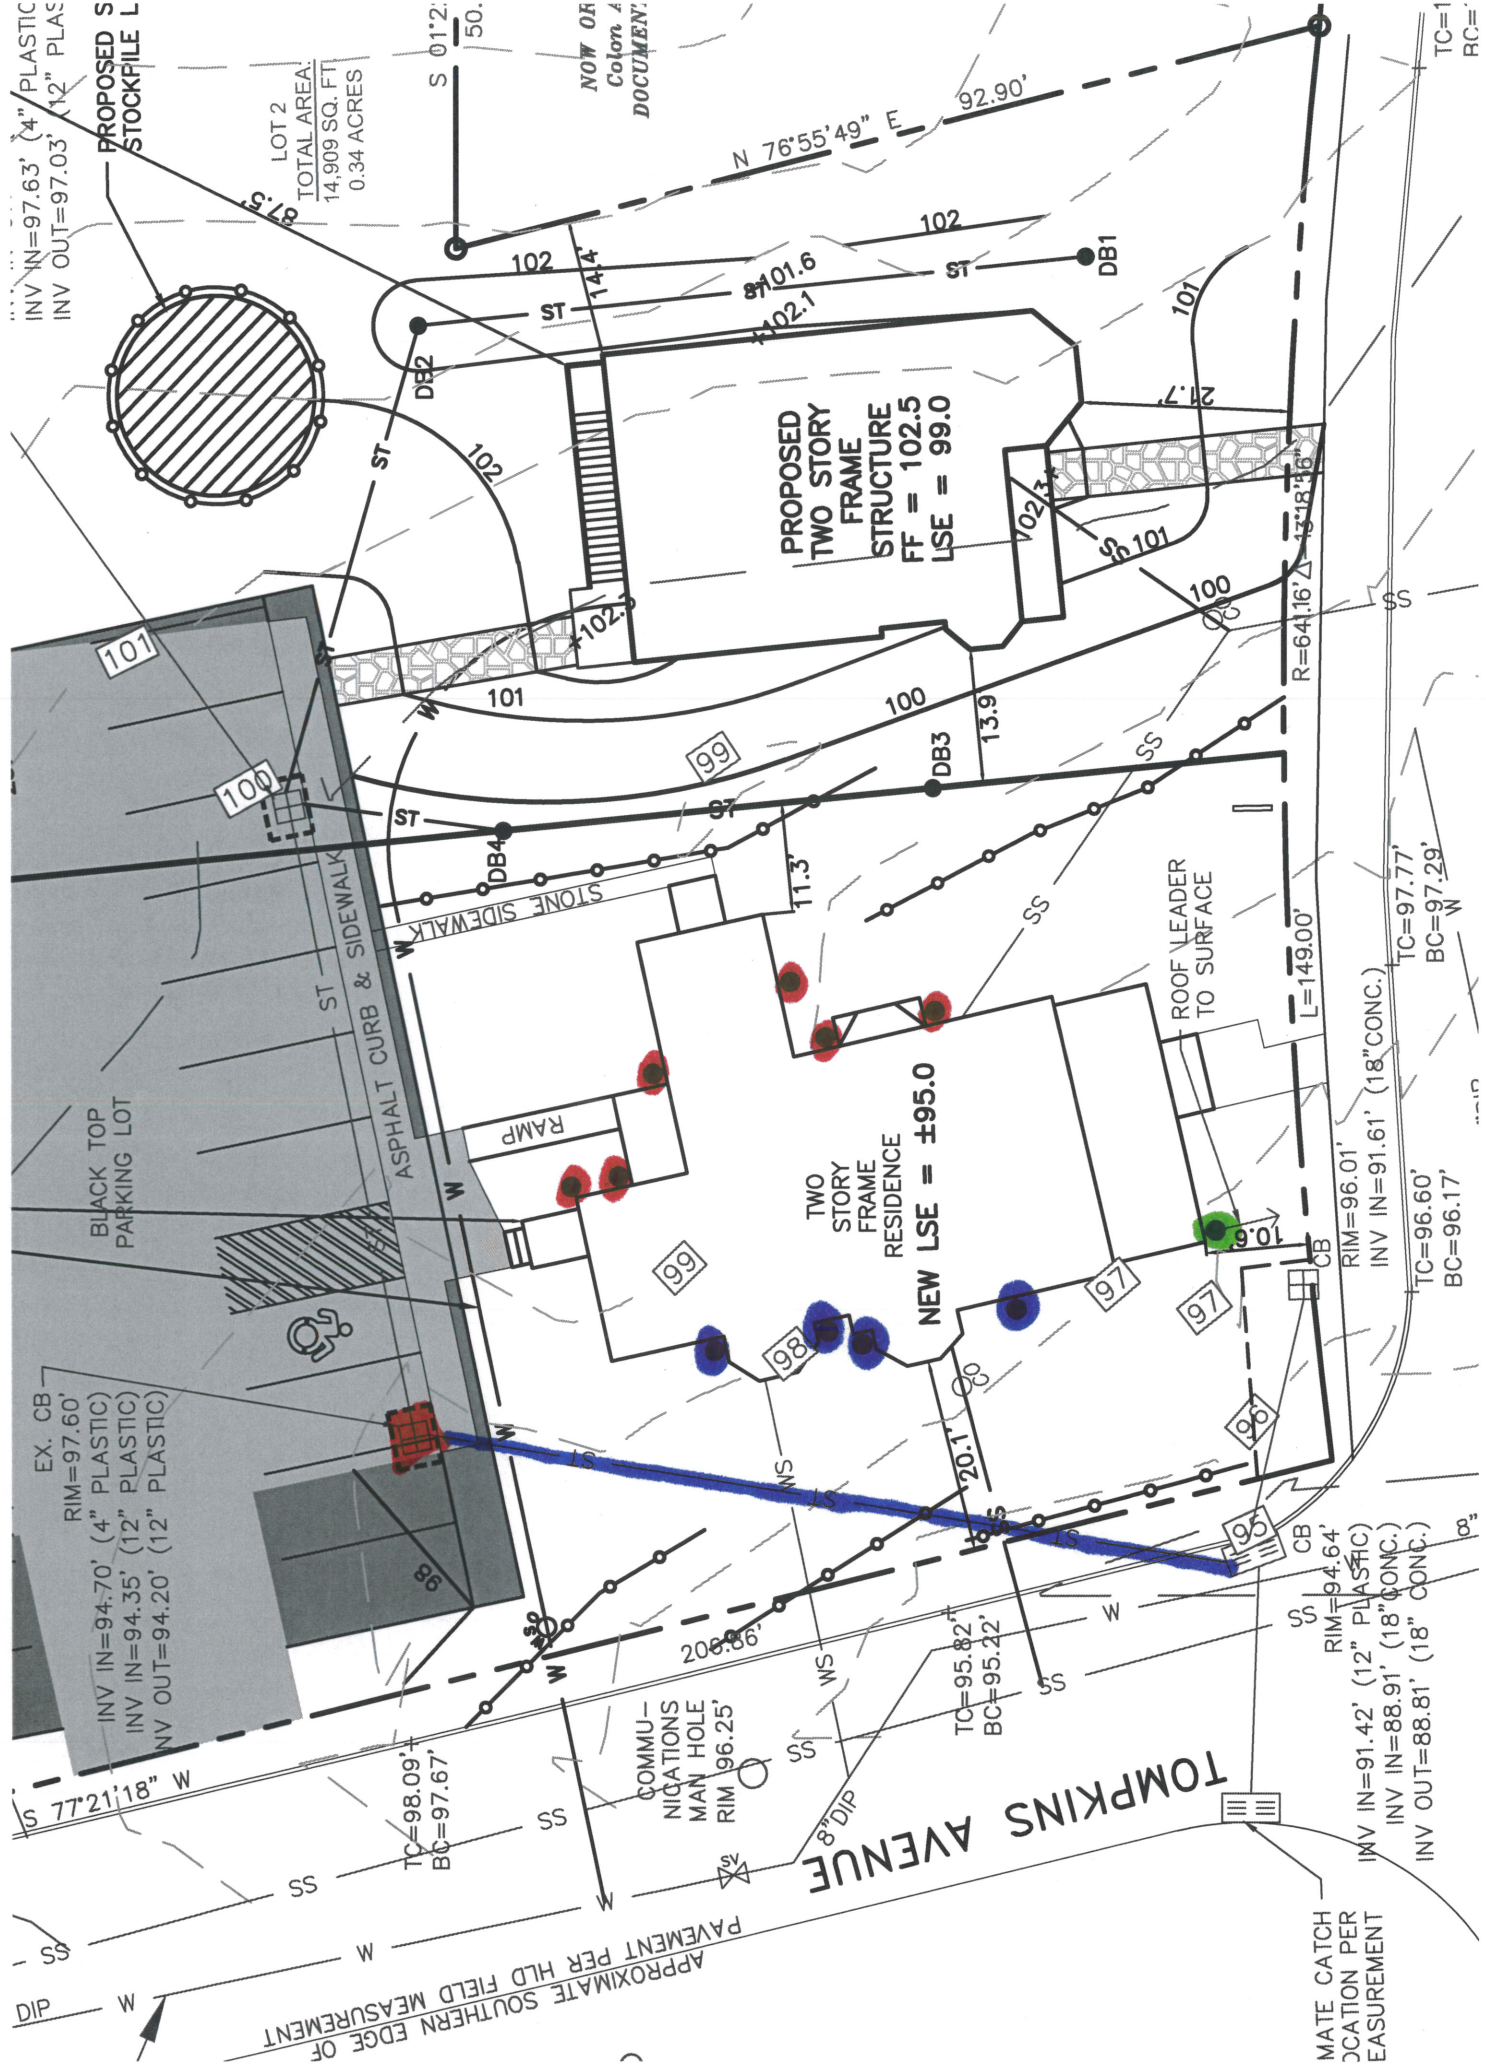
The April 2018 investigation sought to corroborate the presumed discharge location of the PVC piping. Water was piped into the PVC piping at the roof downspout locations from a hose. Referring to the attached sketch, the downspout locations color coded in red were found to discharge into the existing catch basin also color coded in red. These were generally the downspouts on the north side of the building.

For the southern downspout locations, water was added but not directly observed entering into the onsite catch basins. HLD personnel then returned to the site on April 18, 2018 and added dye at the southern downspout locations and determined that those discharge directly into the existing storm pipe discharge from the southern onsite catch basin. These have been color coded blue on the attached sketch. The one roof discharge to the surface has been color coded green.
