Re: Infiltration and Inflow Investigation
850 Wolcott Avenue
City of Beacon, New York
Tax ID: 6054-45-120587

Hudson Land Design (HLD) has completed an infiltration and inflow investigation (I&I) at the above referenced parcel as required by the City of Beacon. The investigation was conducted on July 10, 2018 at the existing school building located at 850 Wolcott Avenue, which consists of a two-story brick/wood construction building currently used as an educational space.

I&I STUDY 850 WOLCOTT

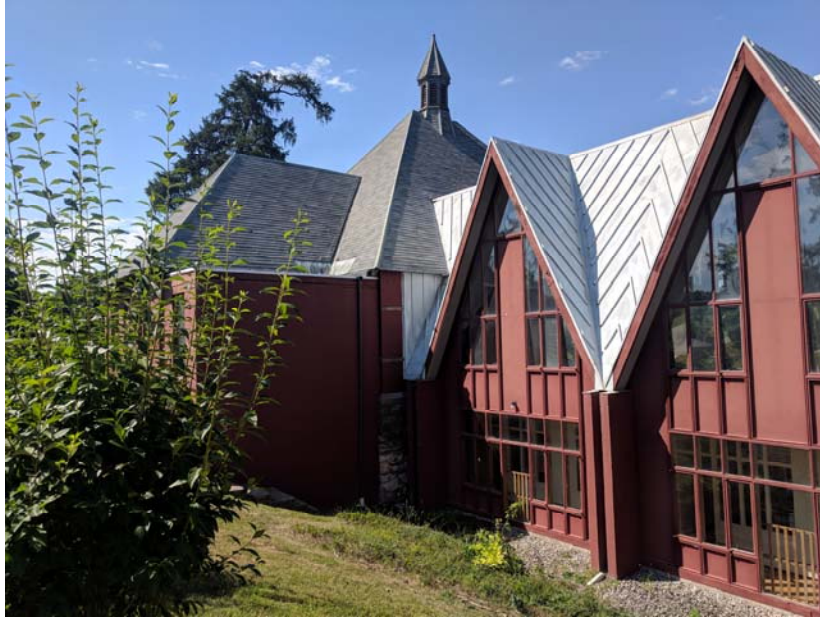
View looking northwest at south side of newer addition

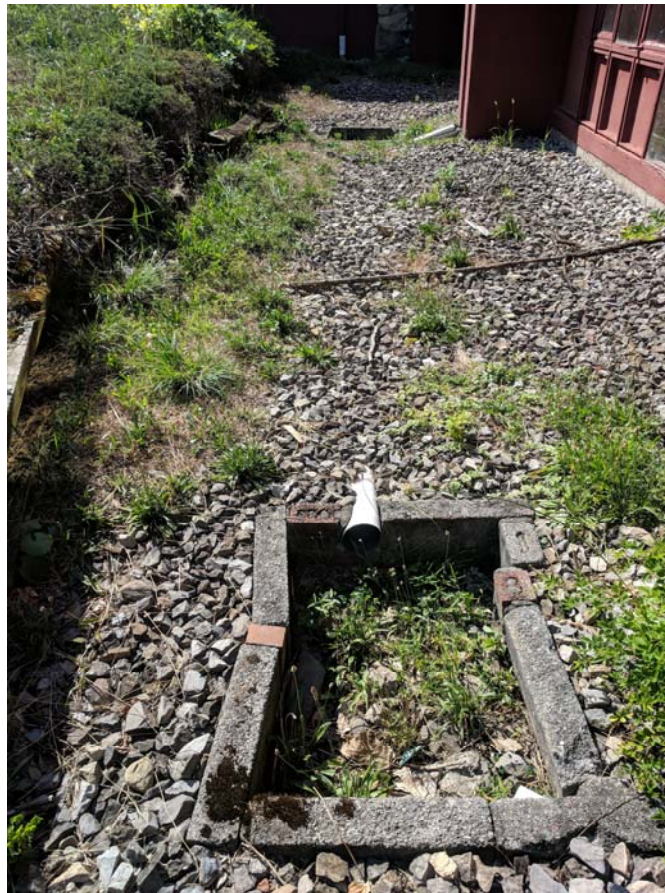
View looking west at the two stone drywells on the south side of the newer addition

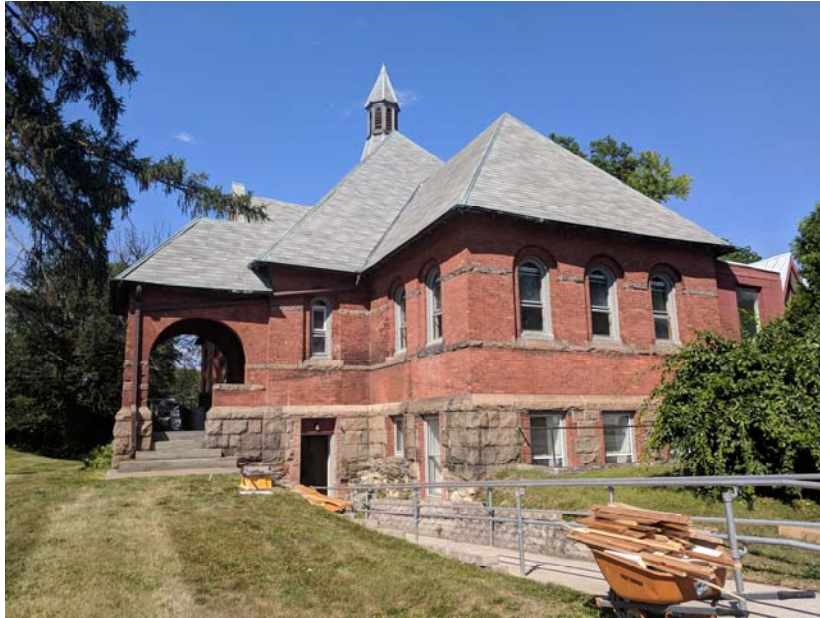
have no gutters and the water sheets off the roof to the ground surface. The west side of the building has a gutter system with roof leaders that discharge to the ground surface. The north side of the building has hip roofs similar to the south side with no gutters. The water on this side of the building discharges directly to the ground surface.

View looking north at west and south side of the older brick portion of the building

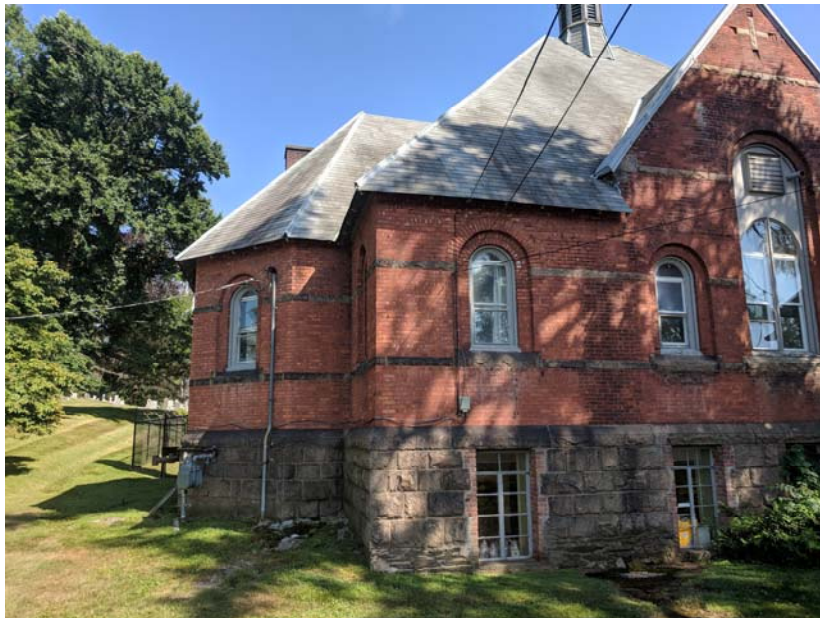
View looking east at west side of the brick building

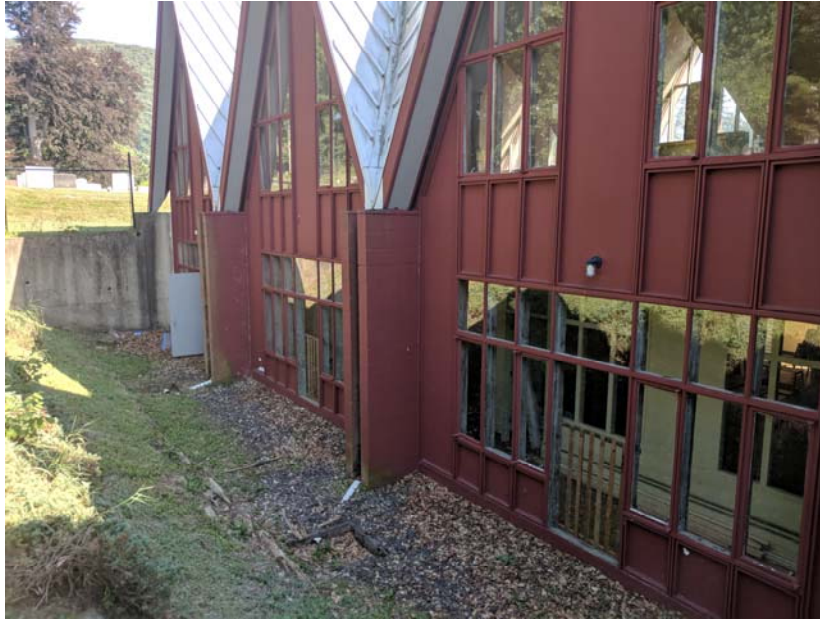
View looking southeast at north side of newer addition

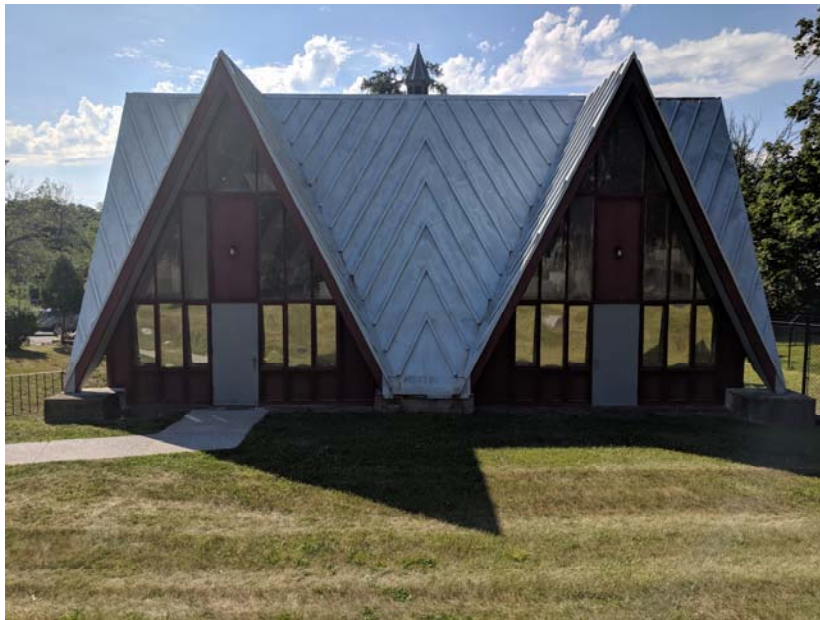
View looking west at east side of newer addition

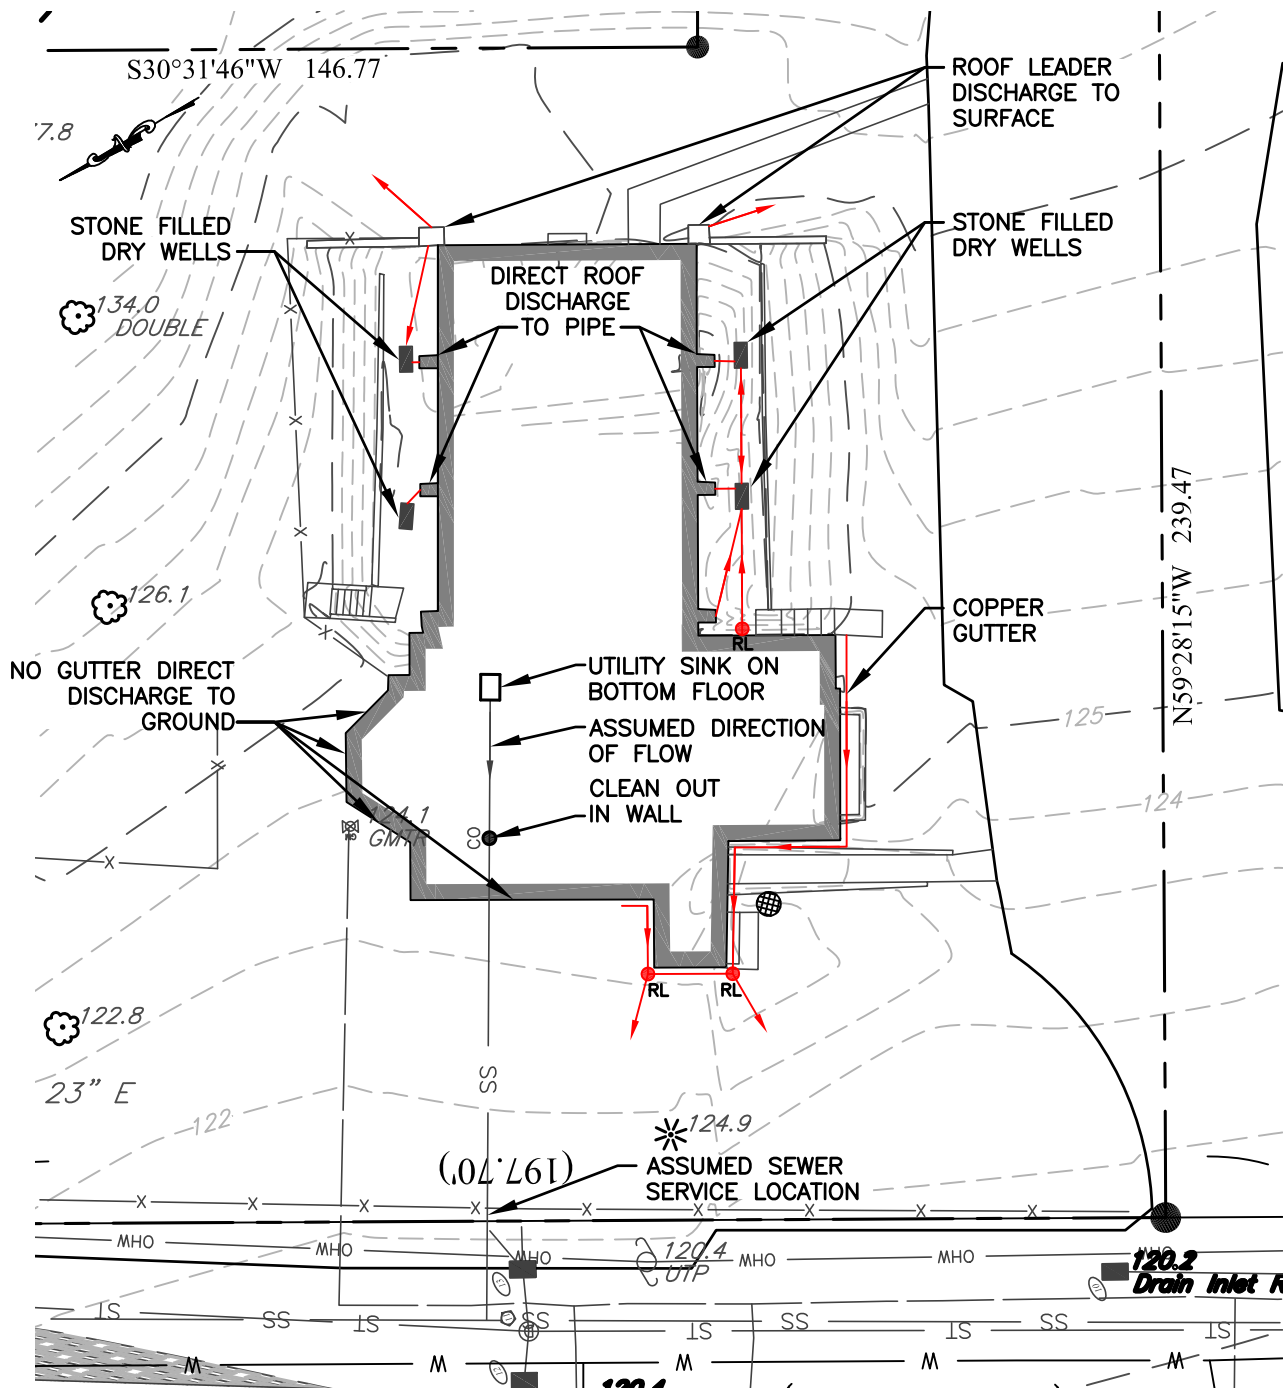
Based on our observations, HLD believes that there are no illicit stormwater connections from the educational building located at 850 Wolcott Avenue to the City of Beacon's sanitary sewer collection system. A sketch showing the roof leader discharge locations and sanitary sewer lateral is attached to this letter.
