# HISTORIC RESOURCE INVENTORY FORM

Property name(if any) Former Hoffman Motors  
Address or Street Location 1154 North Avenue  
County Dutchess Town/City Beacon Village/Hamlet: \_\_\_\_\_  
Owner Lindley, LLC. Address 4 Cross Street, Beacon, NY 12508  
Original use Commercial Current use Commercial  
Architect/Builder, if known \_\_\_\_\_ Date of construction, if known \_\_\_\_\_

Telephone: \_\_\_\_\_ email [jclarkeplandesign@gmail.com](mailto:jclarkeplandesign@gmail.com) Date June 2019

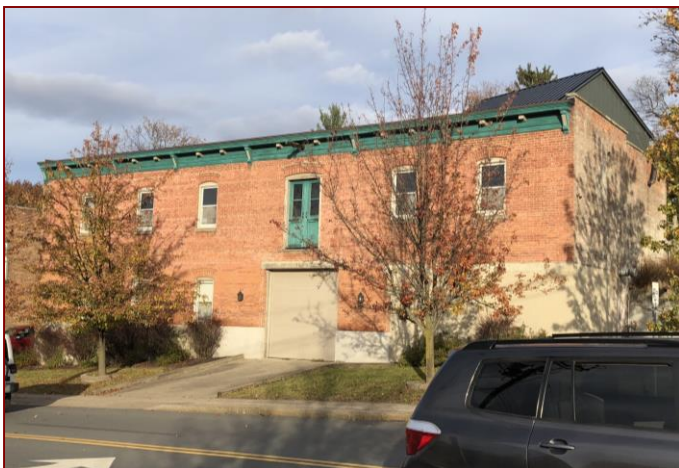
1154 North Avenue

Alterations, if known: Former storefront on southwest corner cemented over Date: After 1979

The building is built into a hillside just north of Main Street on an 0.10-acre parcel along North Avenue. It is a two-story brick building with a flat roof. The most distinctive architectural detail is a wood Italianate bracketed and dentillated cornice along the western façade.

The window openings have arched brick lintels and stone sills. The windows appear to be more modern replacements, as is the front garage door and the door in the former storefront area. The storefront display windows on the southwest corner were boarded up in 1979, and have since been covered over with cement. The second story has older wood double doors with windows and panels and an overhead projecting beam to lift goods to the second floor.

The brick façade facing North Avenue has been cleaned, but there are faded painted signs on the north and south walls.

Front View  
Office of Parks, Recreation and Historic Preservation  
An Equal Opportunity/Affirmative Action Agency

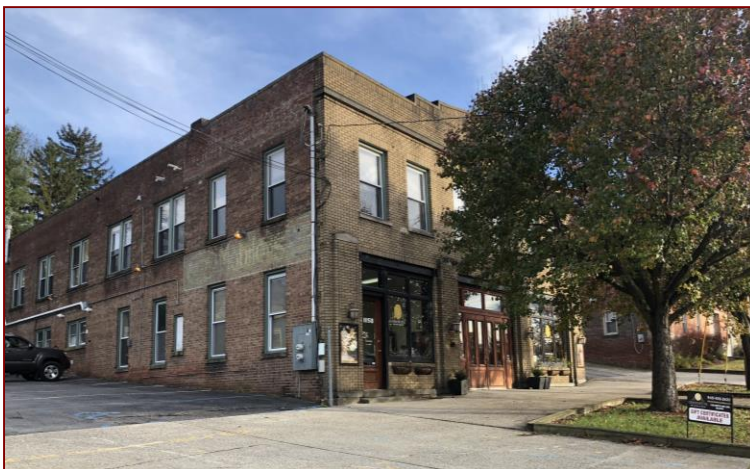
1158 North Avenue

The building is located on North Avenue, built into a hillside north of Main Street. It is a two-story brick building with a flat roof. The front yellowish brick façade has raised parapet wall with a central pediment shape.

The most distinctive architectural details are the historically compatible double glass and paneled front doors with large overhead transom windows and side lights. The central doors are flanked by two storefront windows, four period lighting fixtures, and four raised one-story brick pilasters.

The window openings have brick lintels and stone sills. The windows appear to be more modern replacements. Some of the side windows are paired.

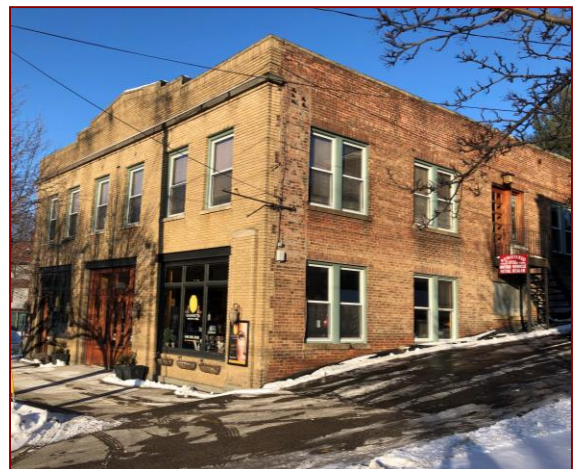
View of South Side

There are faded painted signs on the north and south walls.

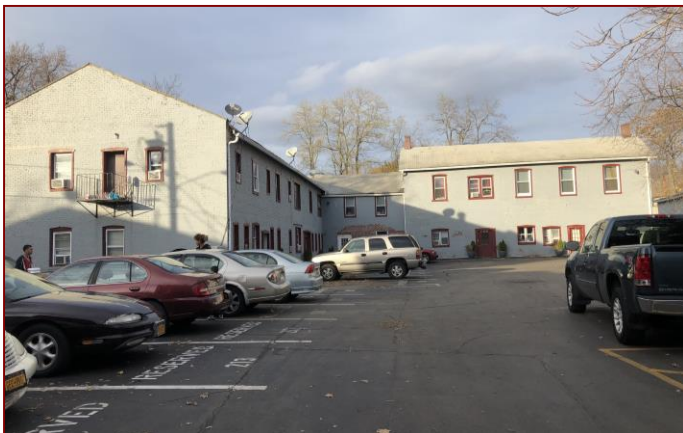
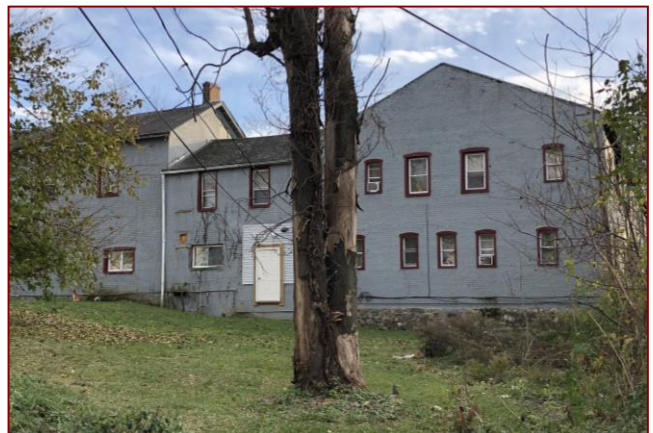
152 Main Street

This building is located in the middle of the block north of Main Street on a 0.64-acre parcel that extends to West Church Street. It is a two-story, painted brick building with a gable roof. The L-shaped structure is utilitarian in character with few distinctive architectural details. Much of the surrounding lot is paved over for residential parking. There is a modern, one-story storage building on east side.

The original windows and doors had arched brick lintels, so it is apparent that the current irregular pattern of windows and doors features many newer window and doors. Several larger commercial doors have been closed-in with brick or block. The existing windows and surrounding wood trim appear to be modern replacements.

The eastern wing has two brick end-wall chimneys and the western wing has a taller brick chimney on the southwest corner.

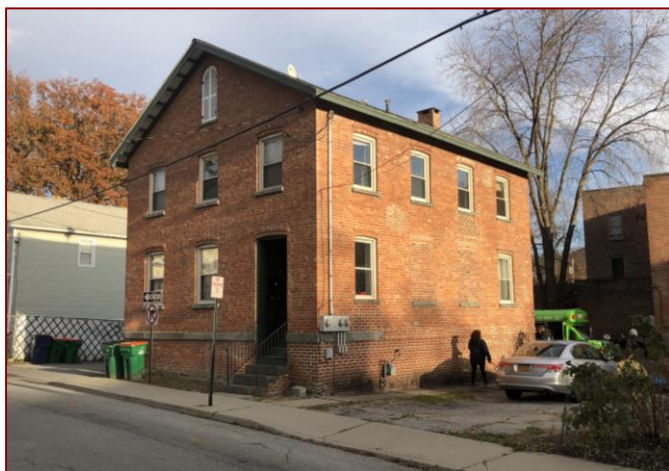
View of South Side

The window openings have arched projecting brick lintels and stone sills, although two of the windows have been bricked-in on the south side. There is an arched window opening with wood shutters under the front gable, but the rest of the window sashes appear to be more modern replacements.

The brick is in generally good condition, although some areas have been obviously repointed, especially along the lower level of the building. The brick chimney is to the rear, projecting out from the rear wall.

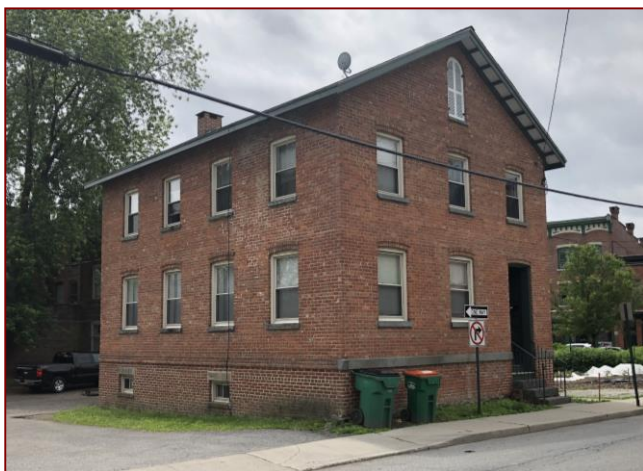
View of North Side

The building is just north of Main Street on an 0.10-acre Cross Street parcel. It is a 2½-story vernacular brick structure with a gable roof. It is raised ½-story with stone course across the façade and stone steps up to a recessed doorway, featuring wood side paneling and a paneled door. The hand railings flanking the steps are modern metal.

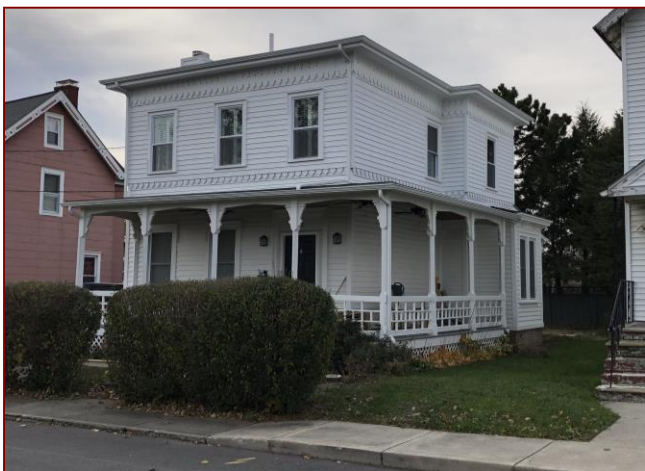
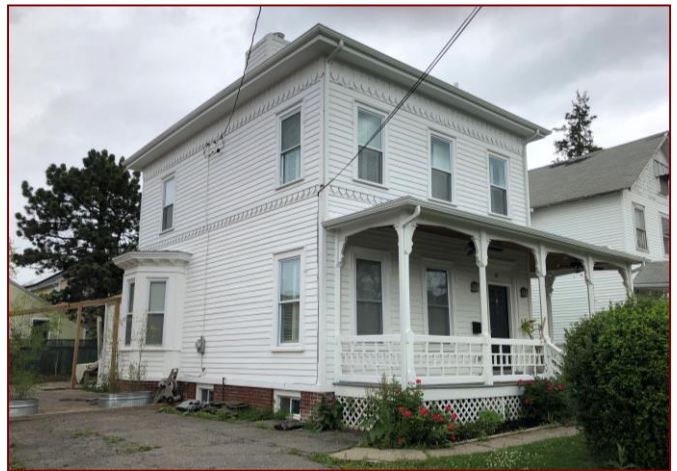
11 Digger Phelps Court

The building is north of Main Street on an 0.10-acre parcel along Digger Phelps Court. It is a 2-story Italianate wood structure with a flat roof. It features a broad cornice and a wide frieze with a pointed cut-out pattern, along with a narrow course of matching cut-outs at the top of the first floor.

The front porch extends around the north side of the building. The decorative corbeled porch posts, detailed railing, and paneled door all appear original, as does the bay window with dentiled cornice on the south side. There is a one-story section to the rear.

The window sashes and the chimney near the south roof line appear to be more modern replacements. Based on changes in wood pattern, paired brackets may have been originally under the roof cornice.

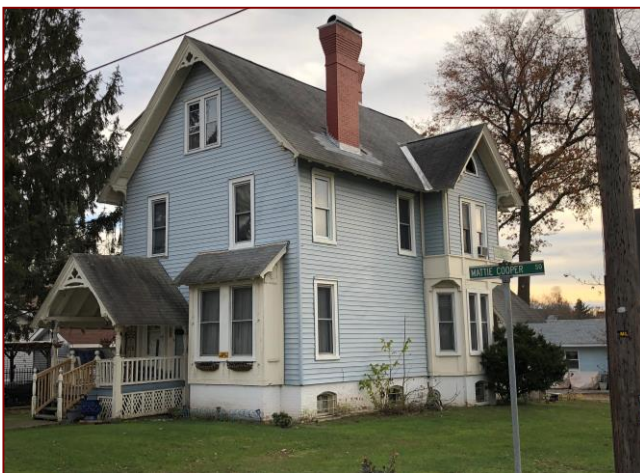
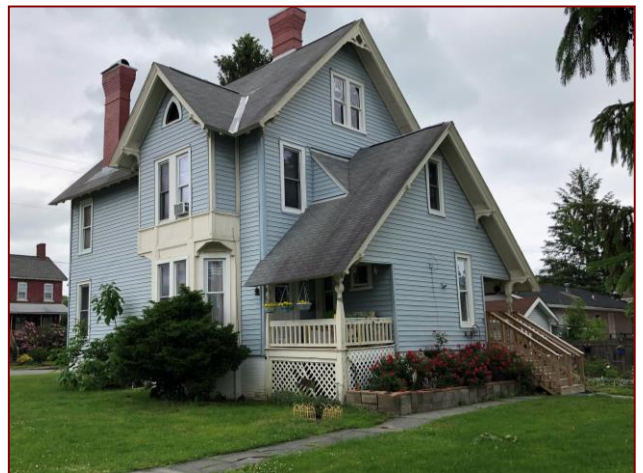
9 Mattie Cooper Square

The house features decorative vergeboards supported by corner brackets with clover leaf cut-outs at the apex of the front and rear gables and the front porch. The northern porch extension and rear porch have turned columns and original balustrade, but the railings flanking the front steps and the rear steps are replacements. The northern façade has a one-story rectangular bay window with a shed roof. There are two brick chimneys with flared tops.

The original siding has been completely covered over with newer vinyl siding and the window sashes appear to be more modern replacements. There is also a one-story, 20<sup>th</sup> century concrete block garage to the rear.

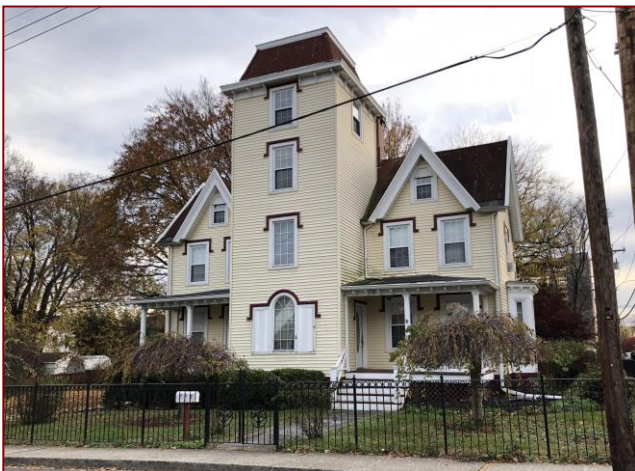
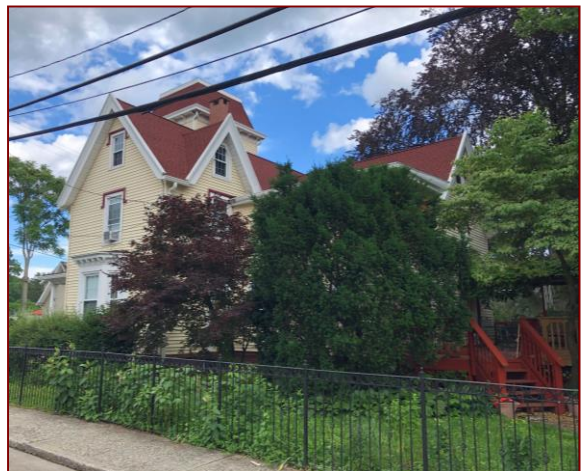
17 Church Street

The original siding has been covered over with new vinyl siding and the window sashes appear to be more modern replacements. There is also a modern raised deck with wide glass door entry to the rear of the house, a modern one-story garage in the back yard, and a newer perimeter metal picket fence.

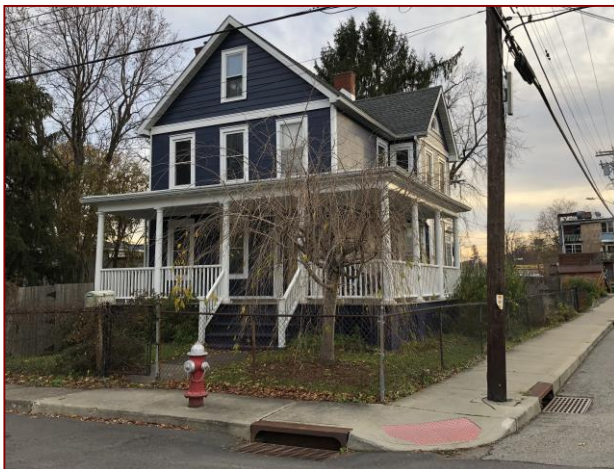
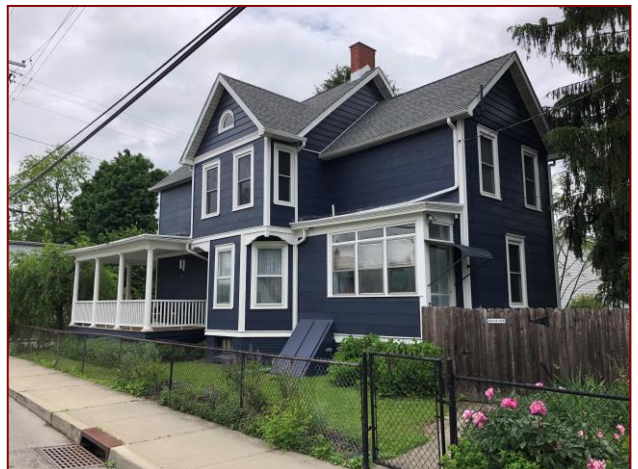
27 Church Street

The original siding has been covered over with asbestos siding and the window sashes and porch railing appear to be more modern replacements. A former rear porch on the west side has been enclosed. There is a one-story, non-historic garage in the rear corner and a black chain link fence around the perimeter of the yard.

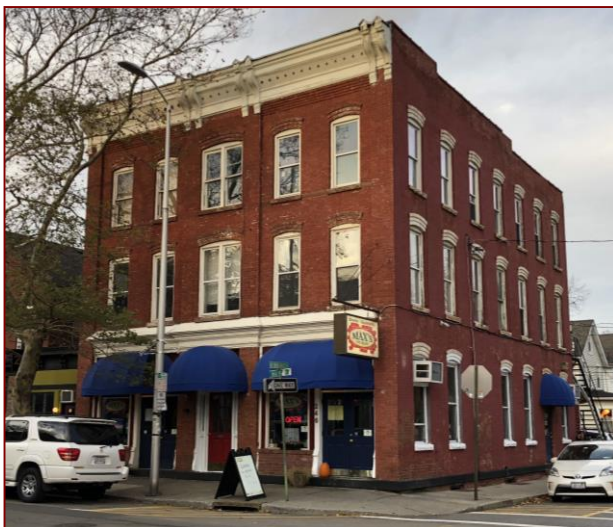
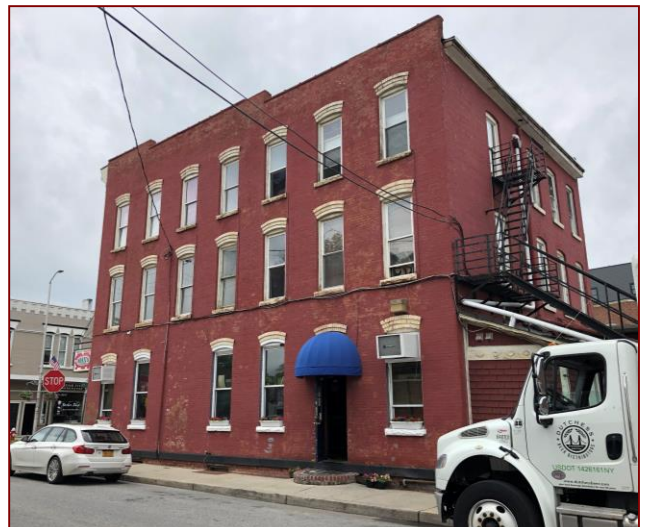
246 Main Street

The windows have arched brick lintels and stone sills with paired windows in the central bay. The sashes appear to be modern replacements. There is a simple secondary cornice over the storefronts and a central doorway for upper floor access. The two storefronts have double doors, but the windows and surrounds do not look original.
