**PHASE IA ARCHEOLOGICAL INVESTIGATION**  
**Scenic Beacon Development LLC**

22 Edgewater Place  
City of Beacon  
Dutchess County, New York

HAA # 5174-11  
OPRHP 17PR06370

September 2017

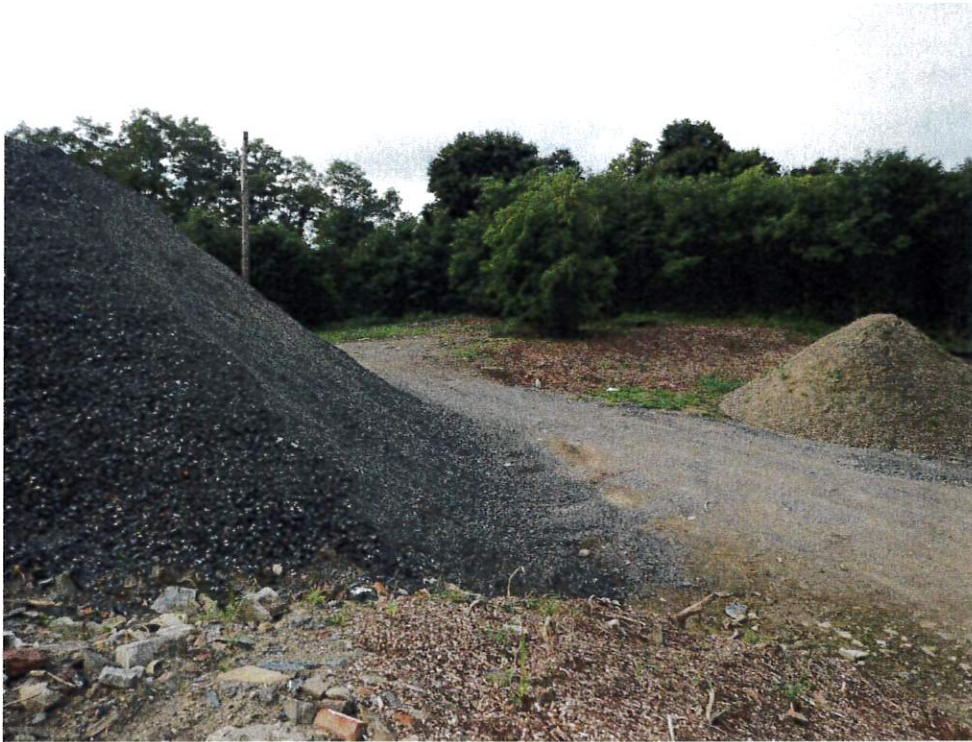
Photo 1. View south of the north central portion of the project area. The surface conditions indicate extensive soil disturbance throughout the area.

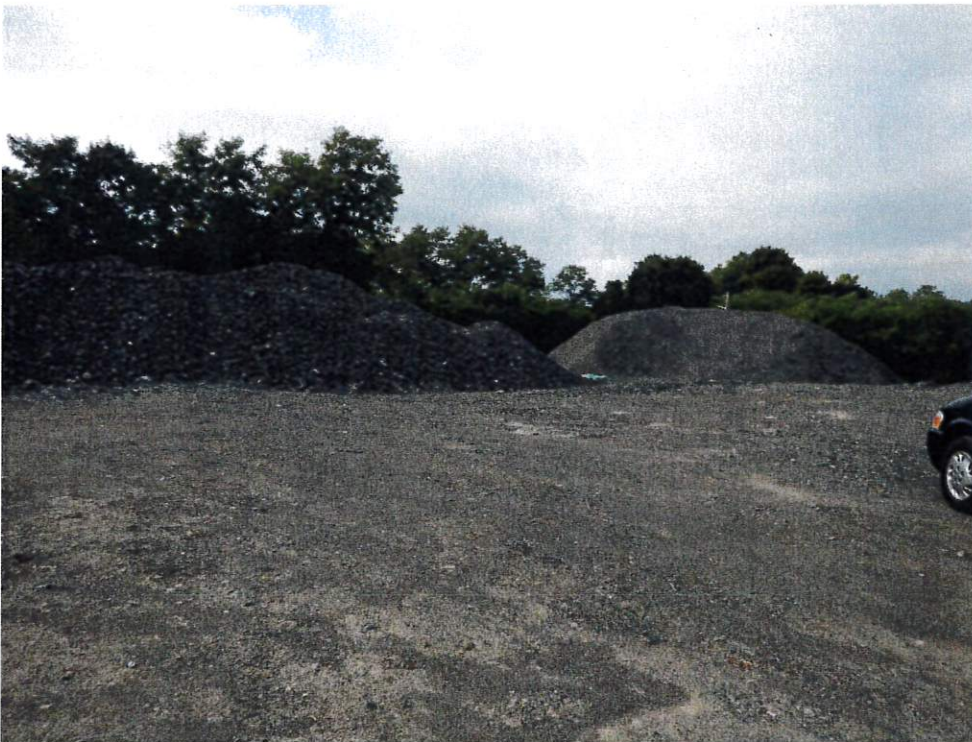
Photo 2. View southeast of the large aggregate piles located within the north central portion of the project area. The surface conditions indicate extensive disturbance throughout the area.

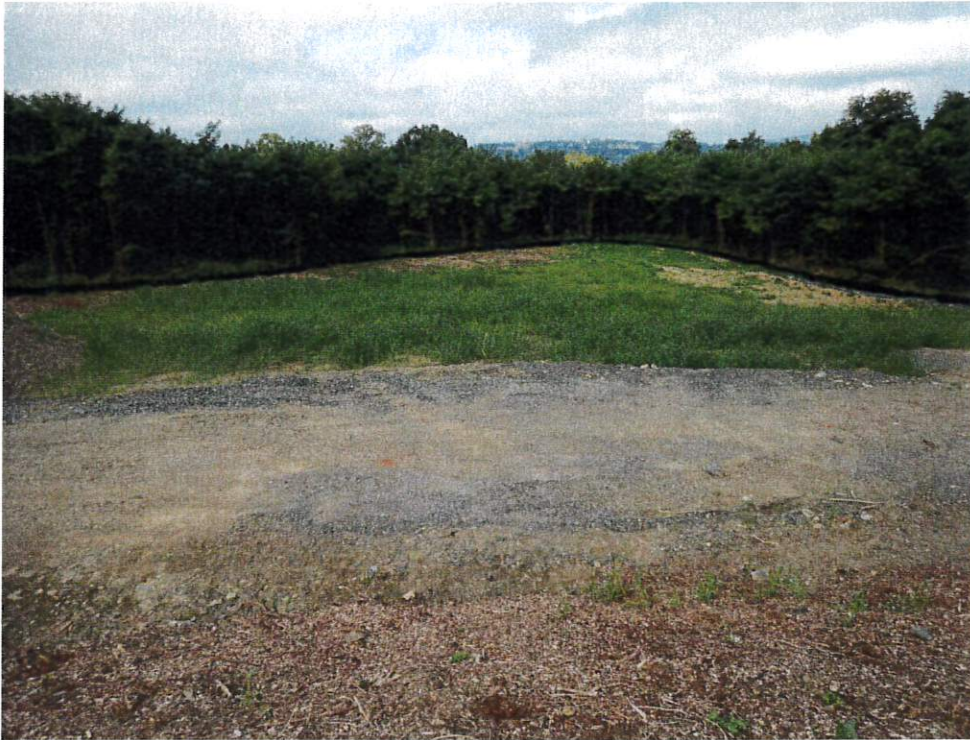
Photo 3. View north of the general surface conditions that extend across the central portion of the project area. The surface conditions indicate extensive soil disturbance throughout the area.

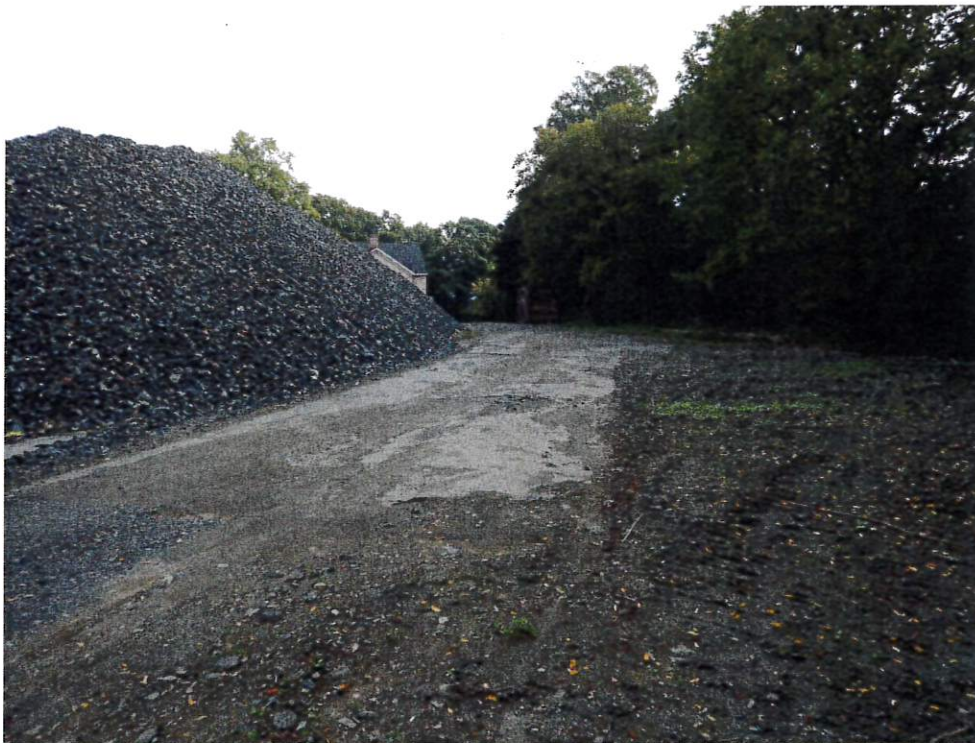
Photo 4. View north of the asphalt roadway and general surface conditions that extend across the northeastern portion of the project area. The surface conditions indicate extensive soil disturbance.

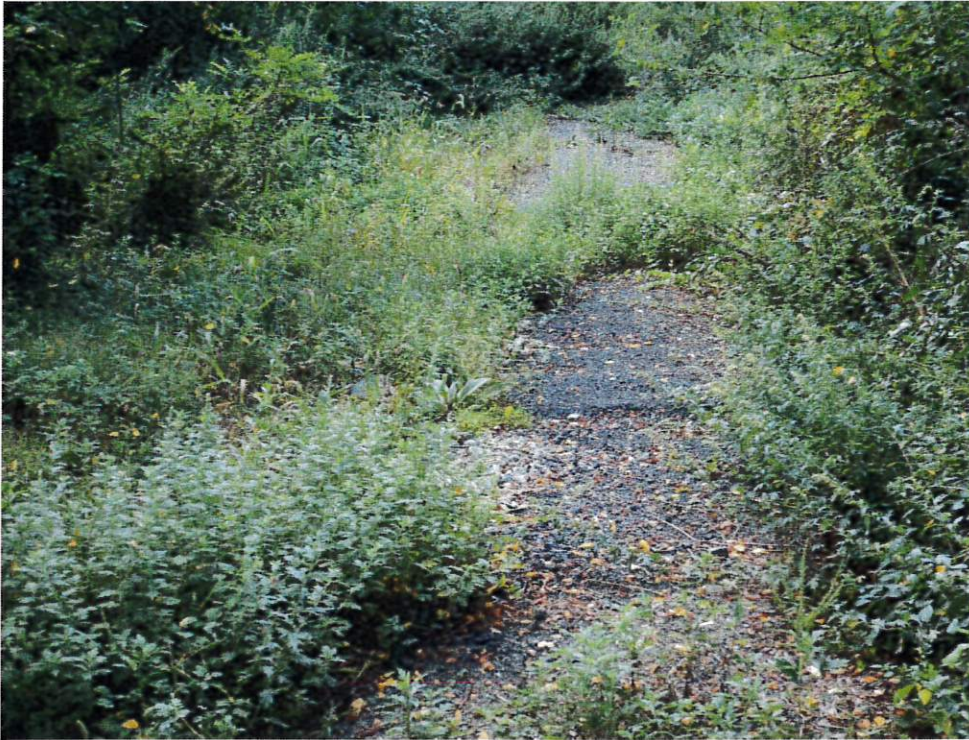
Photo 5. View south of the abandoned roadway that extends along the eastern portion of the project area. Road construction has significantly affected the surface soils in this area

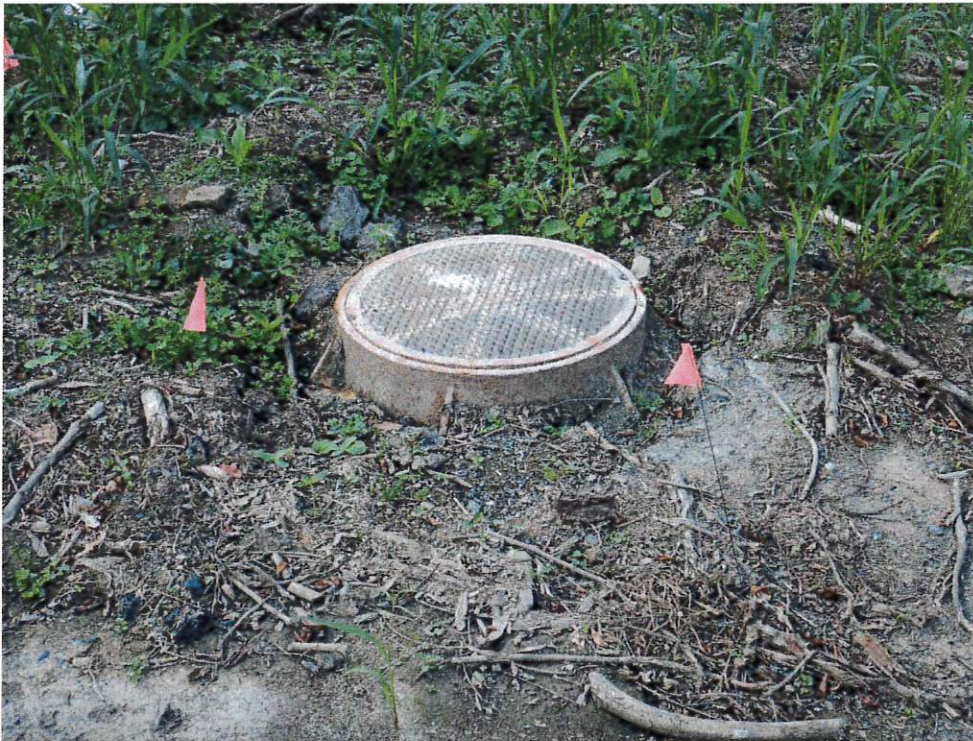
extends across the central portion of the property (Map 2; Photos 4 and 5). A manhole to what appears to be an earlier storm-water drainage system lies within the roadway (Map 2; Photo 6).

Photo 6. View east of a manhole to a storm-water system that continues along the eastern and southern portion of the project area. Installation of the storm-water system has significantly affected the soils in this area.

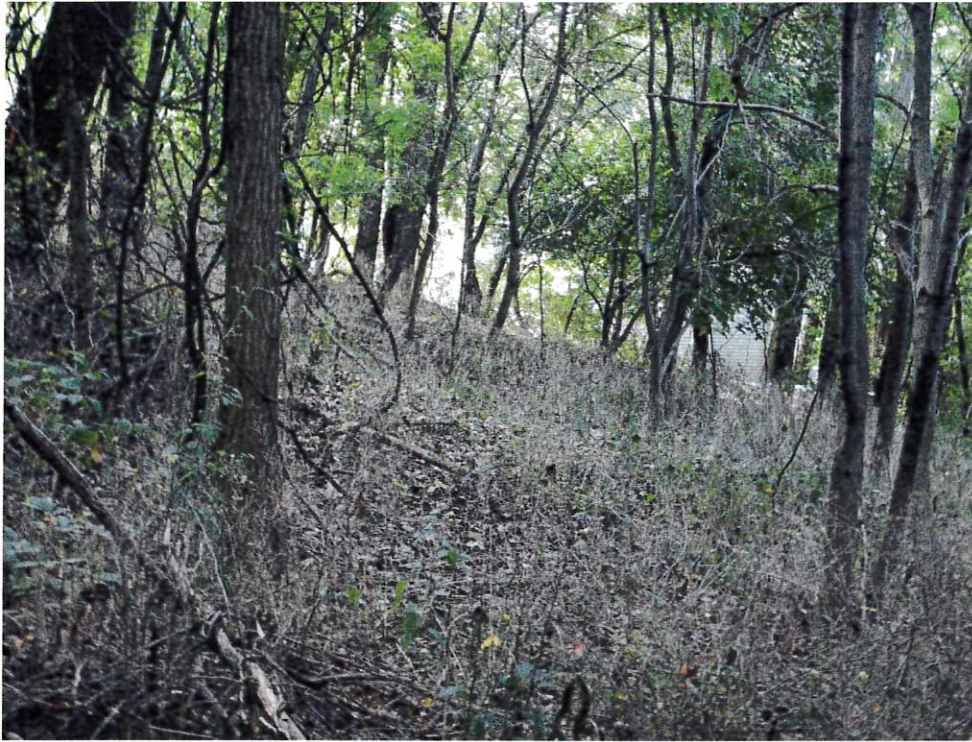
Photo 7. View southeast of the surface vegetation and moderate to steep topography that extends across the southern and eastern portions of the project area.

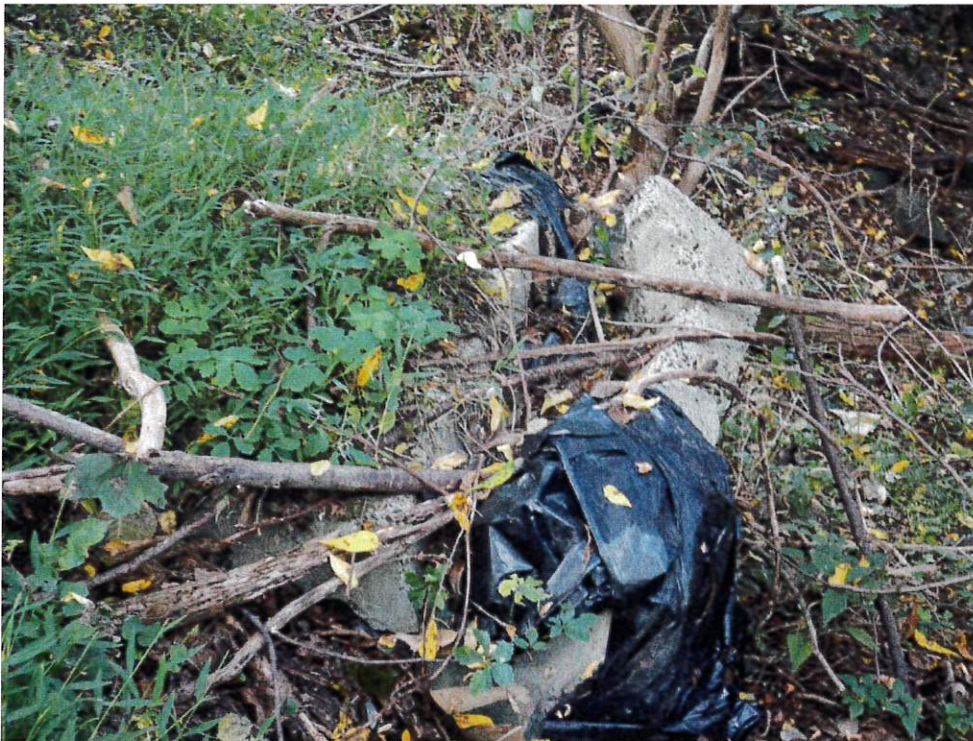
Photo 8. View east of large concrete debris extending out of the surface soil along the south central portion of the project area.

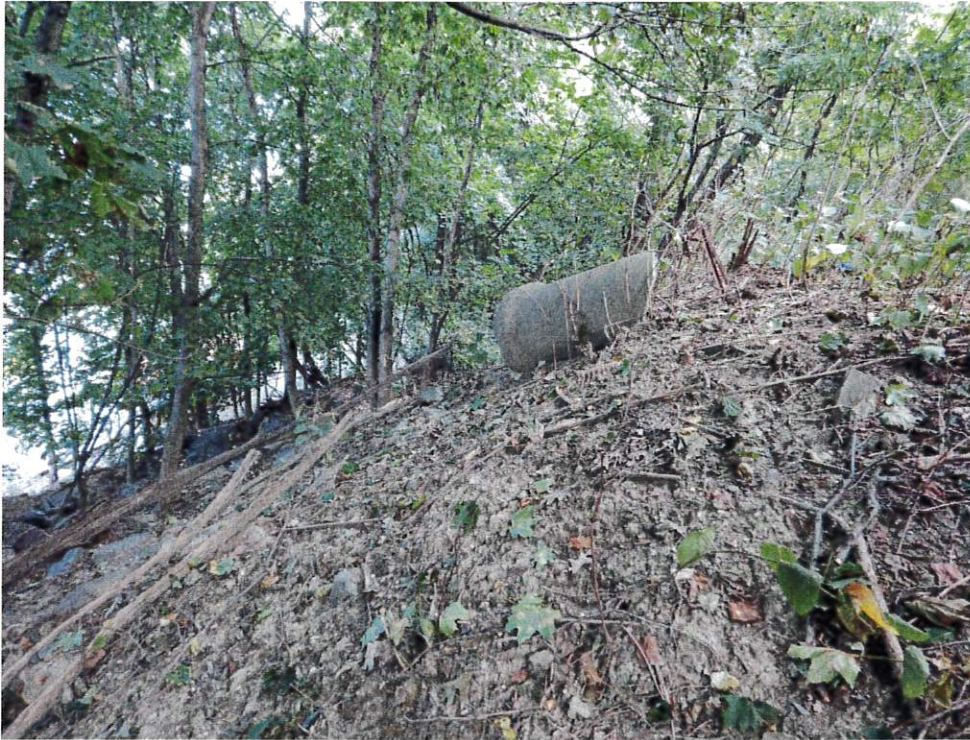
Photo 11. View northwest of the southwestern most edge of the project area showing a mixture of construction debris and soil that was pushed over the edge of the slope.

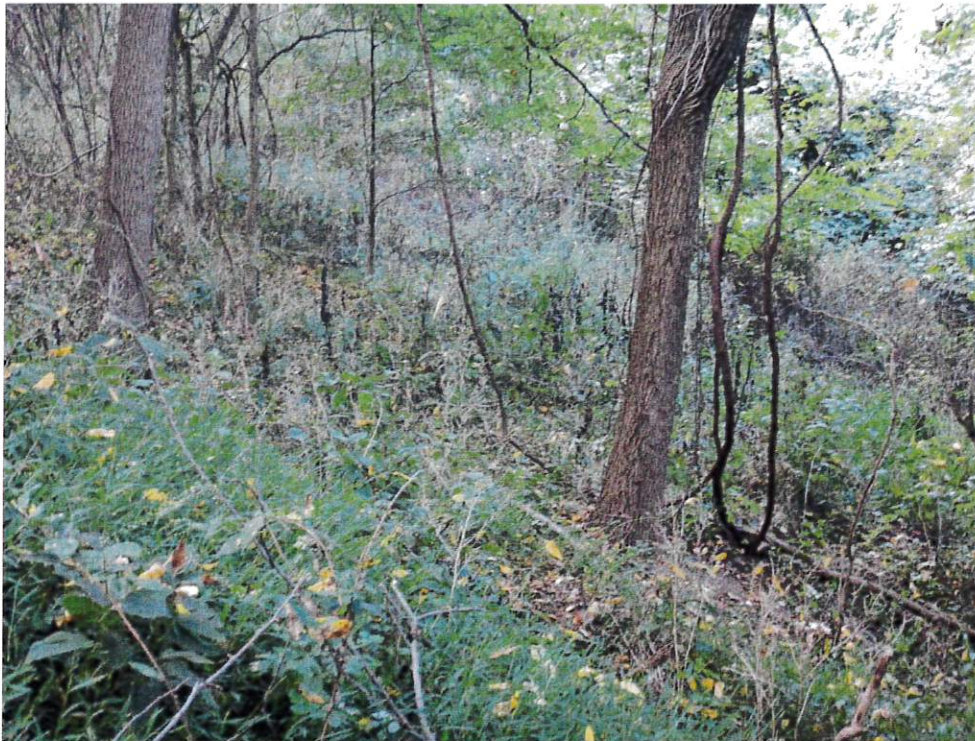
The eastern and southern perimeters of the property slope sharply towards Bank Street (Map 2; Photo 12). The western perimeter slopes sharply towards the train station parking lot (Map 2; Photo 13).

Photo 12. View northeast of the steep sloping southeastern portion of the project area.

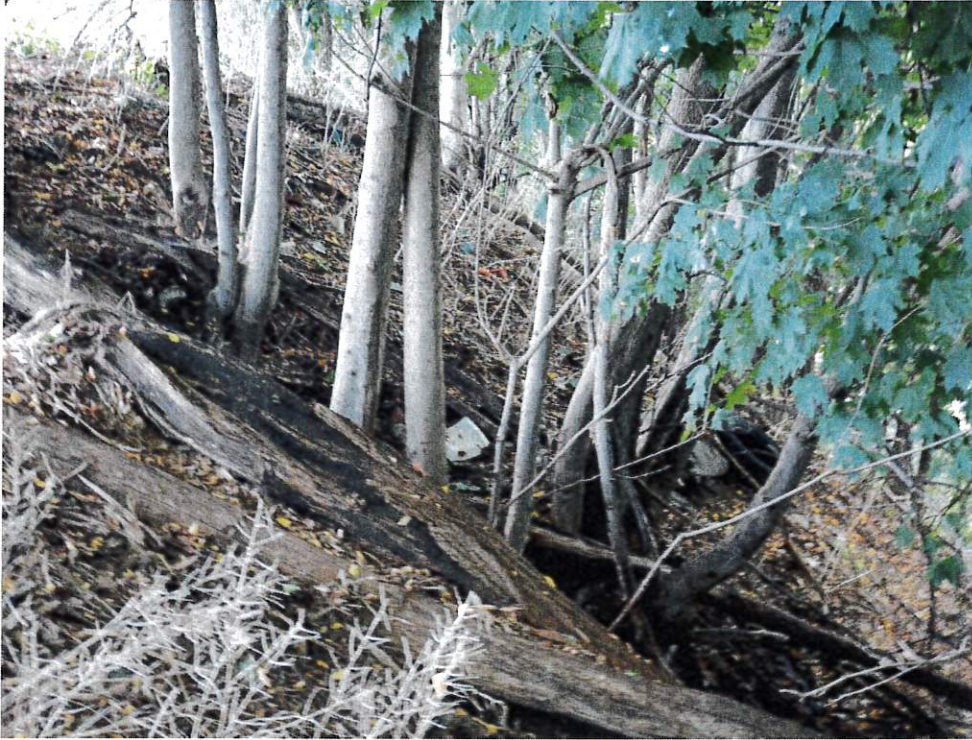
Photo 13. View north of the steep sloping western portion of the project area.

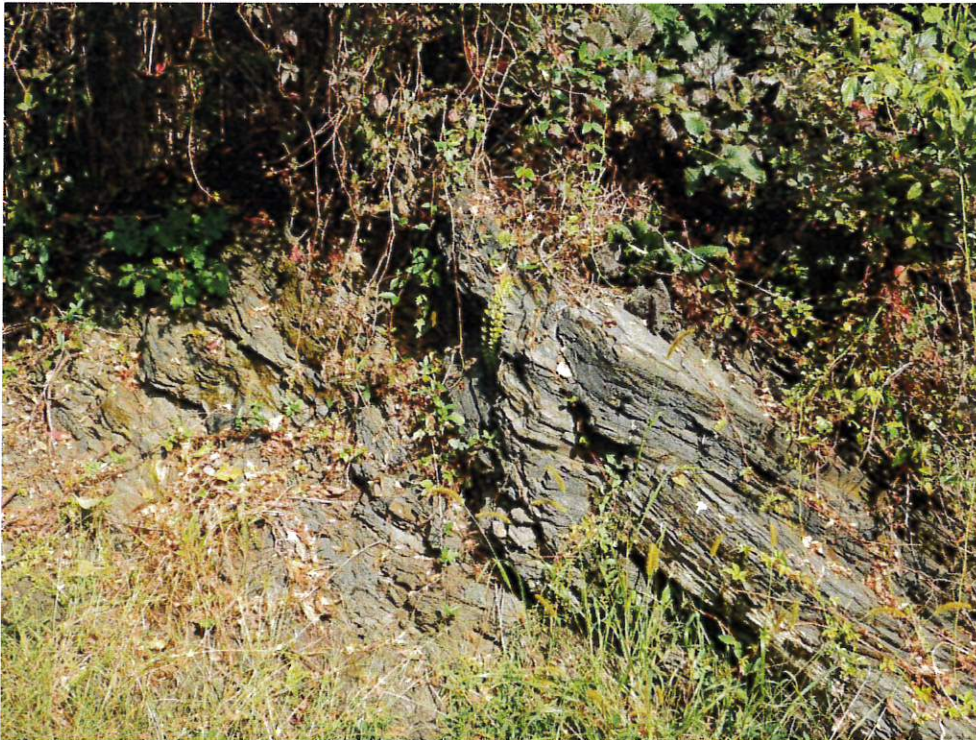
A section of exposed shale and greywacke bedrock was encountered along the southern slope (Map 2; Photo 14). The bedrock outcrops were examined for possible rockshelters and chert outcrops and none were identified.

Photo 14. View north of a shale and greywacke bedrock outcrop located at the south edge of the project area along the slope. The bedrock outcrops were examined for rockshelters and chert outcrops and none were identified.

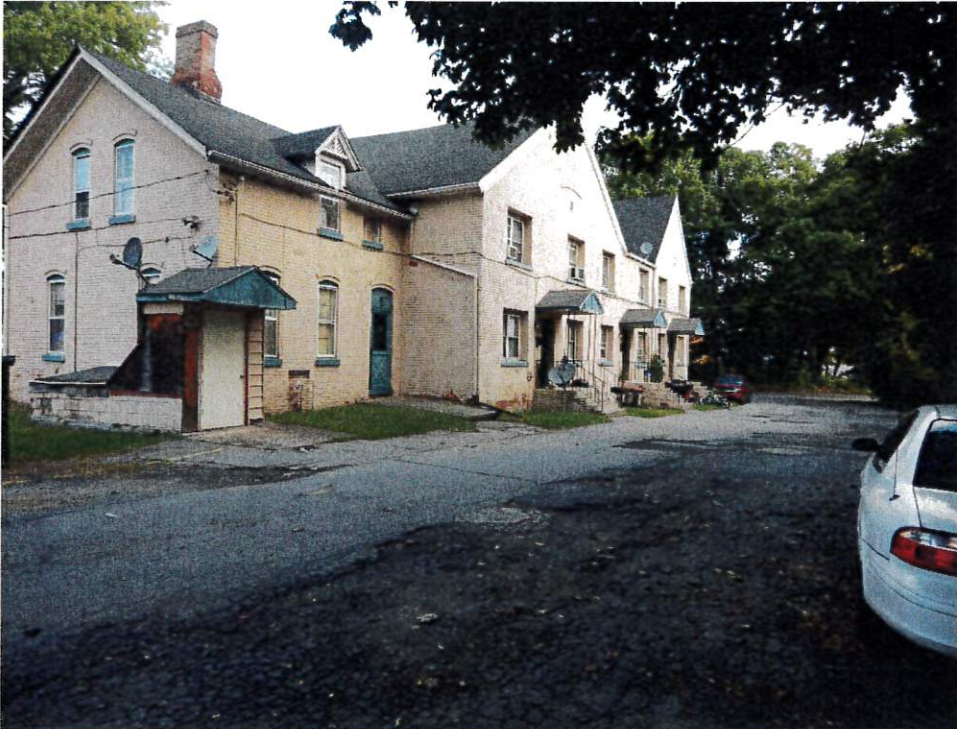
Photo 15. View north of 22 Edgewater place located at the north end of the project area. The building will be removed as part of the development plan

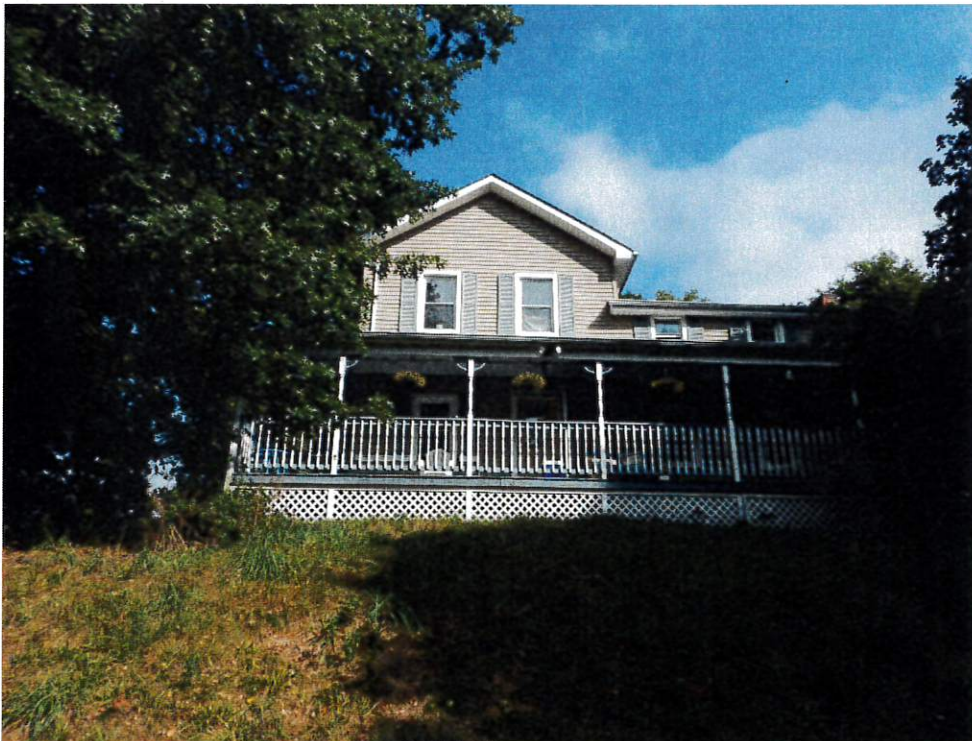
Photo 16. View north of 8 Branch Street located at the south end of the project area. The building will be removed as part of the development plan.
