HISTORIC RESOURCE INVENTORY FORM

Property name(if any) _____
Address or Street Location 250 Main Street
County Dutchess Town/City Beacon Village/Hamlet: _____
Owner Fa Tuan Ni and Ming Fang Chen Address 250 Main Street, Beacon, NY 12508
Original use Commercial Current use Commercial/Mixed-Use
Architect/Builder, if known _____ Date of construction, if known c. 1905-1910

Prepared by: John Clarke address 25 Beech Street, Rhinebeck, NY 12572
Telephone: _____ email jclarkeplandesign@gmail.com Date June 2019

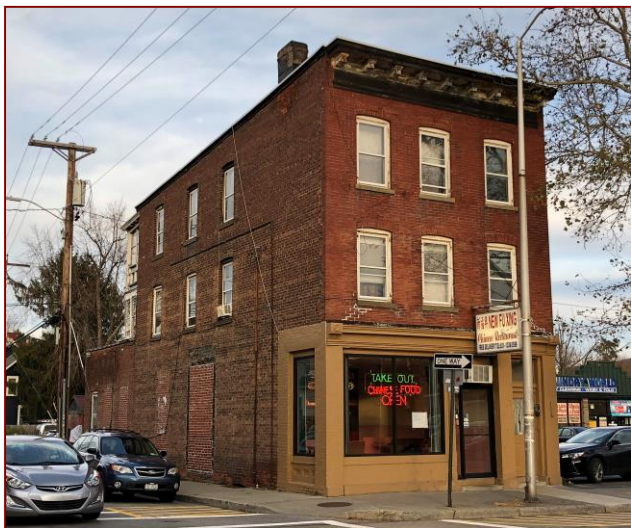
250 Main Street

The building is located on the north side of Main Street on a narrow 0.05-acre lot. It is a three-story, three-bay brick building with a flat roof and brick chimney. The projecting cornice has regular modillions and a wide board underneath.

The windows have arched brick lintels and stone sills. The sashes appear to be modern replacements. There is a simple secondary cornice over the storefront with corner blocks. The storefront surrounds and the door to the upper floors look original, but the storefront window and door are modern.

Other than the bricked-up openings on the west side, the building retains most of its original character, in particular its decorative cornice. This commercial storefront structure is one of the most intact examples of its type, scale, and period in the City. It possesses special historic and aesthetic value as part of the cultural history of the City and embodies distinguishing characteristics of an architectural period and style.

Front View

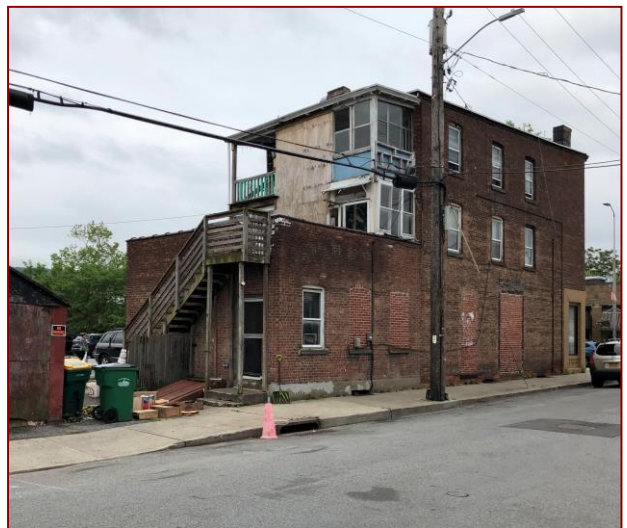
There is a rear porch on the upper levels, one-story rear addition, and a more modern garage towards the rear of the lot. Three windows and a former doorway have been bricked-up on the west side of the building.

Rear View

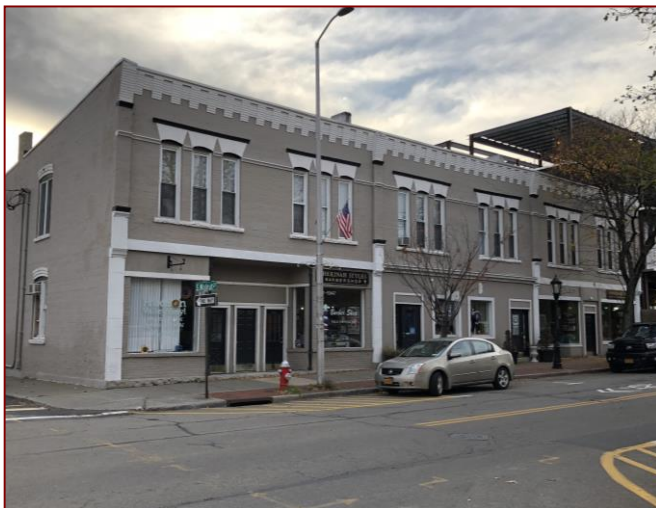
257 Main Street

The building is located on the south side of Main Street on a 0.23-acre lot. It is a two-story painted brick building with a flat roof and three brick chimneys. The projecting cornice is formed by a regular pattern of corbeled brick.

The structure is divided into three sections by projecting piers with originally six storefronts and three separate doors to the upper floor. The tall, narrow second-floor windows are set in six groups of three with broad arching brick lintels, a drip band above, and stone sills below. There is a secondary cornice over the central section of the facade. The central storefront has been modernized, but the outer storefronts retain much of their original character.

Front View

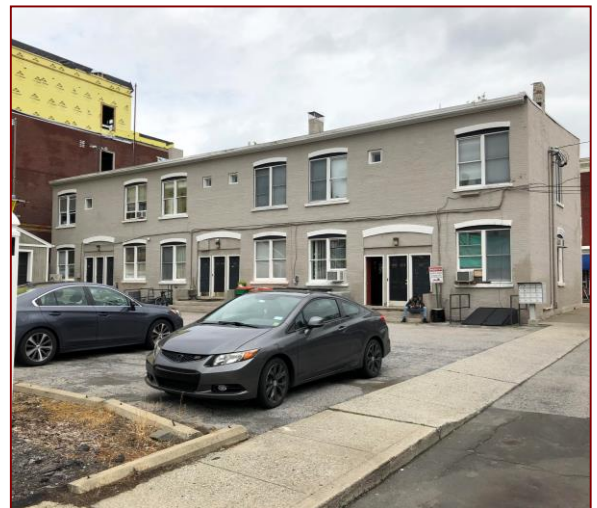
The rear elevation features paired windows with arched brick lintels and stone sills and three doors to the three sections of the building. A modern garage sits at the far corner of the rear parking lot.

Rear View

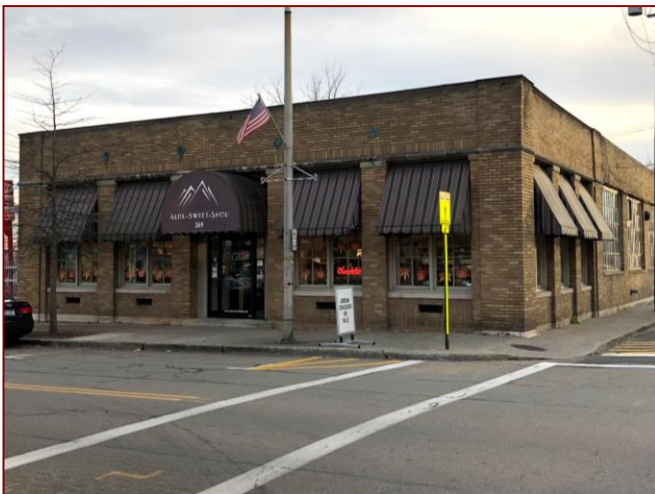
269 Main Street

The building is located on the south side of Main Street on a 0.11-acre lot. It is a one-story brick building with a flat roof. The street-front brick walls contain multiple shades of light brown to tan, while the east and south walls are common red brick.

The Main Street facade is divided into five bays by pilasters with simple stone composite capitals and a stone string course and a soldier course of bricks above. Small metal medallions are placed over the four central pilasters. The cornice is a plain stone composite edge, as are the building's sills along the sidewalk.

The front quarter of the building had tall paired wood windows with eight panes each, while the rear section has large, multi-pane, metal-framed industrial windows, both types with stone composite sills. There is arched doorway at the southwest corner. The eastern wall is blank brick, but has a recessed window well half-way back. The only apparent modern elements are the front metal door and the canvas awnings over the front entrance and wooden windows.

Front View

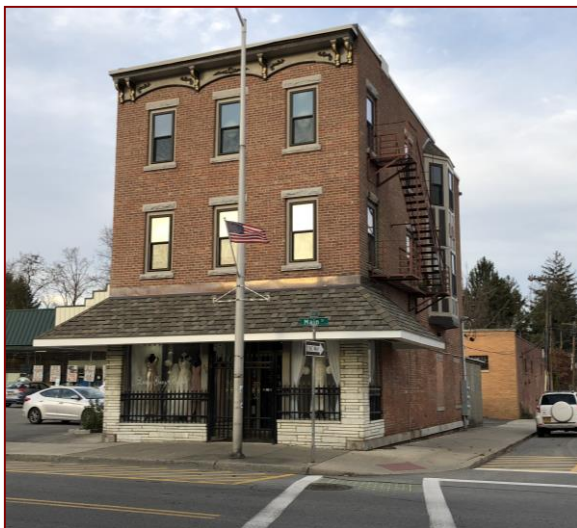
274 Main Street

The building is located on the north side of Main Street on a narrow 0.07-acre lot. It is a three-story, three-bay brick building with a flat roof and rear brick chimney. The bracketed front cornice has paired brackets at the corners with an arching frieze board and attached scrollwork in between the brackets.

The windows have stone lintels and sills, although the sashes appear to be modern replacements. Two windows have been bricked-up on the east side first floor. The east side also has a steel fire escape and a bay window on the upper two floors, which is original to the building, but has been refaced with modern materials. The thoroughly modernized storefront features a broad asphalt shingled roof, horizontally laid white stone, and metal picket fencing in front of the windows.

Front View

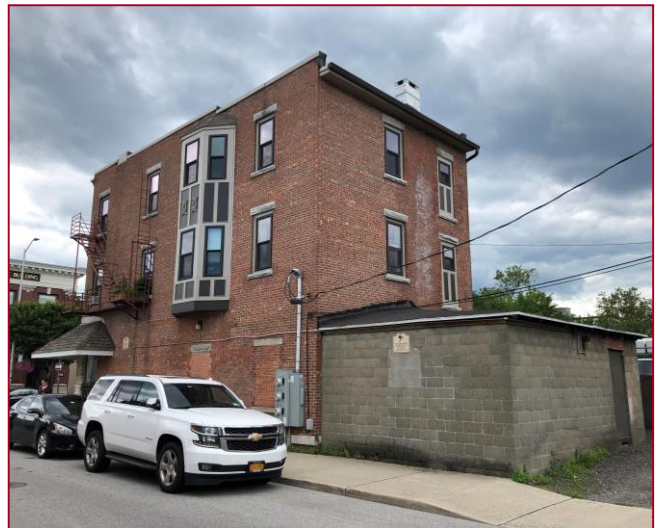
There is a modern, cement block, one-story rear addition.

Rear View

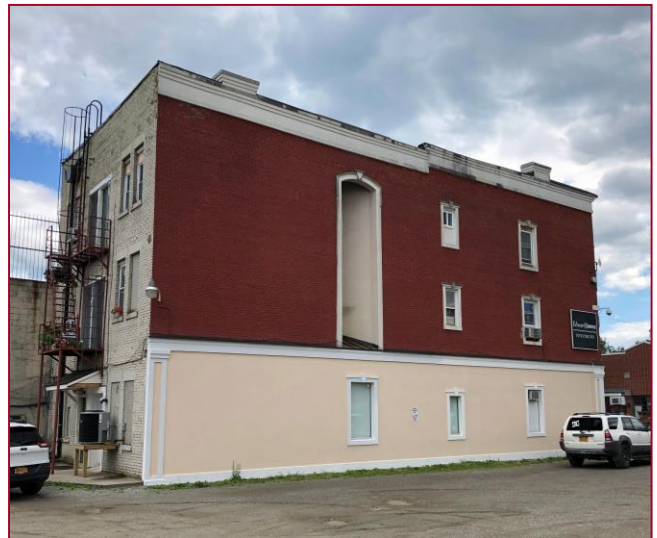
Rear View

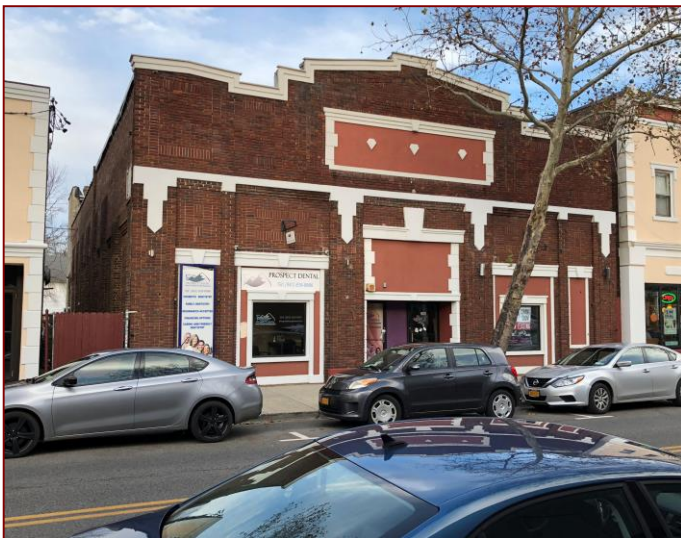
288 Main Street

The first-floor windows also have wide bands above and exaggerated central keys. The south side windows and doors appear to be more modern replacements.

Front View

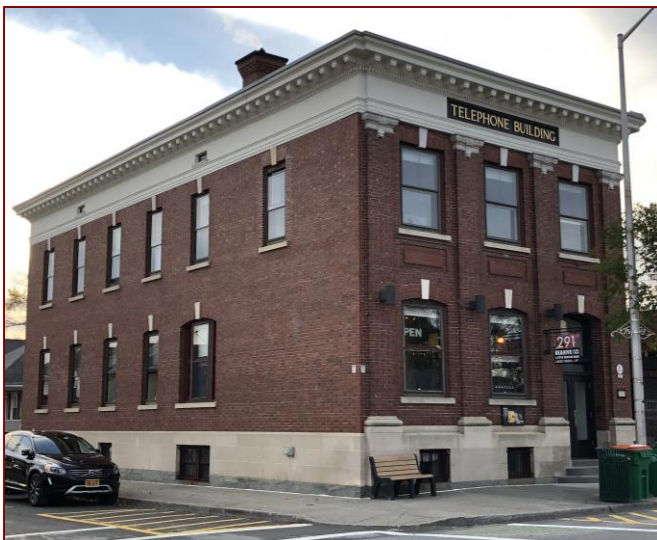
There is no structure at this site on the 1904 Sanborn Map, but this building is shown on the 1912 and subsequent versions, listed as the New York Telephone Building.

The building retains its original character, in particular its distinctive cornice and front facade. This structure is one of the most intact examples of its type, scale, and period in the City. It possesses special historic and aesthetic value as part of the cultural history of the City and embodies distinguishing characteristics of an architectural period and style.

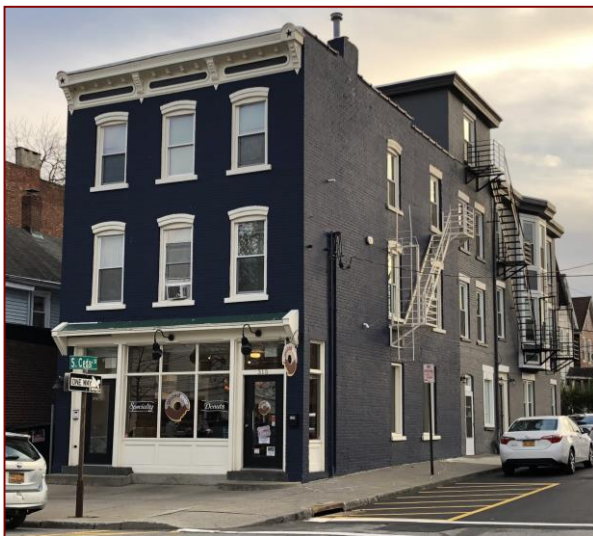
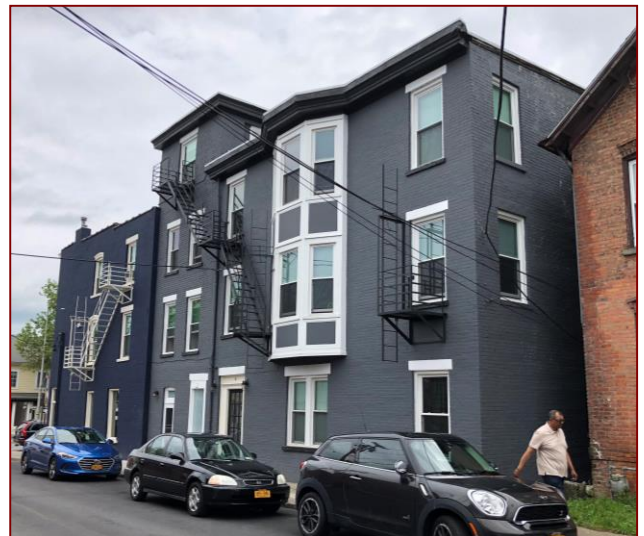
315 Main Street

The front windows have raised arching brick lintels and stone sills, but the windows on the South Cedar Street side have primarily straight stone lintels. The window sashes appear to be modern replacements. On the west side rear section there is a projecting bay window on the upper two floors, which may be a more recent addition because it does not show on the 1946 and earlier Sanborn maps. The west side also has three steel fire escapes.

Rear View

Front View

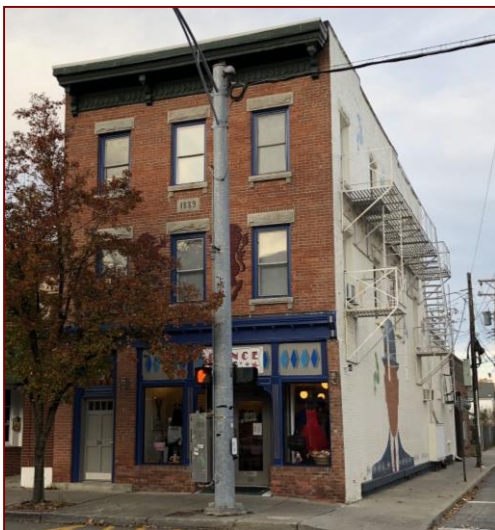
314 Main Street

The windows have large stone lintels and stone sills with small lower corner blocks, but the window sashes appear to be modern replacements. The side walls and one-story rear addition are painted white. The side facing South Chestnut Street has painted artwork, a steel fire escape, and several bricked-over window openings on the first floor.

Front View

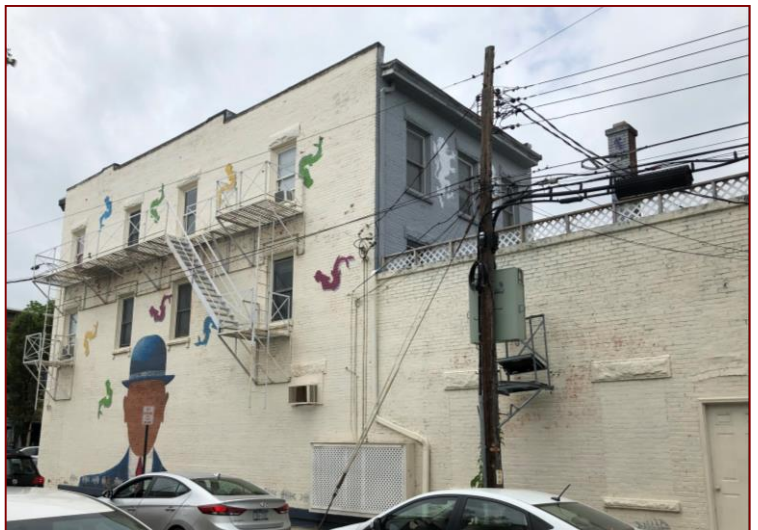
East Side View

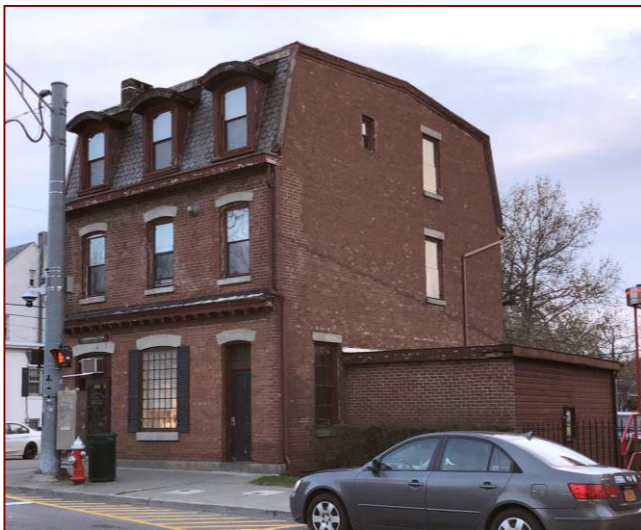
403 Main Street

The second-floor cornices, front and rear, are simple in form, but the storefront cornice has regularly spaced modillions. The storefront features a central 48-pane window. The commercial door has side lights and the transom covered over by an air conditioner. The door to the upper floors has an original transom window.

The windows have large arched stone lintels and stone sills on the Main Street side with primarily straight stone lintels and sills on the other elevations. The window sashes appear to be a combination of original and modern replacements. There is also an original small rear porch with scroll-cut corner brackets and a modern, one-story brick addition to the east side.

Front View

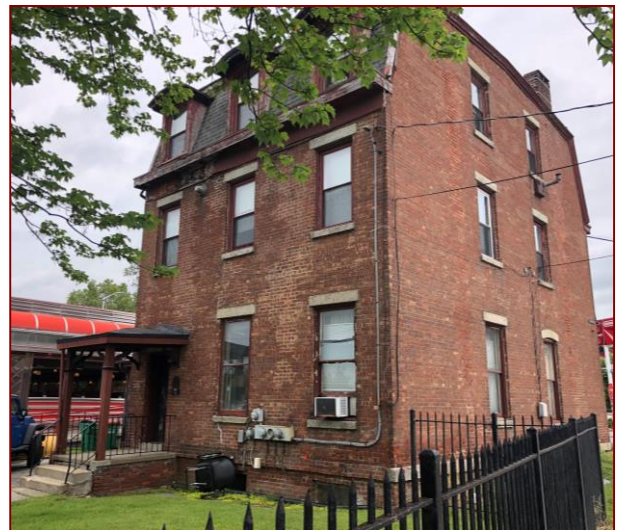
Rear View

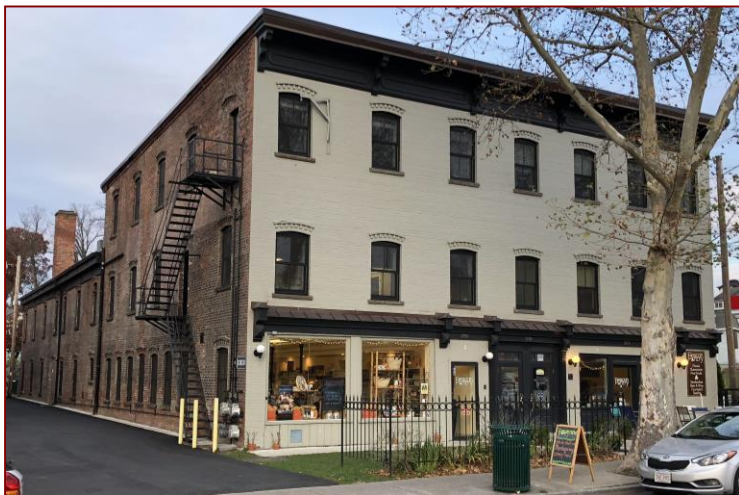
The building retains its original character. This commercial structure is one of the more intact examples of its type, scale, and period in the City. It possesses special historic and aesthetic value as part of the cultural history of the City and embodies distinguishing characteristics of an architectural period and style.
