HISTORIC RESOURCE INVENTORY FORM

IDENTIFICATION

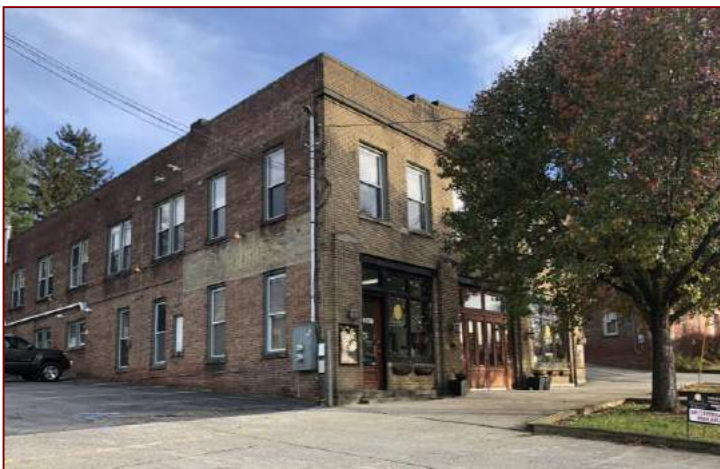
1158 North Avenue

The window openings have brick lintels and stone sills. The windows appear to be more modern replacements. Some of the side windows are paired.

The building retains its original character. This commercial storefront structure in a prominent location, close to the Lower Main Street Historic District and the City's Historic District and Landmark Overlay Zone, is one of the most intact examples of its type, scale, and period in the City. It possesses special historic and aesthetic value as part of the cultural history of the City and embodies distinguishing characteristics of an architectural period and style.

View of North Side

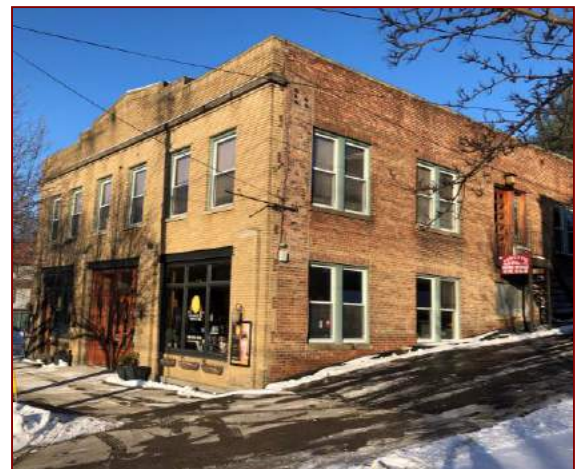
View of South Side

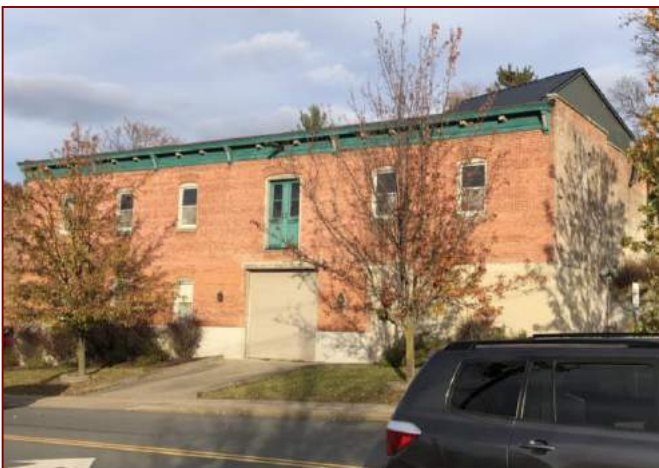
1154 North Avenue

The window openings have arched brick lintels and stone sills. The windows appear to be more modern replacements, as is the front garage door and the door in the former storefront area. The storefront display windows on the southwest corner were boarded up in 1979, and have since been covered over with cement. The second story has older wood double doors with windows and panels and an overhead projecting beam to lift goods to the second floor.

Other than the covered-over corner storefront and garage door, the building retains much of its original character, in particular its decorative cornice. This commercial structure in a prominent location, close to the Lower Main Street Historic District and the City's Historic District and Landmark Overlay Zone, is an intact example of its type, scale, and period in the City. It possesses a special historic and aesthetic value as part of the cultural history of the City and embodies distinguishing characteristics of an architectural period and style.

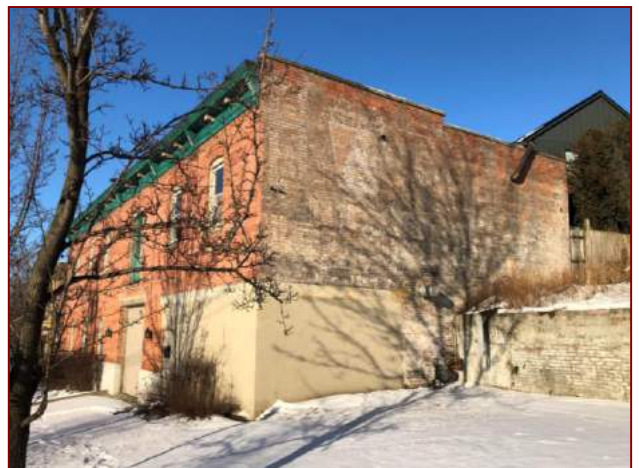
View from South

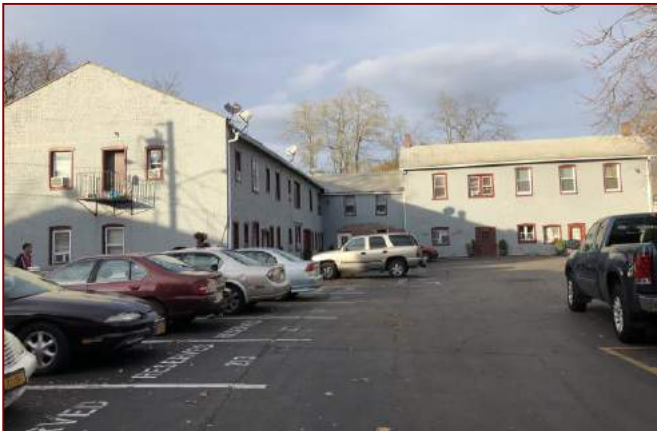
152 Main Street

The original windows and doors had arched brick lintels, so it is apparent that the current irregular pattern of windows and doors features many newer window and doors. Several larger commercial doors have been closed-in with brick or block. The existing windows and surrounding wood trim appear to be modern replacements.

Other than the brick walls and chimneys, most of the building details are modern replacements from when the building was converted to apartments after 1980. However, this early commercial warehouse structure, adjacent to the Lower Main Street Historic District and the City's Historic District and Landmark Overlay Zone, is a surviving example of its type, scale, and period in the City. It possesses special historic and aesthetic value as part of the cultural history of the City and embodies distinguishing characteristics of an architectural period and style.

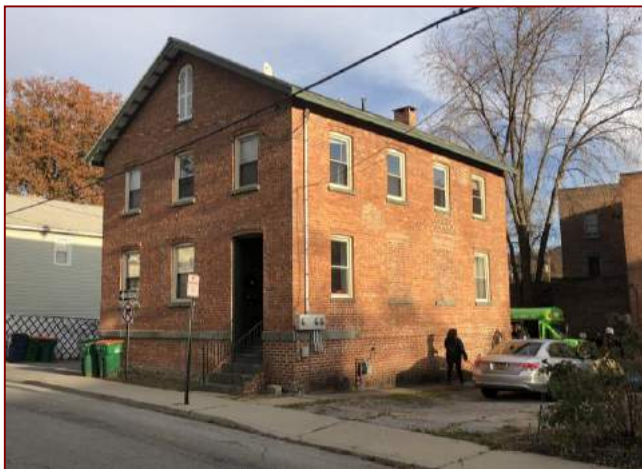
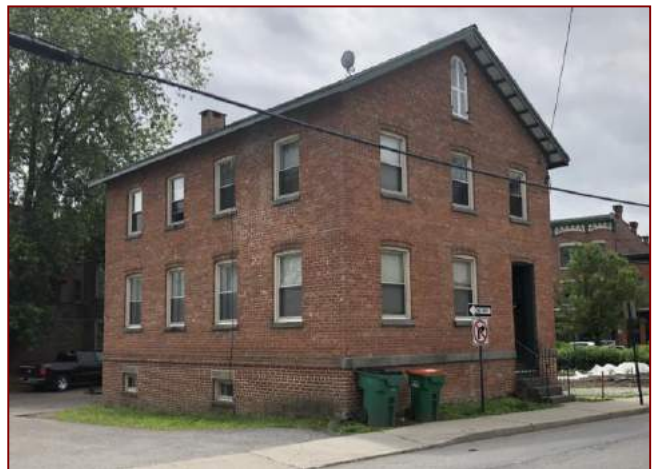
4 Cross Street

The window openings have arched projecting brick lintels and stone sills, although two of the windows have been bricked-in on the south side. There is an arched window opening with wood shutters under the front gable, but the rest of the window sashes appear to be more modern replacements.

The brick is in generally good condition, although some areas have been obviously repointed, especially along the lower level of the building. The brick chimney is to the rear, projecting out from the rear wall.

View of South Side

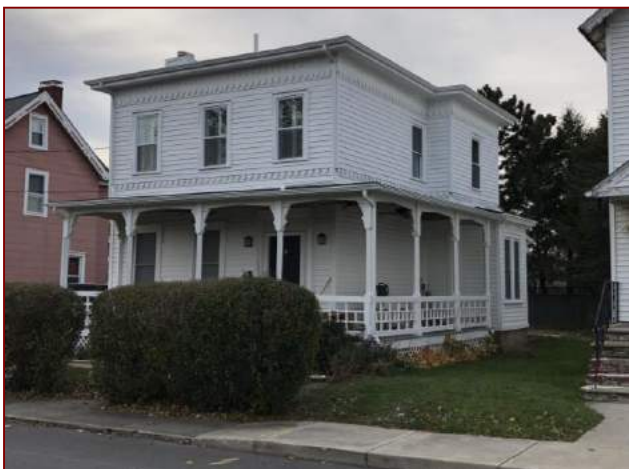
11 Digger Phelps Court

The window sashes and the chimney near the south roof line appear to be more modern replacements. Based on changes in wood pattern, paired brackets may have been originally under the roof cornice.

View of North Side

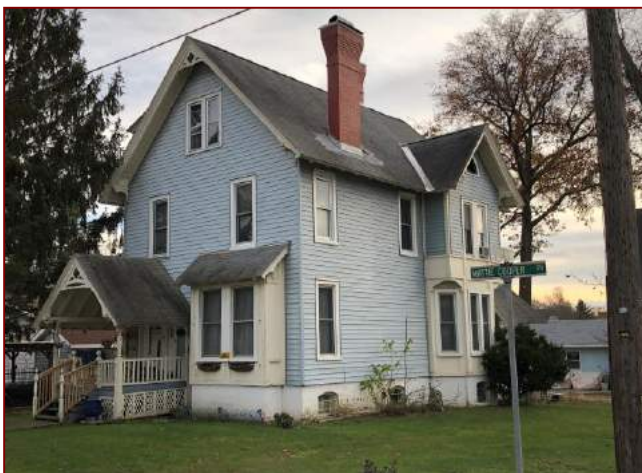
9 Mattie Cooper Square

The house features decorative vergeboards supported by corner brackets with clover leaf cut-outs at the apex of the front and rear gables and the front porch. The northern porch extension and rear porch have turned columns and original balustrade, but the railings flanking the front steps and the rear steps are replacements. The northern façade has a one-story rectangular bay window with a shed roof. There are two brick chimneys with flared tops.

The original siding has been completely covered over with newer vinyl siding and the window sashes appear to be more modern replacements. There is also a one-story, 20th century concrete block garage to the rear.

View of North Side

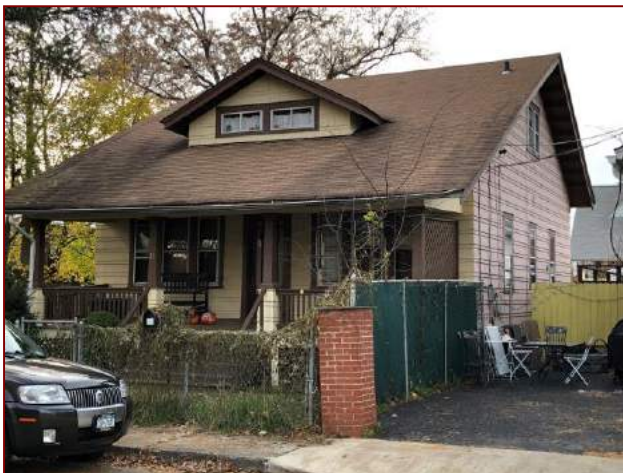
11 North Elm Street

The building retains its original Arts and Crafts character, in particular its distinctive shingle pattern and front porch details. This house is one of the most intact examples of its type, scale, and period in the City. It possesses special historic and aesthetic value as part of the cultural history of the City and embodies distinguishing characteristics of an architectural period and style.

Front View

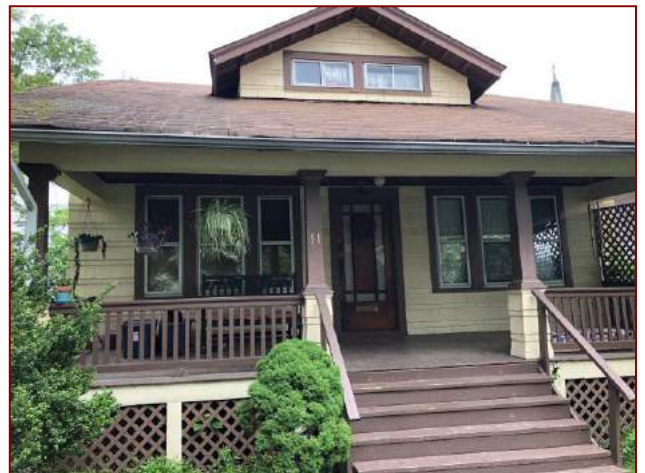
Front Porch Details

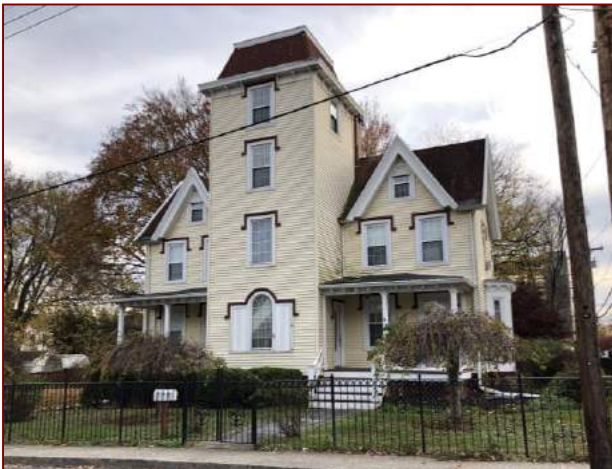
17 Church Street

The original siding has been covered over with new vinyl siding and the window sashes appear to be more modern replacements. There is also a modern raised deck with wide glass door entry to the rear of the house, a modern one-story garage in the back yard, and a newer perimeter metal picket fence.

Front View

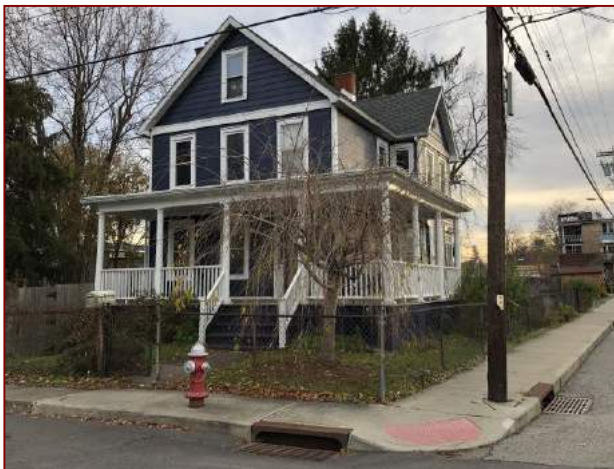
27 Church Street

The original siding has been covered over with asbestos siding and the window sashes and porch railing appear to be more modern replacements. A former rear porch on the west side has been enclosed. There is a one-story, non-historic garage in the rear corner and a black chain link fence around the perimeter of the yard.

Front View

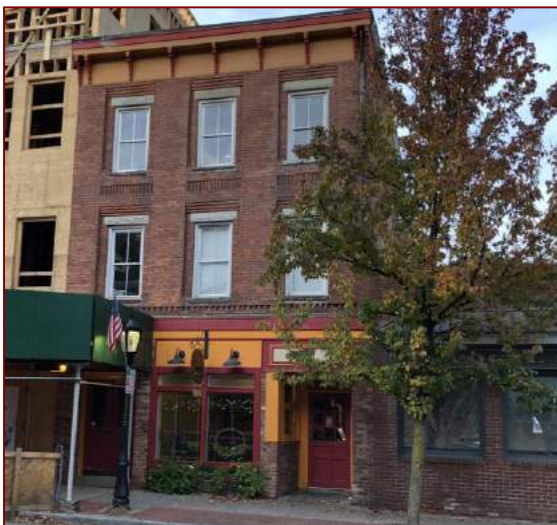
232 Main Street

The building retains its original character, in particular its decorative brickwork. This commercial storefront structure is one of the most intact examples of its type, scale, and period in the City. It possesses special historic and aesthetic value as part of the cultural history of the City and embodies distinguishing characteristics of an architectural period and style.

Front View

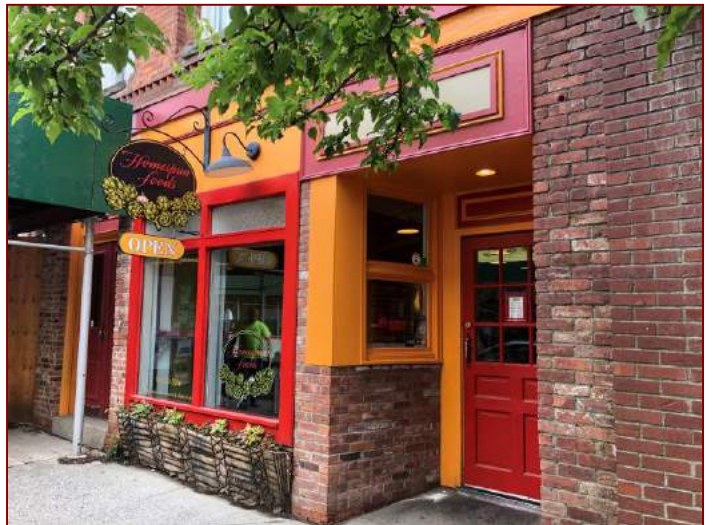
Storefront Details

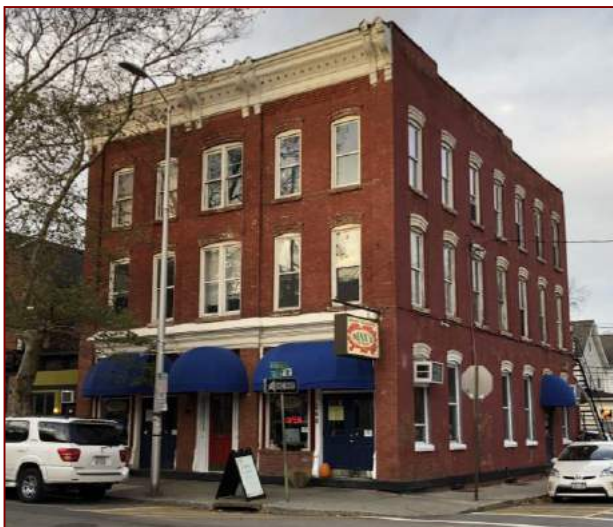
246 Main Street

The windows have arched brick lintels and stone sills with paired windows in the central bay. The sashes appear to be modern replacements. There is a simple secondary cornice over the storefronts and a central doorway for upper floor access. The two storefronts have double doors, but the windows and surrounds do not look original.

The building retains its original character, particularly its elaborate overhanging cornice. This commercial structure is one of the most intact examples of its type, scale, and period in the City. It possesses special historic and aesthetic value as part of the cultural history of the City and embodies distinguishing characteristics of an architectural period and style.

Front View

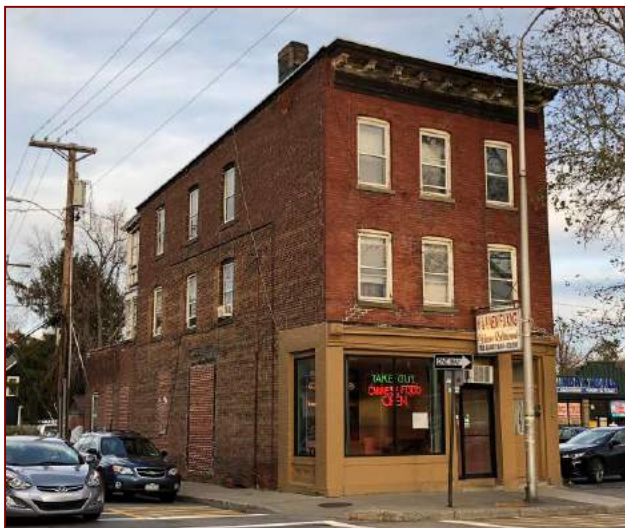
250 Main Street

The windows have arched brick lintels and stone sills. The sashes appear to be modern replacements. There is a simple secondary cornice over the storefront with corner blocks. The storefront surrounds and the door to the upper floors look original, but the storefront window and door are modern.

Other than the bricked-up openings on the west side, the building retains most of its original character, in particular its decorative cornice. This commercial storefront structure is one of the most intact examples of its type, scale, and period in the City. It possesses special historic and aesthetic value as part of the cultural history of the City and embodies distinguishing characteristics of an architectural period and style.

Front View

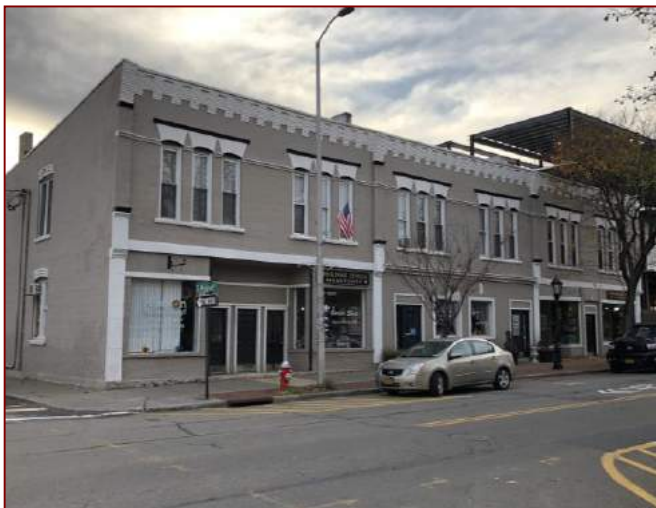
257 Main Street

The building retains its original character, in particular its decorative brickwork. This commercial storefront structure is one of the most intact examples of its type, scale, and period in the City. It possesses special historic and aesthetic value as part of the cultural history of the City and embodies distinguishing characteristics of an architectural period and style.

Front View

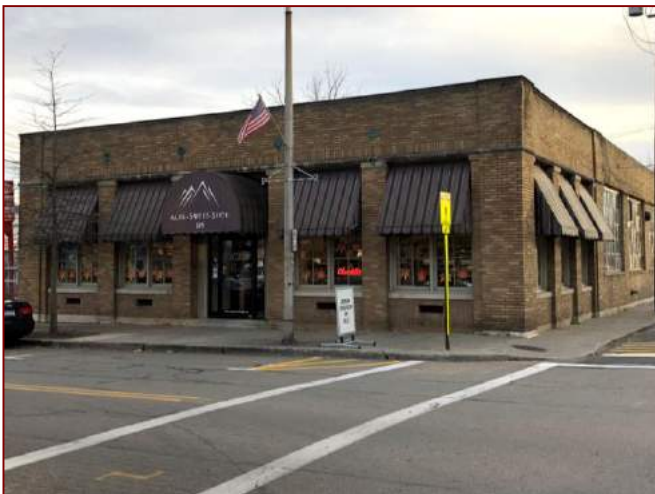
269 Main Street

The building retains its original character. This commercial structure is one of the most intact examples of its type, scale, and period in the City. It possesses special historic and aesthetic value as part of the cultural history of the City and embodies distinguishing characteristics of an architectural period and style.

Front View

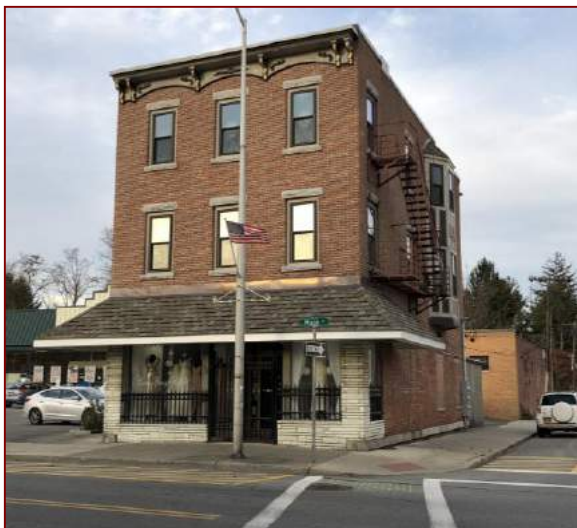
274 Main Street

The windows have stone lintels and sills, although the sashes appear to be modern replacements. Two windows have been bricked-up on the east side first floor. The east side also has a steel fire escape and a bay window on the upper two floors, which is original to the building, but has been refaced with modern materials. The thoroughly modernized storefront features a broad asphalt shingled roof, horizontally laid white stone, and metal picket fencing in front of the windows.

Other than the storefront and bay window, the building retains much of its original character, in particular its decorative cornice. This commercial storefront structure is one of the more intact examples of its type, scale, and period in the City. It possesses special historic and aesthetic value as part of the cultural history of the City and embodies distinguishing characteristics of an architectural period and style.

Front View

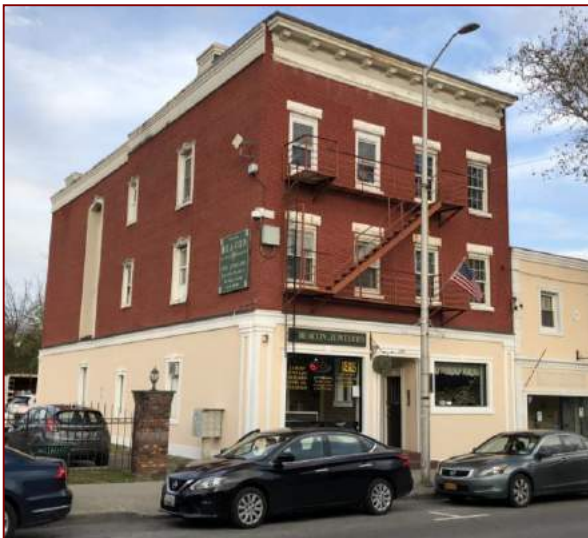
284 Main Street

The south windows have stone lintels and sills, although the sashes appear to be modern replacements. On the west side the windows are wood framed with central keys above, as is the pointed arch above the recessed window well on the two upper floors.

Front View

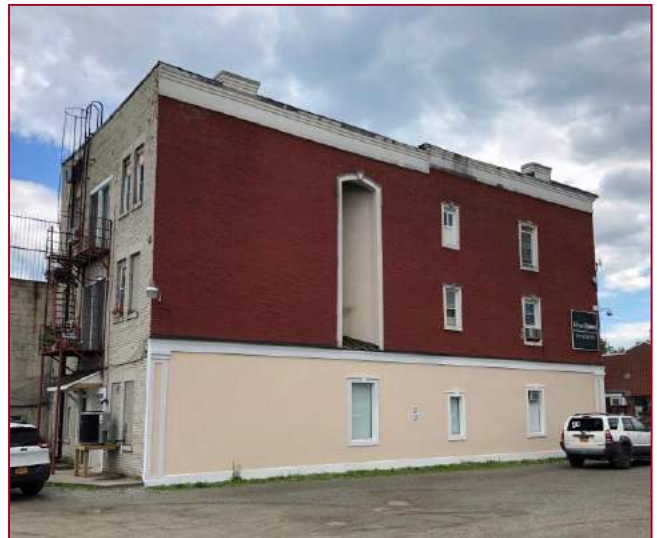
Rear View

Other than the storefront level and replaced windows, the building retains much of its original character, in particular its decorative cornice. This commercial storefront structure is one of the more intact examples of its type, scale, and period in the City. It possesses special historic and aesthetic value as part of the cultural history of the City and embodies distinguishing characteristics of an architectural period and style.

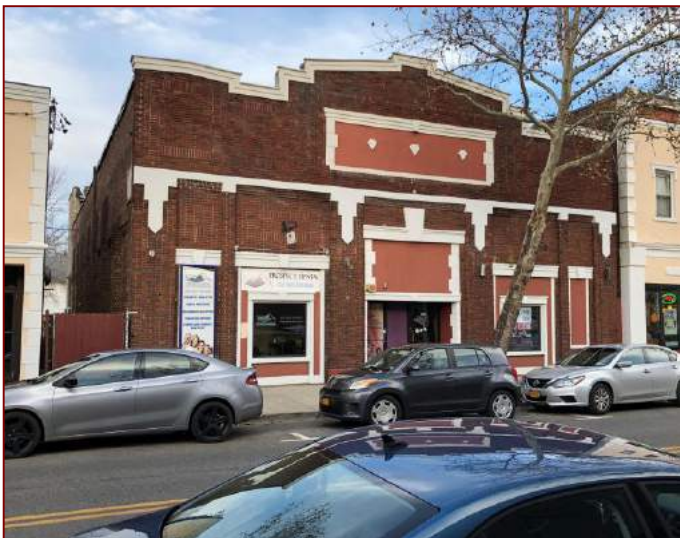
288 Main Street

The first-floor windows also have wide bands above and exaggerated central keys. The south side windows and doors appear to be more modern replacements.

Front View

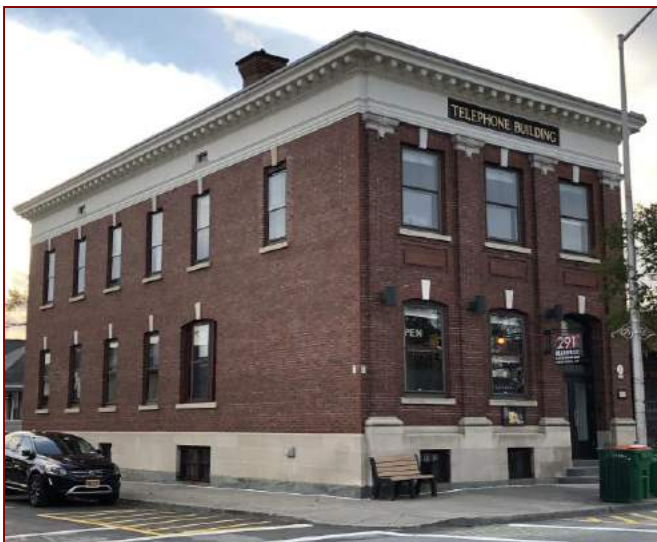
291 Main Street

The building retains its original character, in particular its distinctive cornice and front facade. This structure is one of the most intact examples of its type, scale, and period in the City. It possesses special historic and aesthetic value as part of the cultural history of the City and embodies distinguishing characteristics of an architectural period and style.

Front View

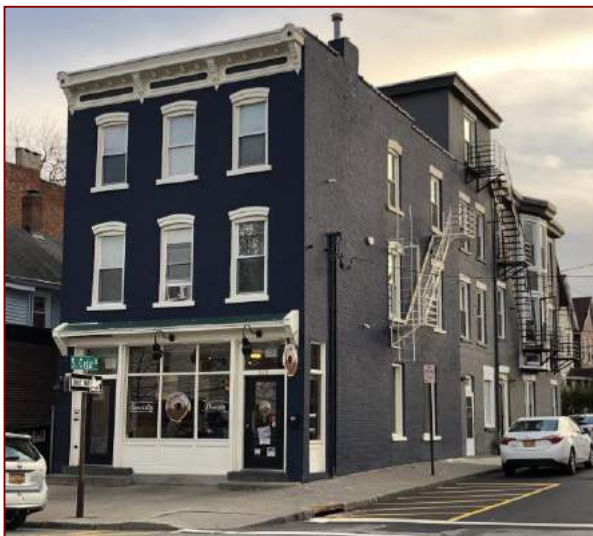
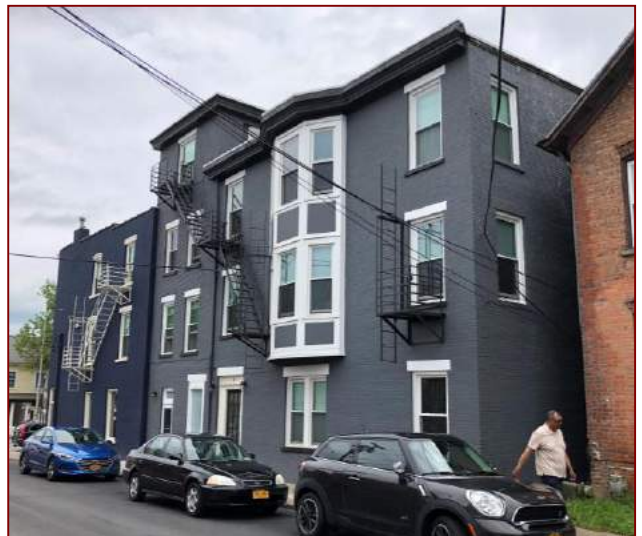
315 Main Street

The front windows have raised arching brick lintels and stone sills, but the windows on the South Cedar Street side have primarily straight stone lintels. The window sashes appear to be modern replacements. On the west side rear section there is a projecting bay window on the upper two floors, which may be a more recent addition because it does not show on the 1946 and earlier Sanborn maps. The west side also has three steel fire escapes.

The building retains much of its original character, in particular its decorative cornice. This mixed-use structure is one of the more intact examples of its type, scale, and period in the City. It possesses special historic and aesthetic value as part of the cultural history of the City and embodies distinguishing characteristics of an architectural period and style.

Rear View

Front View

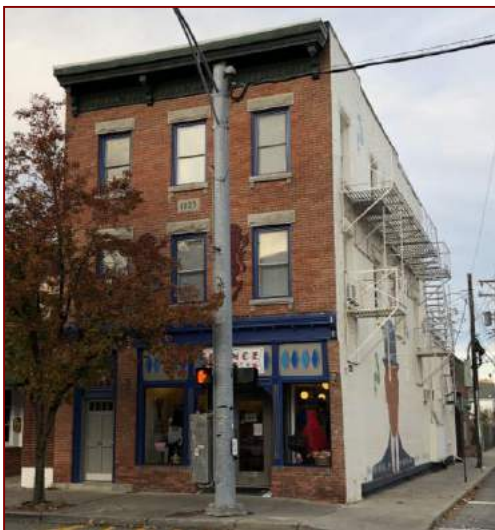
314 Main Street

The windows have large stone lintels and stone sills with small lower corner blocks, but the window sashes appear to be modern replacements. The side walls and one-story rear addition are painted white. The side facing South Chestnut Street has painted artwork, a steel fire escape, and several bricked-over window openings on the first floor.

The building retains its original character, in particular its decorative cornices. This commercial storefront structure is one of the more intact examples of its type, scale, and period in the City. It possesses special historic and aesthetic value as part of the cultural history of the City and embodies distinguishing characteristics of an architectural period and style.

Front View

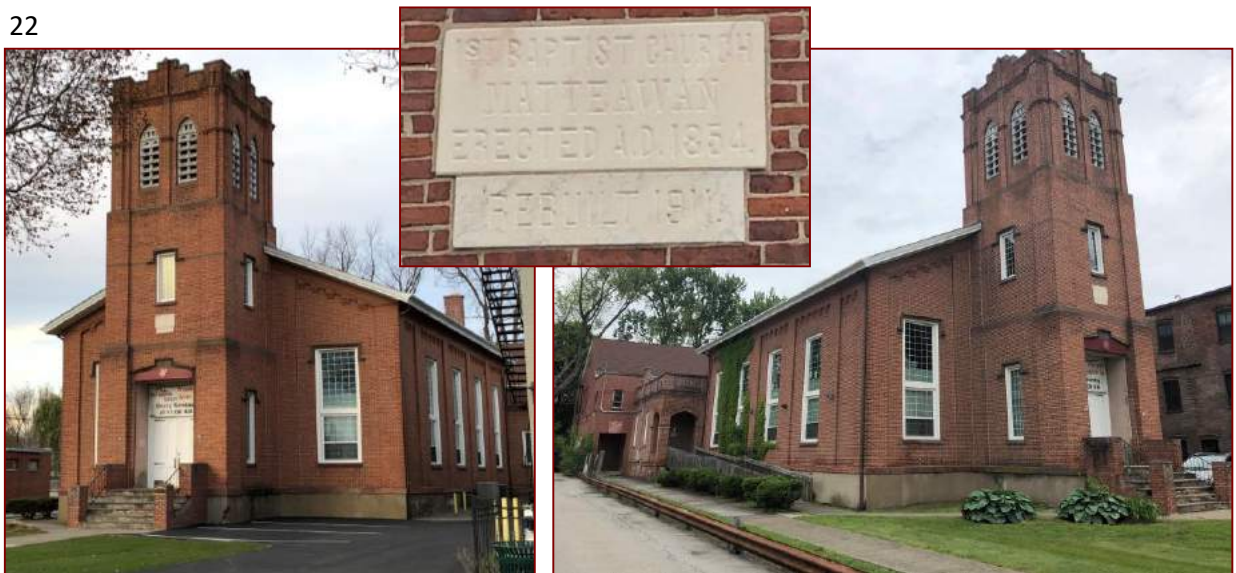
372 Main Street Front View and East Side

The brick church is located on the north side of Main Street set back from the street on a 0.6-acre lot. The main section has square brick corbelling under the eaves, and the square bell tower up front has Gothic Revival details, such as pointed arches and a crenellated top. There are stone courses along the top of the foundation and dividing the tower into three levels.

The construction dates are carved into a central stone above the double front doors, which have multi-pane transom windows. The windows are set in recessed brick panels with stone lintels and sills. The windows facing the street and on the tower have stone drip-molds over the top. The window sashes are more modern replacements.

Front View and West Side

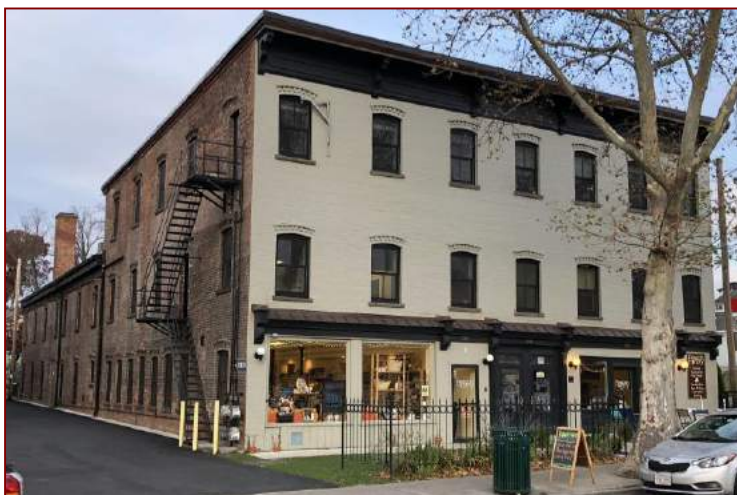
378-382 Main Street

The building retains most of its original character. This commercial structure is one of the more intact examples of its type, scale, and period in the City. It possesses special historic and aesthetic value as part of the cultural history of the City and embodies distinguishing characteristics of an architectural period and style.

Front View

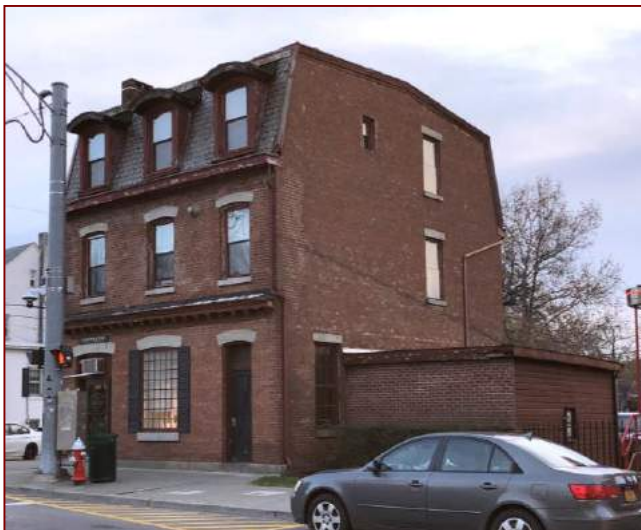
403 Main Street

The second-floor cornices, front and rear, are simple in form, but the storefront cornice has regularly spaced modillions. The storefront features a central 48-pane window. The commercial door has side lights and the transom covered over by an air conditioner. The door to the upper floors has an original transom window.

The windows have large arched stone lintels and stone sills on the Main Street side with primarily straight stone lintels and sills on the other elevations. The window sashes appear to be a combination of original and modern replacements. There is also an original small rear porch with scroll-cut corner brackets and a modern, one-story brick addition to the east side.

The building retains its original character. This commercial storefront structure is one of the more intact examples of its type, scale, and period in the City. It possesses special historic and aesthetic value as part of the cultural history of the City and embodies distinguishing characteristics of an architectural period and style.

Front View

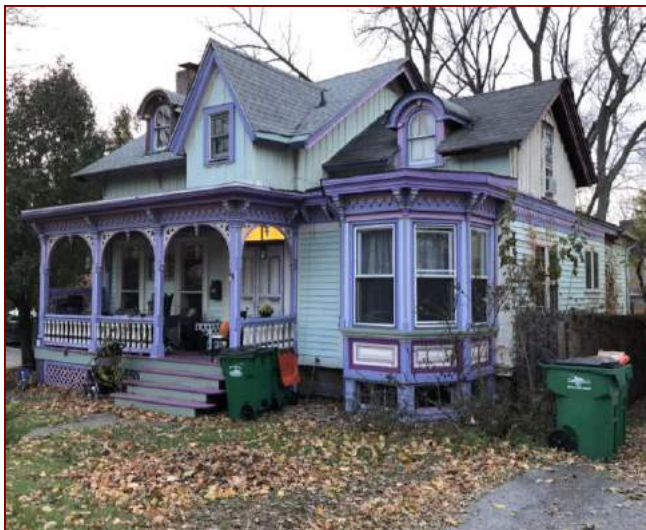
159 Fishkill Avenue

The building retains its original character with a mix of Gothic and Italianate features. This elaborately decorated house is one of the most intact examples of its type, scale, and period in the City. It possesses special historic and aesthetic value as part of the cultural history of the City and embodies distinguishing characteristics of an architectural period and style.

Front View

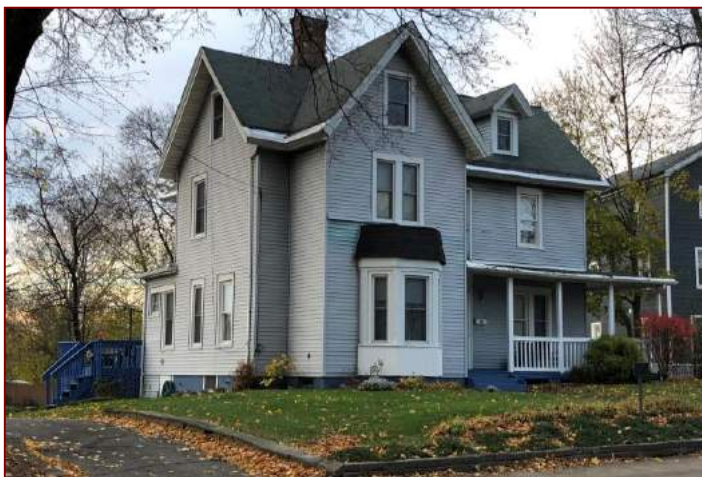
189 Fishkill Avenue

Although the house has lost almost all its architectural details since the 1979 Historic Survey, the building is associated with a historic person in national history, James V. Forrestal (1892-1949). He was born here and graduated from Matteawan High School at the age of 16. A naval aviator in WWI and Wall Street executive between the wars, Forrestal's friendship with Franklin D. Roosevelt led to his appointment as Undersecretary of the Navy in 1940 and Secretary of the Navy in 1944. He is noted for his effective mobilization of the war effort, his advocacy for racial integration in the military, and, after the war, a strong national defense. Forrestal was appointed the first Secretary of Defense by President Truman in 1947, but disagreed with Truman over the military budget and other political issues and was forced to resign in 1949. He fell into depression and either fell or jumped to his death from a hospital window two months later. An aircraft carrier, a major office building in Washington DC, and an elementary school in Beacon were subsequently named after him.

Front View

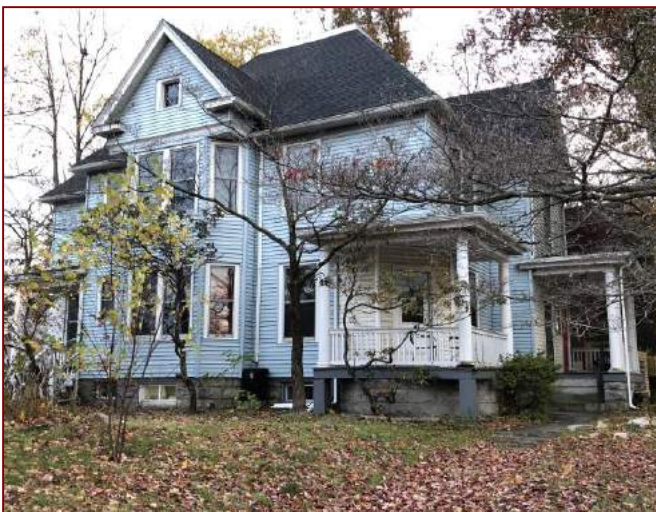
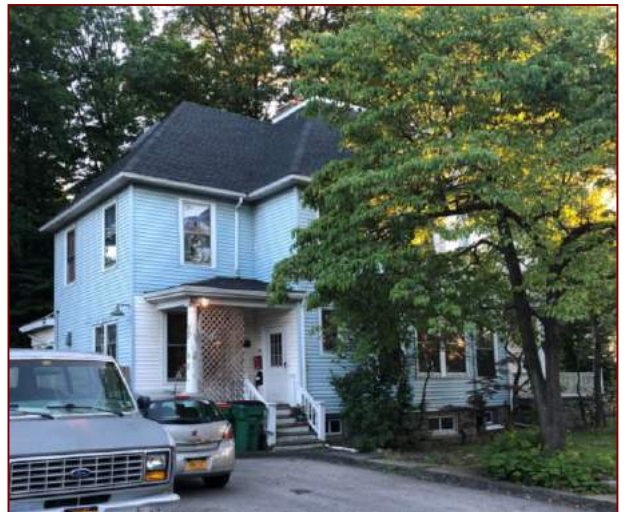
Views from Verplanck Avenue

The building is located on the east side of Fishkill Avenue on a 0.23-acre corner lot. It is a 2-story building with a hip roof, two cross gables, and a central brick chimney. The basement level has a rusticated cement block foundation. There is a 2-story, three-sided bay with paired central windows facing Verplanck Avenue.

The clapboard siding and shingled gables noted in the 1979 Historic Survey have been covered over with vinyl siding. As a result, the most notable architectural features are the three street-front porches with flat roofs, Tuscan columns, and straight balusters. The porch facing the intersection has a doorway set in an angled corner.

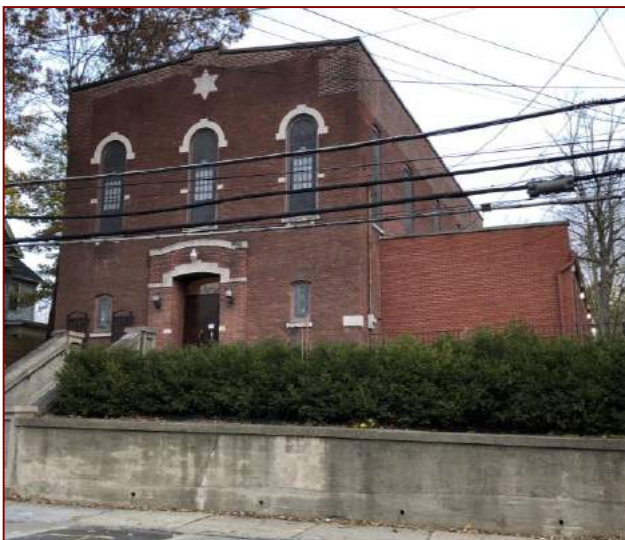
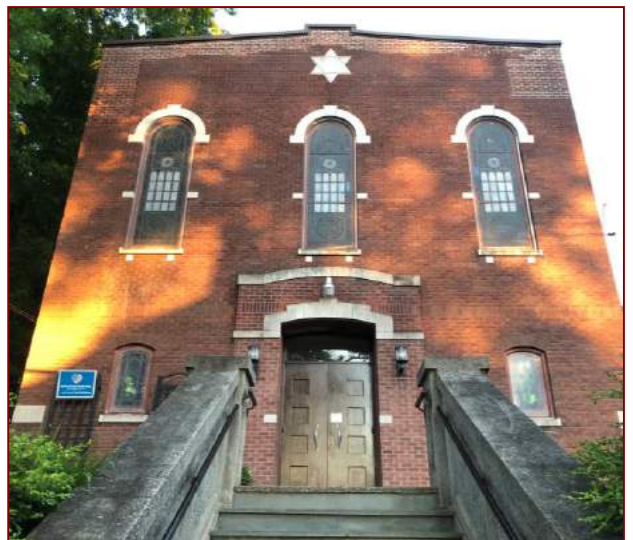
331 Verplanck Avenue

The façade features a raised parapet roofline with a Star of David just below and three tall stained-glass windows. These windows are topped by arched stone elements with central keys and stone sills with supporting blocks below. Two smaller stained-glass windows flank the front entrance with arched brick lintels and stone sills. The brick entrance surrounds project out from the facade with a stone shallow arch above and the name of the building inscribed along the top edge. Two paneled wood doors have a transom window above and lantern lighting fixtures on both sides.

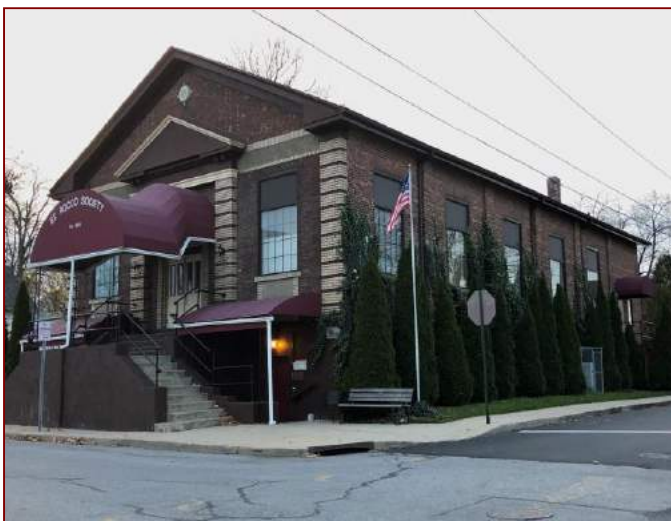
26 S. Chestnut Street

Front View

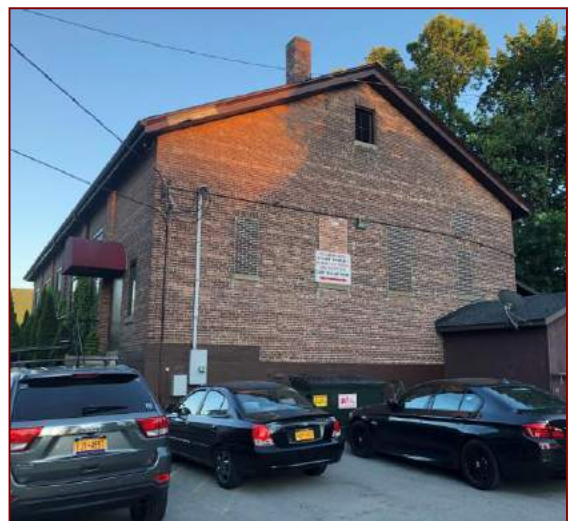
The windows appear to be modern replacements and the front stairs, metal railings, and overhead canopy are likely newer construction. Four windows on the rear wall have been bricked over. There is also a 1-story shed addition on the rear side.

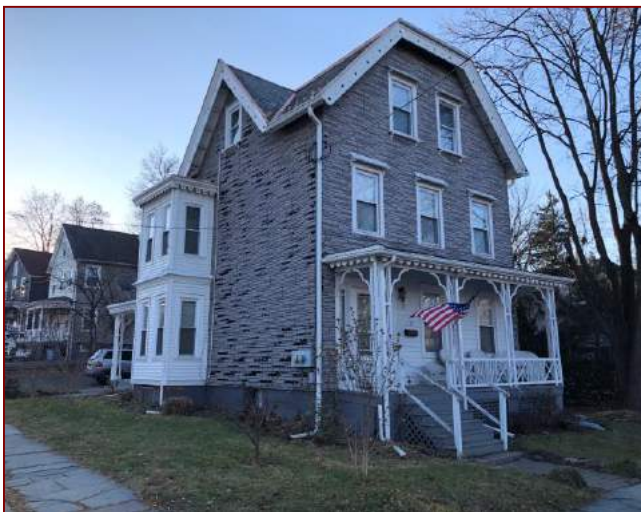
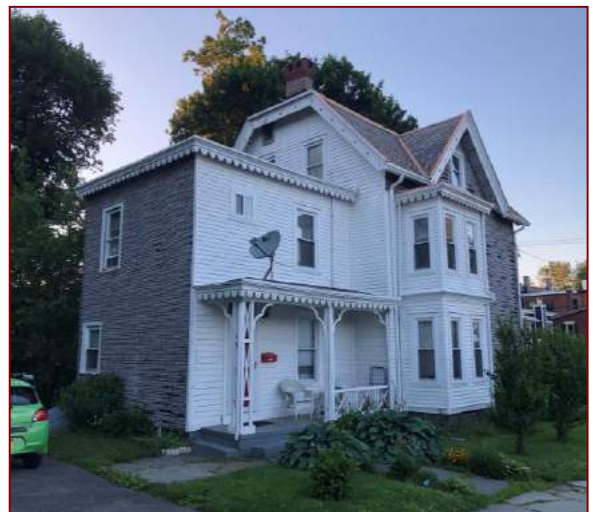
Front View

The front upper-floor windows have shed hoods with small corner brackets. All the window sashes appear to be modern replacements, but the front door and side lights seem to be original.

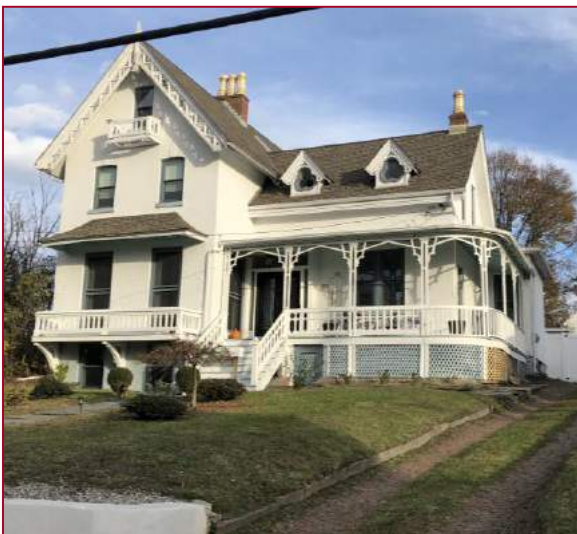
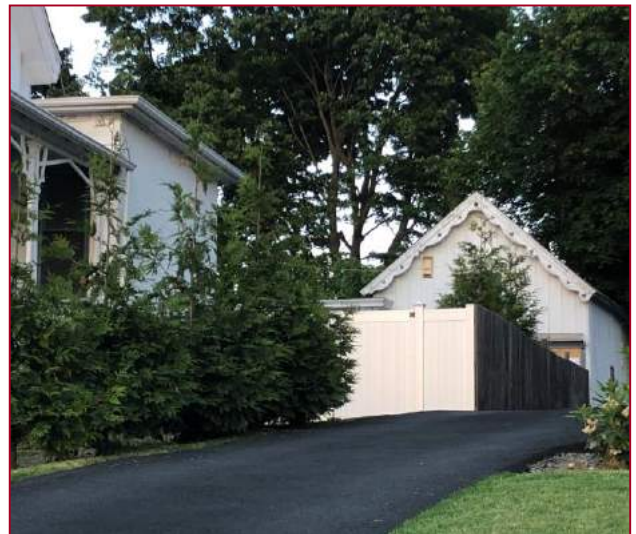
Front View

The front-facing gable has a wide vergeboard with elaborate cut-outs, pinnacle above, and a window and balcony below. The first floor in front has a canopy roof, two French doors, and an elevated porch with large projecting supports. There is a one-story bay window on the north side. The porch curving around the southern section of the house has lightweight columns and bracketed supports. Parts of the original balusters have been replaced. The double front doors have glass panels and a transom window.

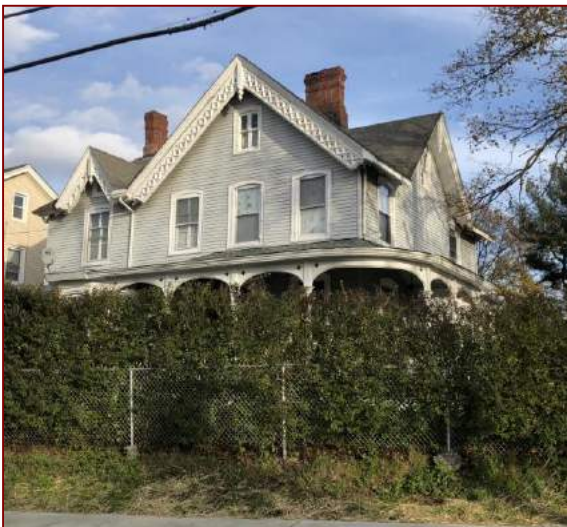
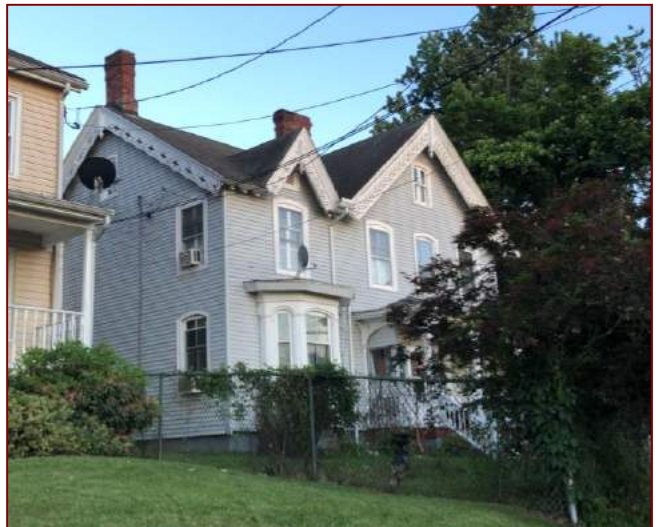
Front Views

There are 1-story bay windows on the south and west sides and a 2-story bay on the north side. The cornice brackets remain on the northern bay. The windows have arched wood frames, but some of the 2 over 2 sashes have been replaced.

The front porch curves around to the south side. It has chamfered columns and arched supports with corner cut-outs. The front doorway appears to be a modern replacement.

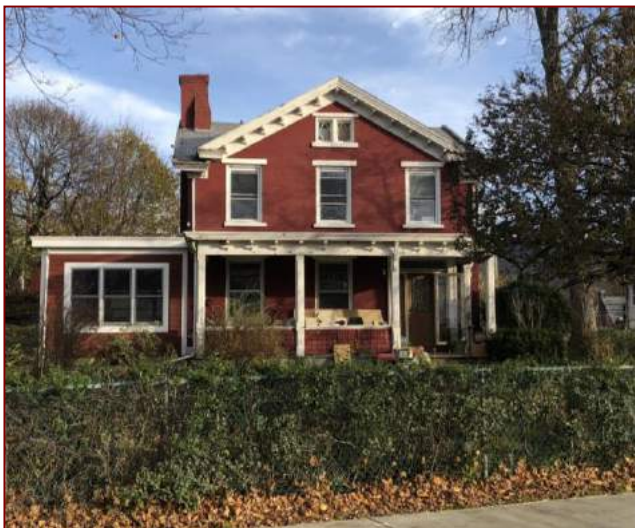
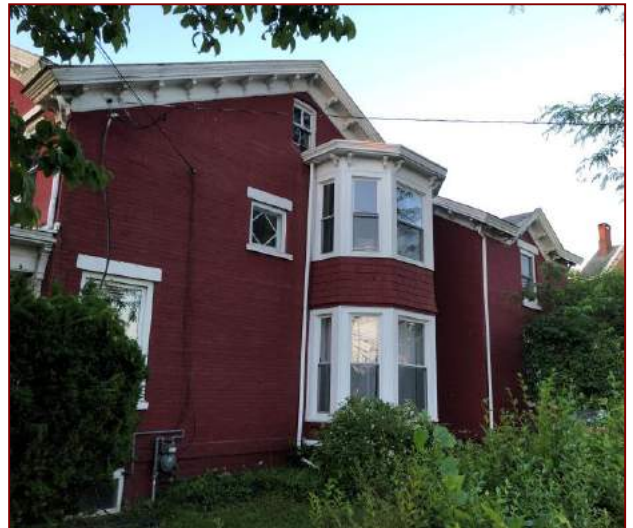
Beacon Street View

The windows have stone lintels and sills, but appear to have replacement sashes. A smaller set of paired windows under the western eaves has a distinctive diamond glazing pattern. A small, similarly shaped window with a diamond glass pattern also exists on the southern wall next to the bay.
