HISTORIC RESOURCE INVENTORY FORM

NYS OFFICE OF PARKS, RECREATION
& HISTORIC PRESERVATION
P.O. BOX 189, WATERFORD, NY 12188
(518) 237-8643

Property name(if any) _____
Address or Street Location 1158 North Avenue 1
County Dutchess Town/City Beacon Village/Hamlet: _____
Owner Hibernation Auto Storage, Inc. Address 1158 North Avenue, Beacon, NY 12508
Original use Commercial Current use Commercial
Architect/Builder, if known _____ Date of construction, if known c. 1915

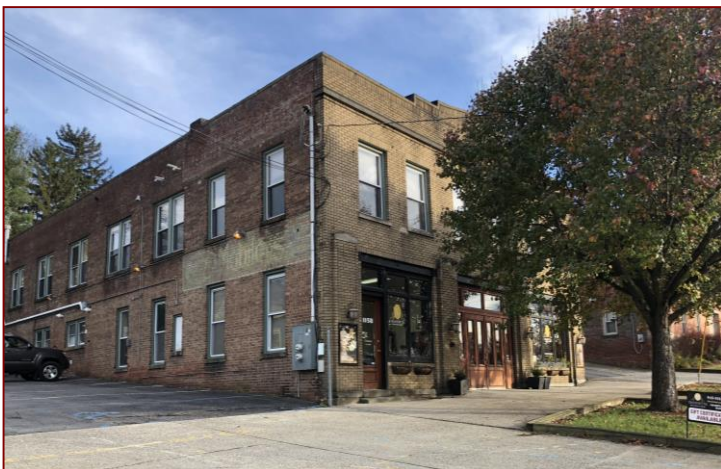
1158 North Avenue

There are faded painted signs on the north and south walls.

View of North Side

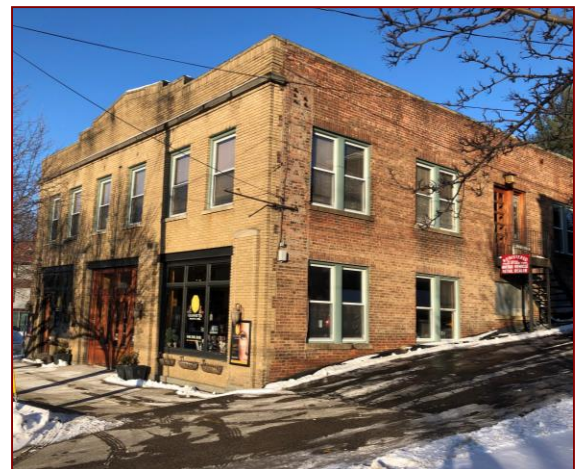
View of South Side

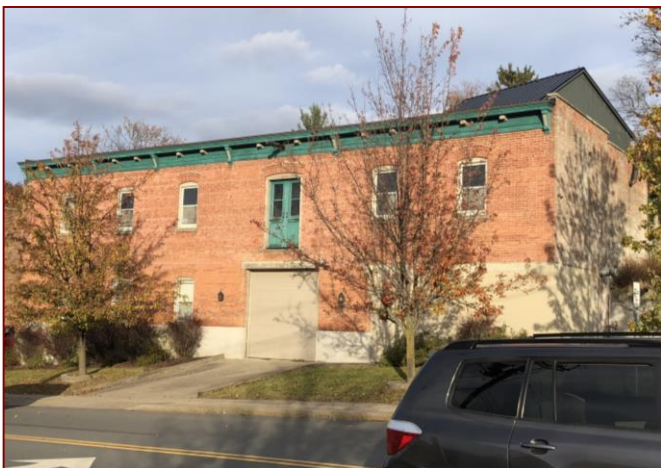
1154 North Avenue

The window openings have arched brick lintels and stone sills. The windows appear to be more modern replacements, as is the front garage door and the door in the former storefront area. The storefront display windows on the southwest corner were boarded up in 1979, and have since been covered over with cement. The second story has older wood double doors with windows and panels and an overhead projecting beam to lift goods to the second floor.

The brick façade facing North Avenue has been cleaned, but there are faded painted signs on the north and south walls.

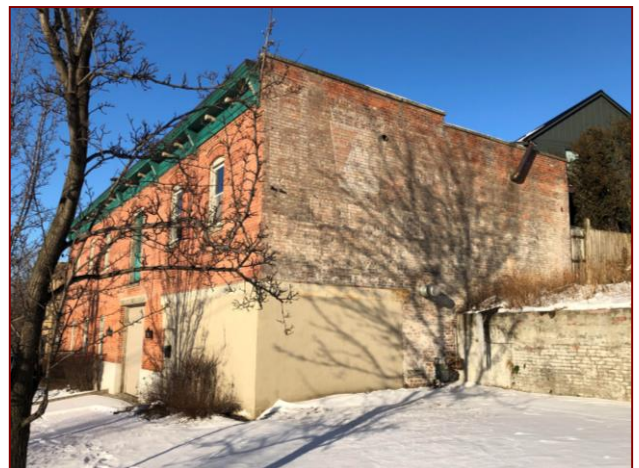
View from South

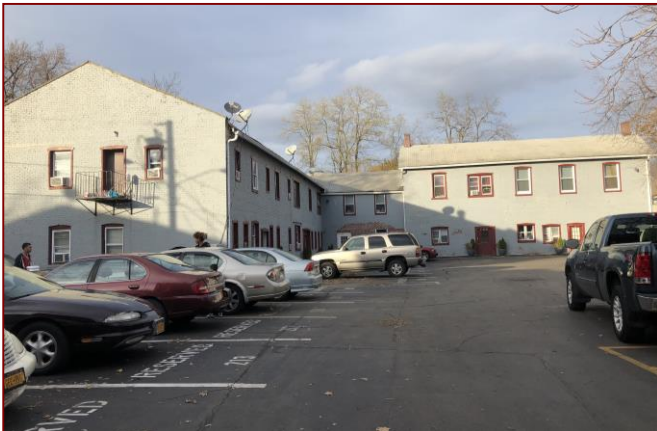
152 Main Street

The original windows and doors had arched brick lintels, so it is apparent that the current irregular pattern of windows and doors features many newer window and doors. Several larger commercial doors have been closed-in with brick or block. The existing windows and surrounding wood trim appear to be modern replacements.

The eastern wing has two brick end-wall chimneys and the western wing has a taller brick chimney on the southwest corner.

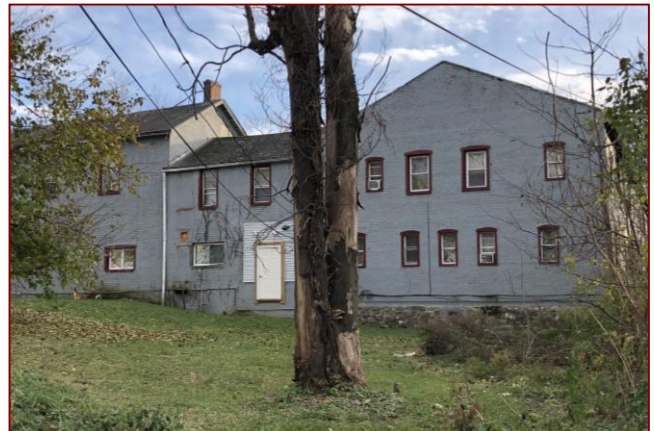
View from North

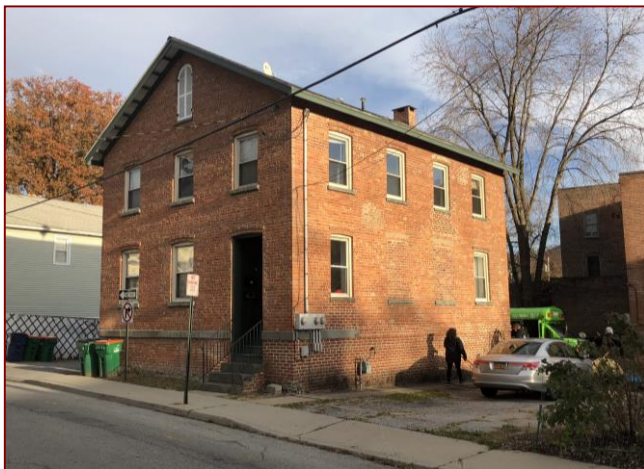
4 Cross Street

The window openings have arched projecting brick lintels and stone sills, although two of the windows have been bricked-in on the south side. There is an arched window opening with wood shutters under the front gable, but the rest of the window sashes appear to be more modern replacements.

View of South Side

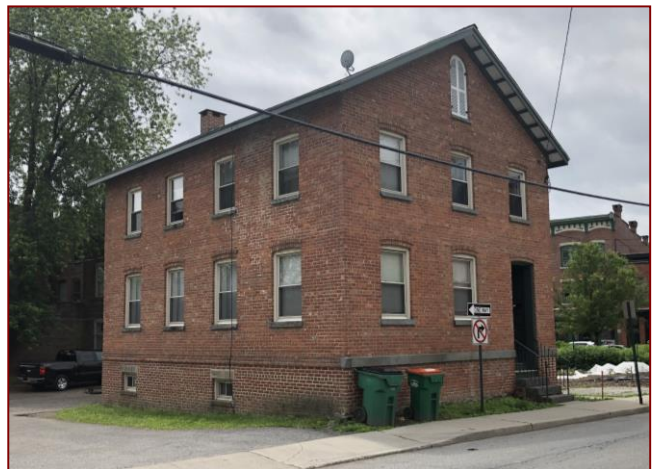
The brick is in generally good condition, although some areas have been obviously repointed, especially along the lower level of the building. The brick chimney is to the rear, projecting out from the rear wall.

View of North Side

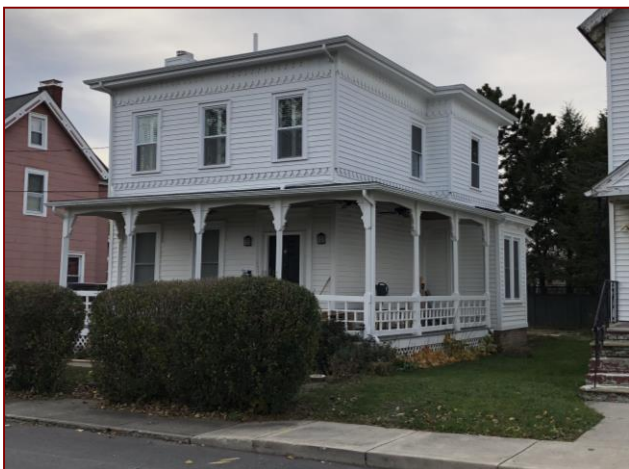
11 Digger Phelps Court

The front porch extends around the north side of the building. The decorative corbeled porch posts, detailed railing, and paneled door all appear original, as does the bay window with dentiled cornice on the south side. There is a one-story section to the rear.

View of North Side

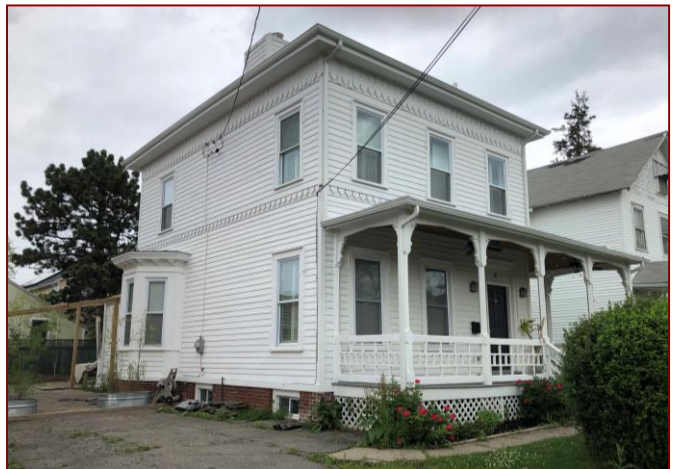
The window sashes and the chimney near the south roof line appear to be more modern replacements. Based on changes in wood pattern, paired brackets may have been originally under the roof cornice.

View of South Side

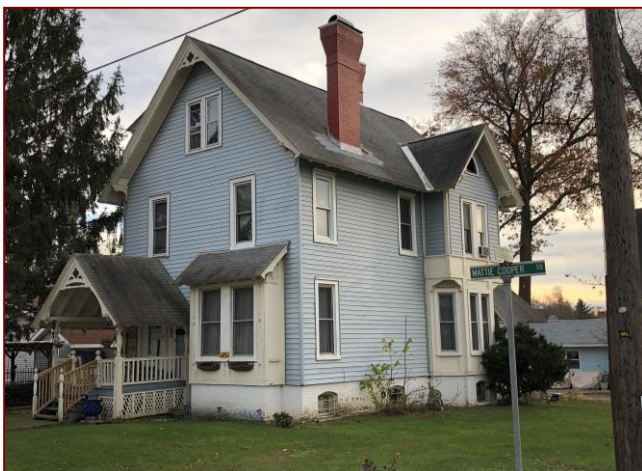
9 Mattie Cooper Square

The house features decorative vergeboards supported by corner brackets with clover leaf cut-outs at the apex of the front and rear gables and the front porch. The northern porch extension and rear porch have turned columns and original balustrade, but the railings flanking the front steps and the rear steps are replacements. The northern façade has a one-story rectangular bay window with a shed roof. There are two brick chimneys with flared tops.

View of North Side

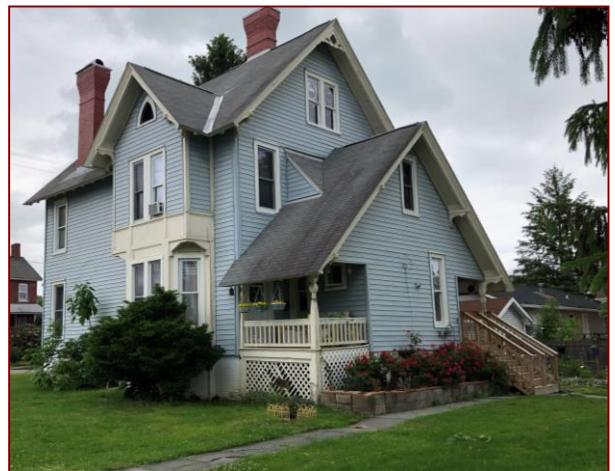
The original siding has been completely covered over with newer vinyl siding and the window sashes appear to be more modern replacements. There is also a one-story, 20th century concrete block garage to the rear.

View of South Side

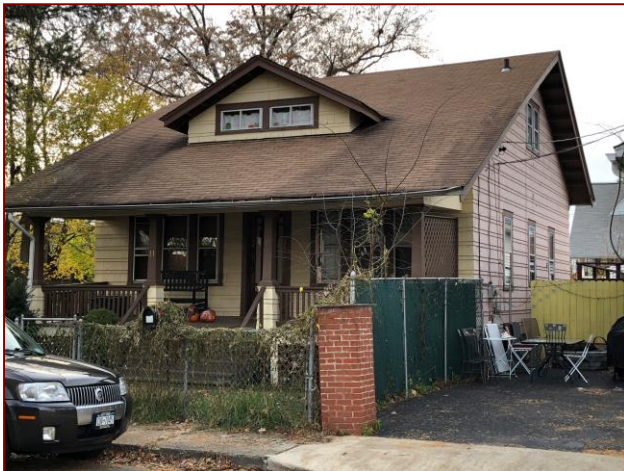
11 North Elm Street

The building is a half-block north of Main Street on an 0.18-acre parcel facing North Elm Street. It is a 1½-story Arts and Crafts structure with a broad, low-pitched gable roof and a central gabled dormer.

Front View

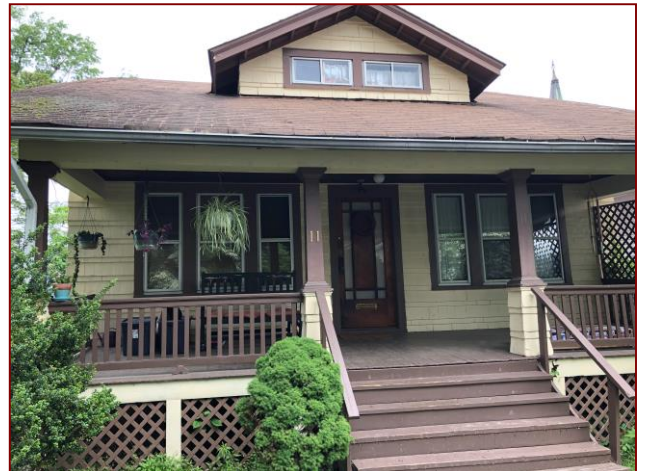
The building retains its original Arts and Crafts character, in particular its distinctive shingle pattern and front porch details. This house is one of the most intact examples of its type, scale, and period in the City. It possesses special historic and aesthetic value as part of the cultural history of the City and embodies distinguishing characteristics of an architectural period and style.

Front Porch Details

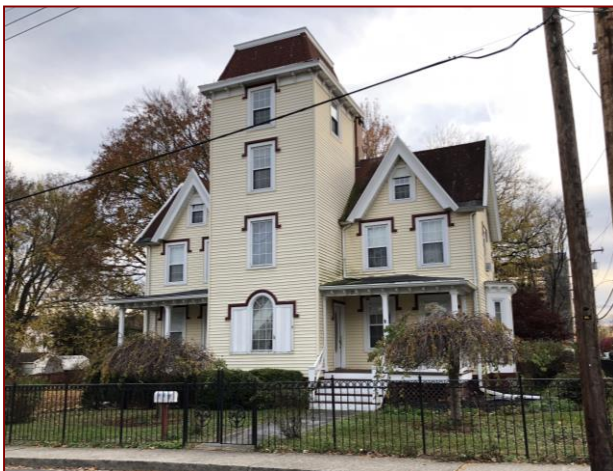
17 Church Street

The original siding has been covered over with new vinyl siding and the window sashes appear to be more modern replacements. There is also a modern raised deck with wide glass door entry to the rear of the house, a modern one-story garage in the back yard, and a newer perimeter metal picket fence.

Front View

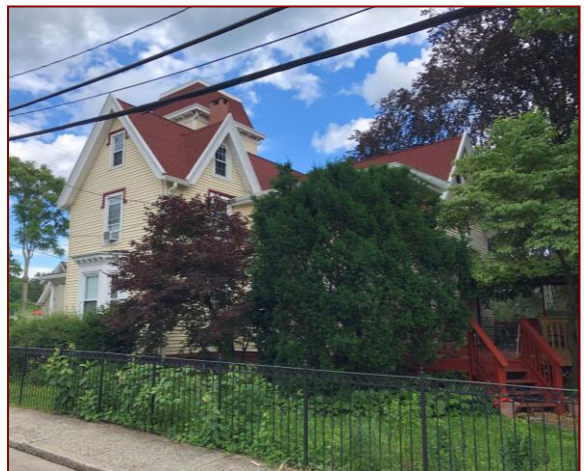
Rear View

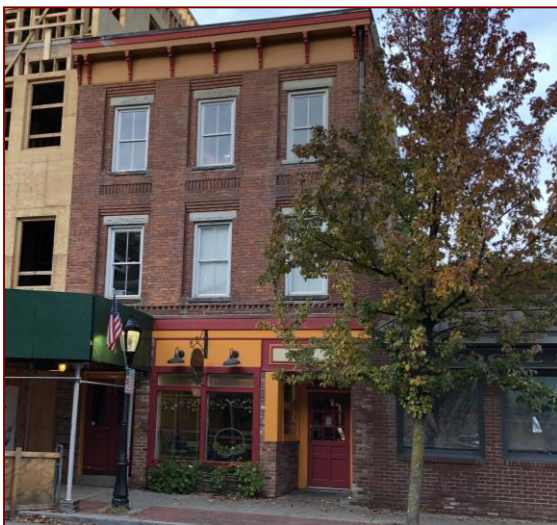
232 Main Street

The building retains its original character, in particular its decorative brickwork. This commercial storefront structure is one of the most intact examples of its type, scale, and period in the City. It possesses special historic and aesthetic value as part of the cultural history of the City and embodies distinguishing characteristics of an architectural period and style.

Front View

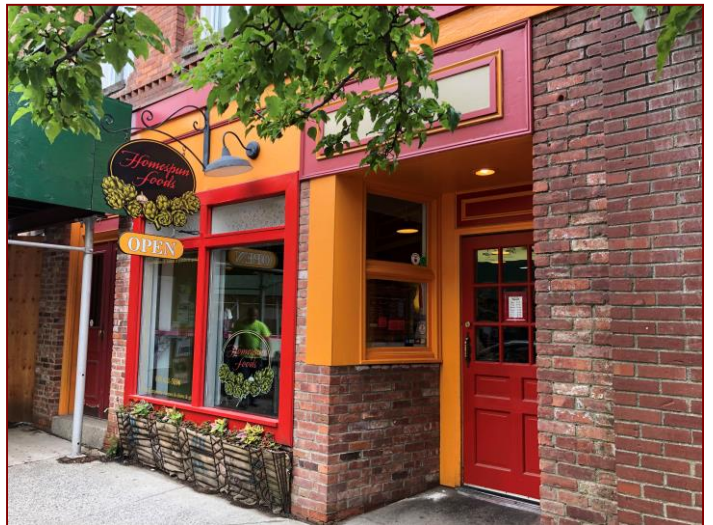
Storefront Details

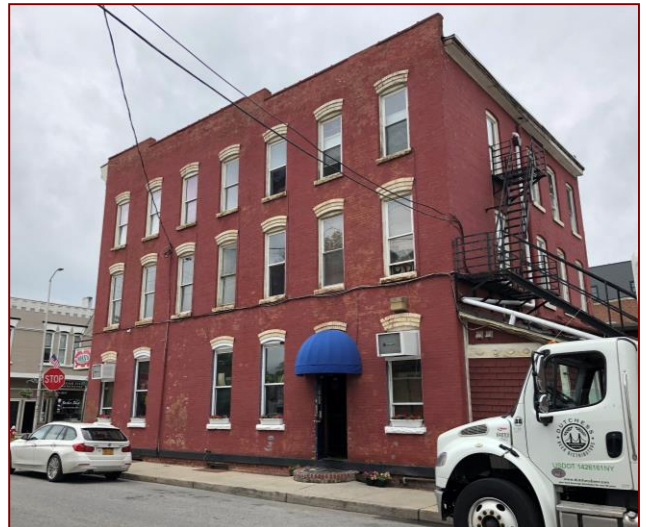
Rear View
