HISTORIC RESOURCE INVENTORY FORM

Property name(if any) _____
Address or Street Location 159 Fishkill Avenue 25
County Dutchess Town/City Beacon Village/Hamlet: _____
Owner Kimberly Garcia/James Halstead Address 159 Fishkill Avenue, Beacon, NY 12508
Original use Residential Current use Residential
Architect/Builder, if known _____ Date of construction, if known _____

Prepared by: John Clarke address 25 Beech Street, Rhinebeck, NY 12572
Telephone: _____ email jclarkeplandesign@gmail.com Date 6/2019; revised 2/2020

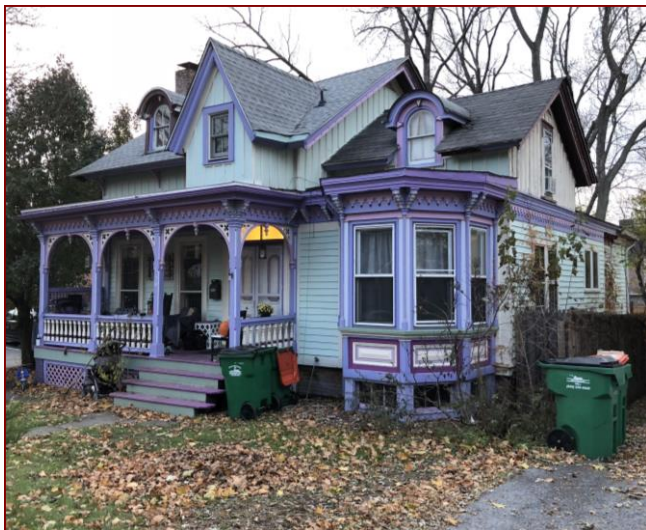
Front View

The building is located on the west side of Fishkill Avenue on a 0.2-acre lot. It is a 1½-story building with a multi-gabled roof, brick chimney, and an extraordinary level of Victorian detailing, especially for a modestly scaled house. The first story has horizontal clapboard siding and the second level has vertical board and batten siding. There are two east-facing dormers with rounded hoods.

There is a projecting one-story bay on the western corner with raised panels below the windows. The cornices over the front porch and corner bay are highly decorated with brackets and a frieze pattern that extends along the north and south walls. The chamfered porch posts have elaborate cut-out corner brackets that extend to central pendants. The heavy porch railings have turned balusters. There are two French doors onto the porch, as well as a double-door front entrance with transom window.

These contributing decorative details on the house are emphasized by a multi-color paint job.

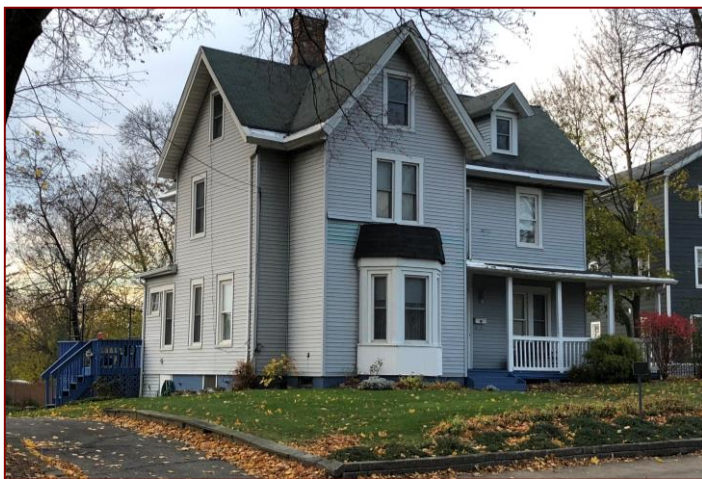
Front View

The building is located on the west side of Fishkill Avenue on a 0.3-acre lot. It is a 2½-story building with a cross gable roof, front-facing dormer, and two central brick chimneys. The 1979 Historic Survey shows a highly decorated vergeboard, bracketed bay window, and elaborately detailed front porch supports and balustrade. However, the current building has been covered over with vinyl siding and all the former architectural details are gone. The first-level bay window on the front and a wraparound porch on the north side still exist, but without any decorative elements. There is a raised deck and one-story garage to the rear.

Although the house has lost almost all its architectural details since the 1979 Historic Survey, the building is associated with a historic person in national history, James V. Forrestal (1892-1949). He was born here and graduated from Matteawan High School at the age of 16. A naval aviator in WWI and Wall Street executive between the wars, Forrestal's friendship with Franklin D. Roosevelt led to his appointment as Undersecretary of the Navy in 1940 and Secretary of the Navy in 1944. He is noted for his effective mobilization of the war effort, his advocacy for racial integration in the military, and, after the war, a strong national defense. Forrestal was appointed the first Secretary of Defense by President Truman in 1947, but disagreed with Truman over the military budget and other political issues and was forced to resign in 1949. He fell into depression and either fell or jumped to his death from a hospital window two months later. An aircraft carrier, a major office building in Washington DC, and an elementary school in Beacon were subsequently named after him.

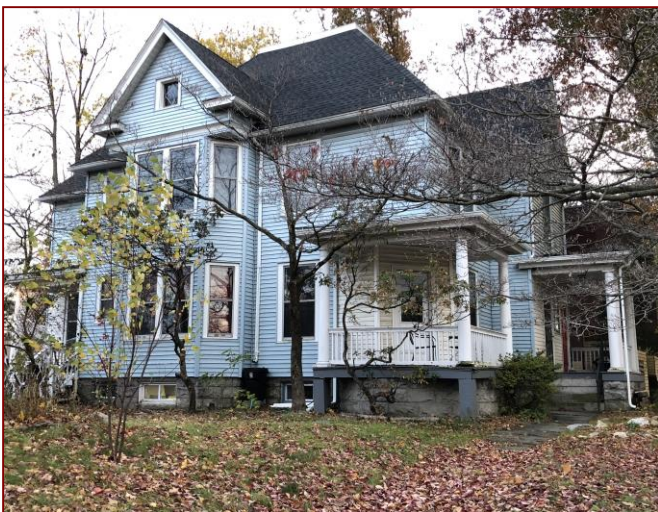
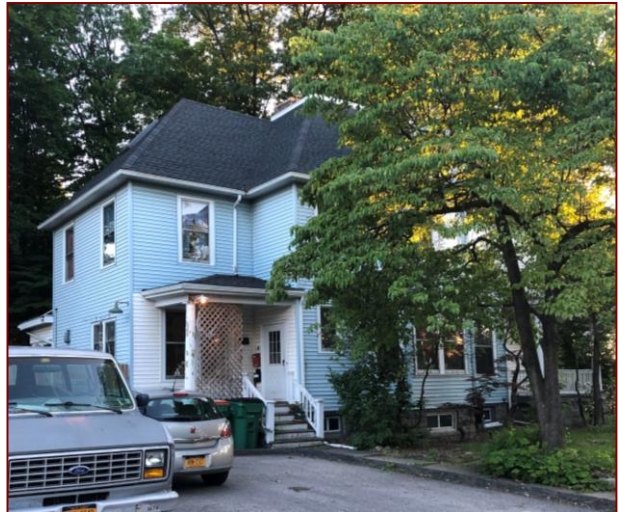
Views from Verplanck Avenue

The building is located on the east side of Fishkill Avenue on a 0.23-acre corner lot. It is a 2-story building with a hip roof, two cross gables, and a central brick chimney. The basement level has a rusticated cement block foundation. There is a 2-story, three-sided bay with paired central windows facing Verplanck Avenue.

The clapboard siding and shingled gables noted in the 1979 Historic Survey have been covered over with vinyl siding. As a result, the most notable architectural features are the three street-front porches with flat roofs, Tuscan columns, and straight balusters. The porch facing the intersection has a doorway set in an angled corner.

There is a small garage, probably from the 1920s, on the eastern rear side of the house and a historically contributing stone retaining wall along the Fishkill Avenue sidewalk.

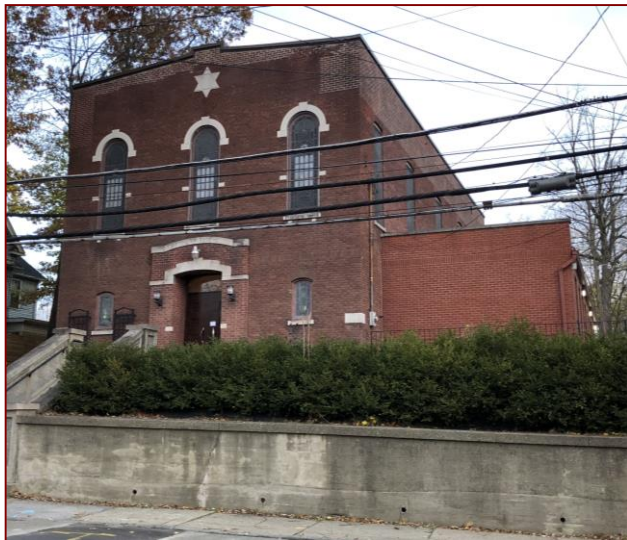
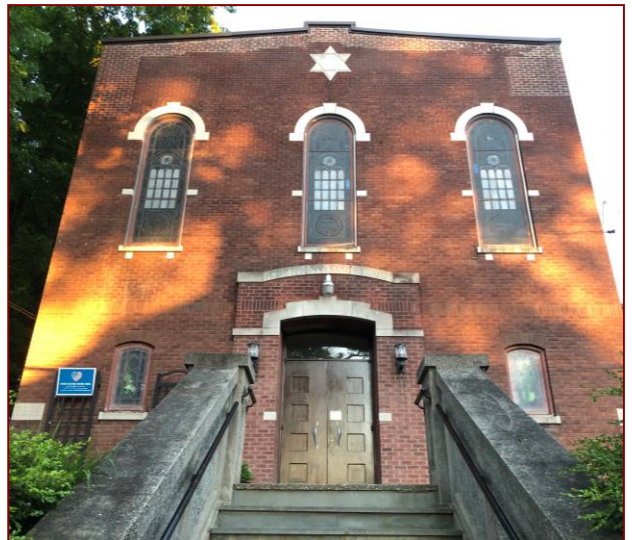
Views from Fishkill Avenue

The building is located on the east side of Fishkill Avenue on a 0.19-acre lot. It is a 2-story brick structure with a flat roof. It is well above the street, accessed by more modern central steps and a concrete retaining wall along the sidewalk.

The façade features a raised parapet roofline with a Star of David just below and three tall stained-glass windows. These windows are topped by arched stone elements with central keys and stone sills with supporting blocks below. Two smaller stained-glass windows flank the front entrance with arched brick lintels and stone sills. The brick entrance surrounds project out from the facade with a stone shallow arch above and the name of the building inscribed along the top edge. Two paneled wood doors have a transom window above and lantern lighting fixtures on both sides.

There is a modern 1-story addition on the south side and the brick under the top edge of the structure has been re-pointed with a lighter shade of mortar.

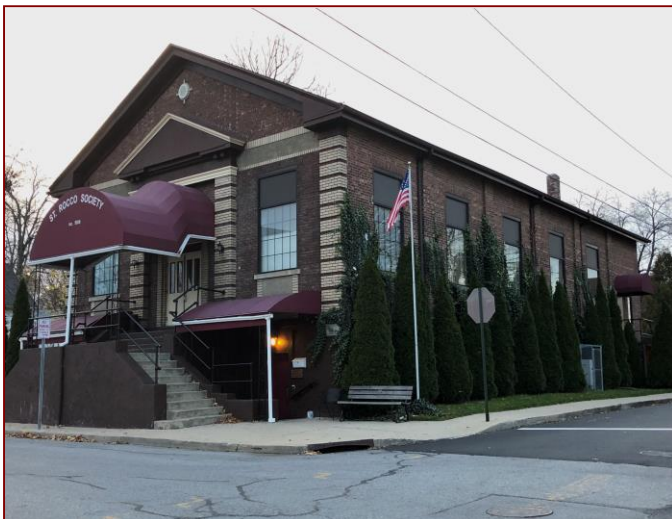
Front View

The building is located on the west side of S. Chestnut Street on a 0.17-acre corner lot. It is a 1½-story brick structure with a gable roof and rear chimney. The raised basement level has a stucco exterior.

The façade features polychrome brick that imitate quoins on the front corners. A band of light-colored soldier bricks and stucco cross under the front gable. This reinforces the projecting pediment with modillions and flanking polychrome brick columns around the front entrance. An arched stucco panel with a central key and inscribed St. Rocco Society is above the double doors. The side walls have buttresses between the windows, which have soldier brick lintels and stone sills.

The windows appear to be modern replacements and the front stairs, metal railings, and overhead canopy are likely newer construction. Four windows on the rear wall have been bricked over. There is also a 1-story shed addition on the rear side.

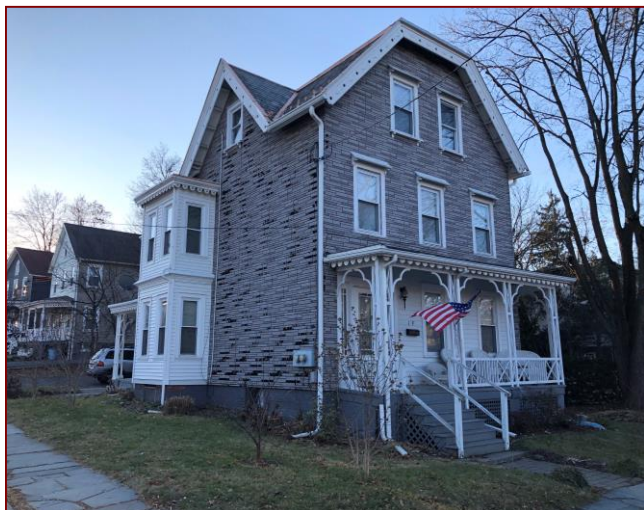
Front View

The building is located on the south side of Commerce Street on a 0.11-acre corner lot. It is a 2½-story wood-frame structure with a cross gable roof that has an unusual flat center section and a central brick chimney. To the rear the house drops down to two stories with a flat roof. The gable ends have decorated vergeboards with applied diamonds and circular cut-outs. Parts of the existing asphalt siding have been covered over with new vinyl siding.

The rear section, front porch, side porch, and 2-story rectangular bay window facing Cliff Street all feature the same repetitive cutwork pattern along the top edges. The porch posts have lightweight crosshatching and double-arch brackets, while the porch railing supports have both crosshatch and straight pieces.

The front upper-floor windows have shed hoods with small corner brackets. All the window sashes appear to be modern replacements, but the front door and side lights seem to be original.

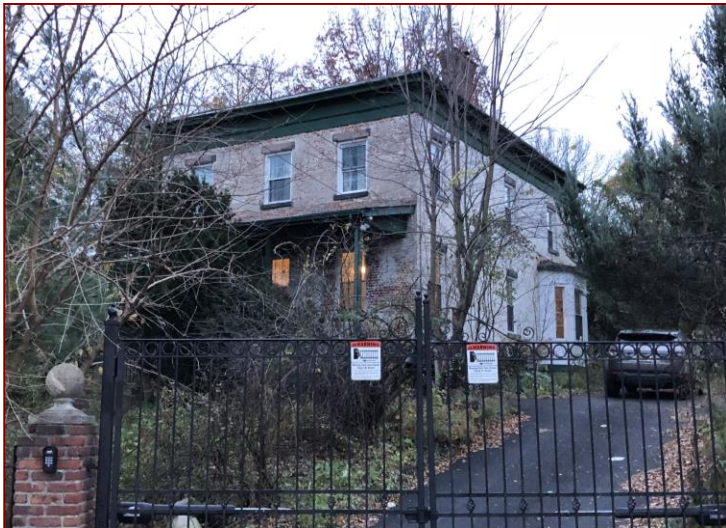
Front View

The building is located on the south side of Commerce Street on a 0.43-acre lot. It is a 2-story brick building with a flat roof and brick chimney. The house is surrounded by a metal fence with brick piers flanking the walkway and driveway entrances, as well as overgrown plantings, so it is difficult to see the building from the street for an accurate description.

The roof line features a broad overhanging eave and wide frieze board without brackets. There is a one-story bay window on the west side towards the rear. The windows have stone lintels and sills with 6 over 6 sashes. The porch across the front of the house has a simple shed roof. The double front doors have arched windows with raised panels below.

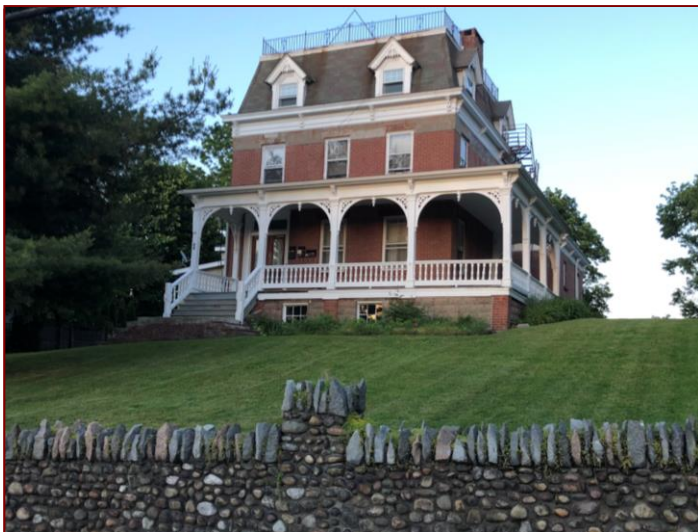
Front View

The building retains its original distinctive character, particularly its Second Empire roof and elaborately decorated wraparound porch. This house is one of the most intact examples of its type, scale, and period in the City. It possesses special historic and aesthetic value as part of the cultural history of the City and embodies distinguishing characteristics of an architectural period and style.

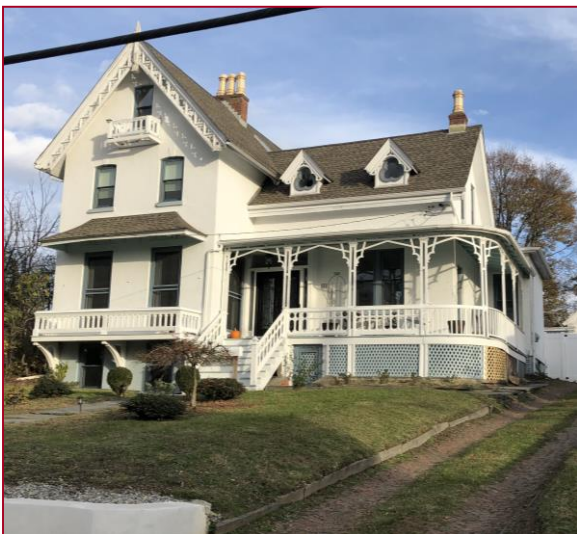
22 South Avenue

The front-facing gable has a wide vergeboard with elaborate cut-outs, pinnacle above, and a window and balcony below. The first floor in front has a canopy roof, two French doors, and an elevated porch with large projecting supports. There is a one-story bay window on the north side. The porch curving around the southern section of the house has lightweight columns and bracketed supports. Parts of the original balusters have been replaced. The double front doors have glass panels and a transom window.

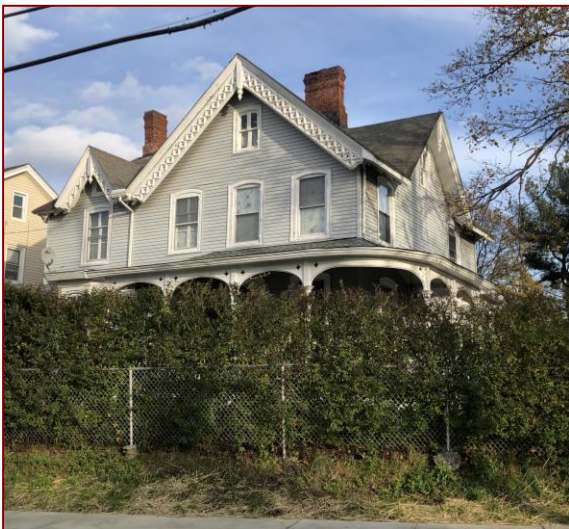
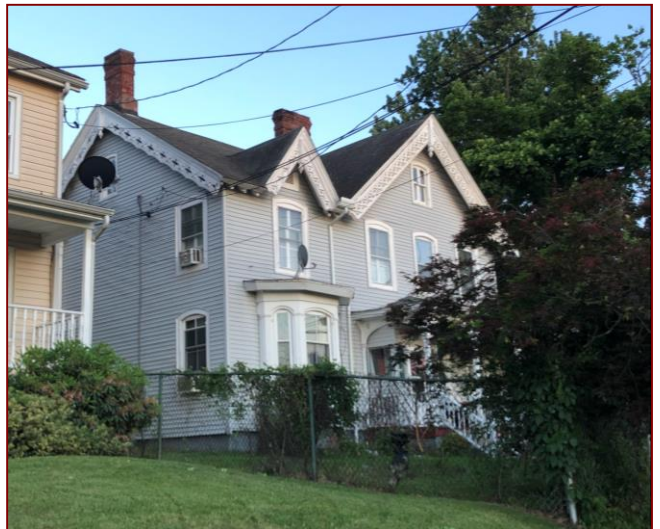
Front Views

There are 1-story bay windows on the south and west sides and a 2-story bay on the north side. The cornice brackets remain on the northern bay. The windows have arched wood frames, but some of the 2 over 2 sashes have been replaced.

The front doorway appears to be a modern replacement and the siding is now vinyl.

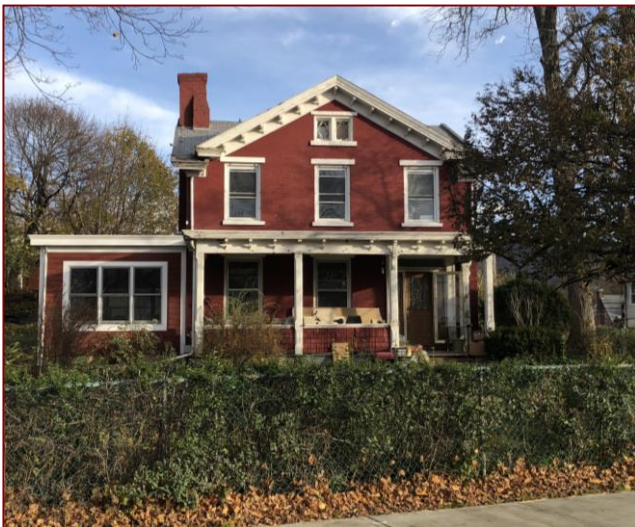
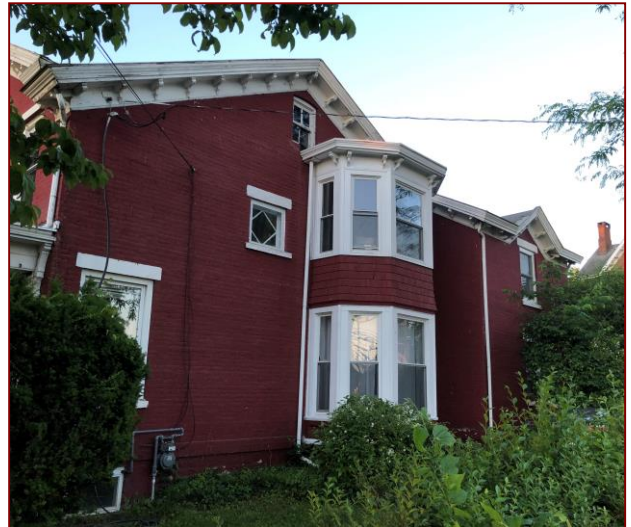
30 South Avenue

The windows have stone lintels and sills, but appear to have replacement sashes. A smaller set of paired windows under the western eaves has a distinctive diamond glazing pattern. A small, similarly shaped window with a diamond glass pattern also exists on the southern wall next to the bay.
