# PHASE IA ARCHEOLOGICAL INVESTIGATION

Scenic Beacon Development LLC

22 Edgewater Place City of Beacon Dutchess County, New York

HAA # 5174-11 OPRHP 17PR06370

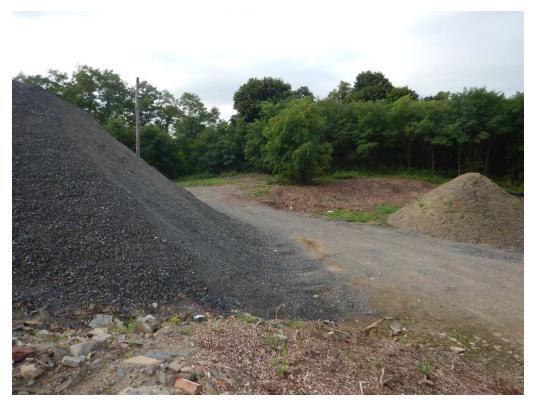
Photo 1. View south of the north central portion of the project area. The surface conditions indicate extensive soil disturbance throughout the area.

A site visit was conducted by Andre Krievs on September 18, 2017 to observe and photograph existing conditions within the Project Area. The proposed APE is located along a steep to moderately sloping hillside overlooking the City of Beacon train station parking lot to the west. Beyond the parking lot lie the railroad tracks and Hudson River (Maps 1 and 2). The surface reconnaissance revealed extensive soil disturbance across the property. Several large stockpiles of aggregate and topsoil are located within the central portion of the property (Map 2; Photos 1, 2 and 3). The stockpiles lie on either side of the remnants of an asphalt road that

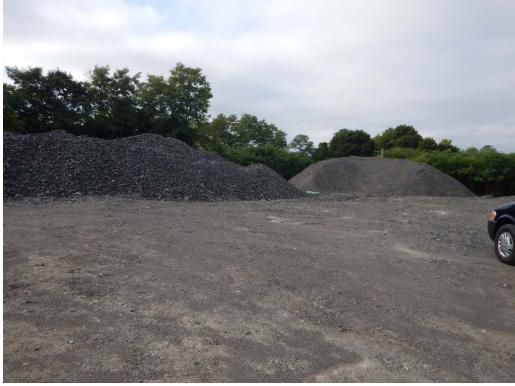
Photo 2. View southeast of the large aggregate piles located within the north central portion of the project area. The surface conditions indicate extensive disturbance throughout the area.

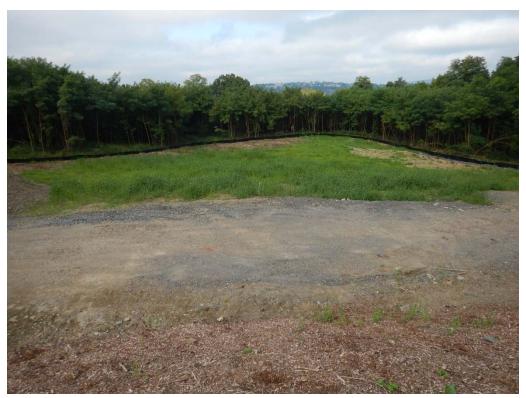
Photo 3. View north of the general surface conditions that extend across the central portion of the project area. The surface conditions indicate extensive soil disturbance throughout the area.

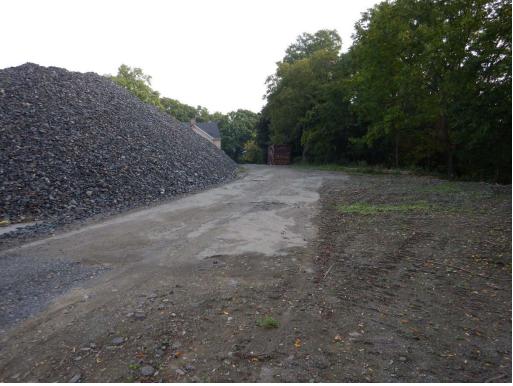
Photo 4. View north of the asphalt roadway and general surface conditions that extend across the northeastern portion of the project area. The surface conditions indicate extensive soil disturbance.

extends across the central portion of the property (Map 2; Photos 4 and 5). A manhole to what appears to be an earlier storm-water drainage system lies within the roadway (Map 2; Photo 6).

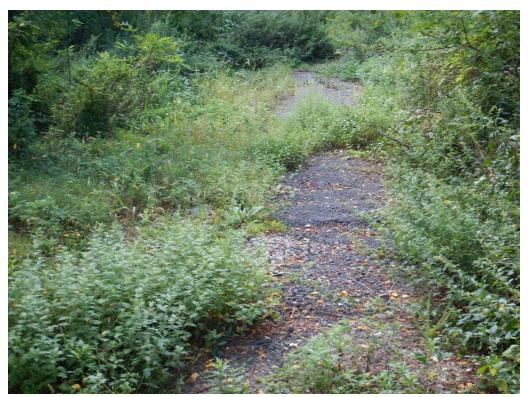
Photo 5. View south of the abandoned roadway that extends along the eastern portion of the project area. Road construction has significantly affected the surface soils in this area

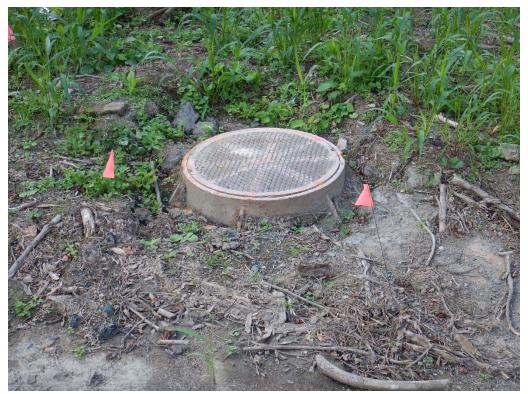
Photo 6. View east of a manhole to a storm-water system that continues along the eastern and southern portion of the project area. Installation of the storm-water system has significantly affected the soils in this area.

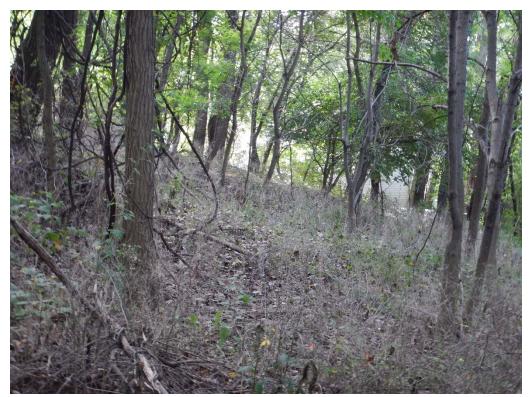
Photo 7. View southeast of the surface vegetation and moderate to steep topography that extends across the southern and eastern portions of the project area.

The surface vegetation across the western portion of the property consists of small locust trees (Map 2; Photo 7). This type of vegetation is commonly found in areas of disturbed soils. Numerous large blocks of concrete protruding out of the surface soil were evident throughout the area (Map 2; Photos 8 and 9). An examination of the westernmost perimeter of the property near the edge of the steep slope revealed large deposits of concrete rubble intermixed with brick and the remnants of large concrete pipe. According to the client, the building materials originated from several previously demolished buildings that once occupied the property (Map 2; Photos 10 and 11). Backhoe tests conducted for the client indicate some the material continues to depths in excess of six feet below the surface (Hudson Land Design; Personal Communication 2017).

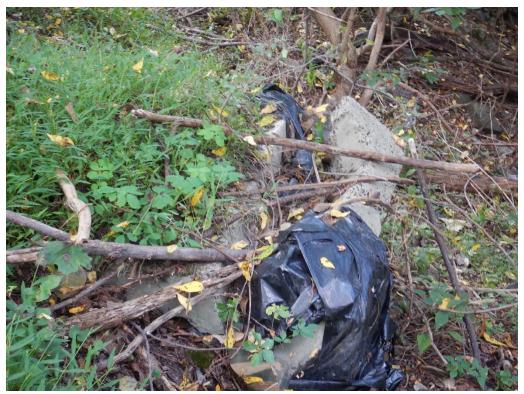
Photo 8. View east of large concrete debris extending out of the surface soil along the south central portion of the project area.

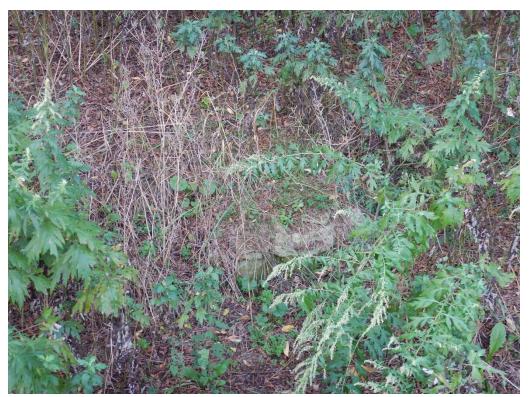
Photo 9. View southeast of buried concrete debris extending out of the surface soil along the southeastern portion of the project area.

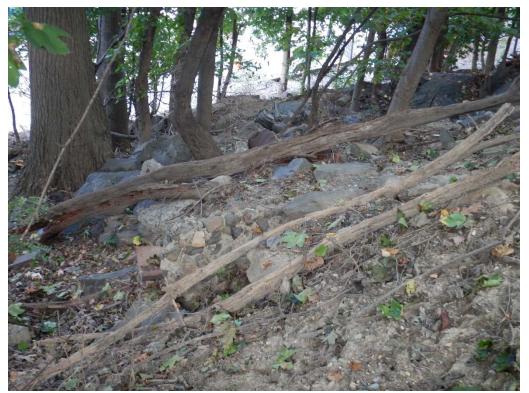
Photo 10. View northwest of the southwestern most edge of the project area showing a mixture of construction debris and soil that was pushed over the edge of the slope.

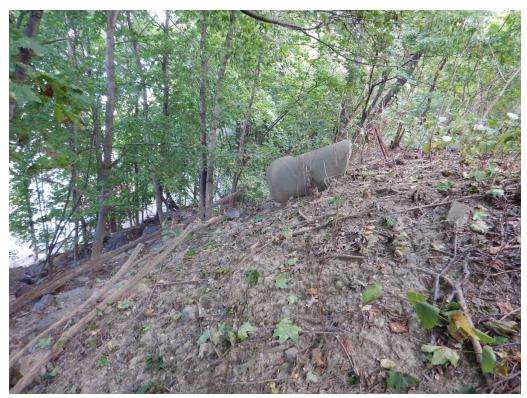
Photo 11. View northwest of the southwestern most edge of the project area showing a mixture of construction debris and soil that was pushed over the edge of the slope.

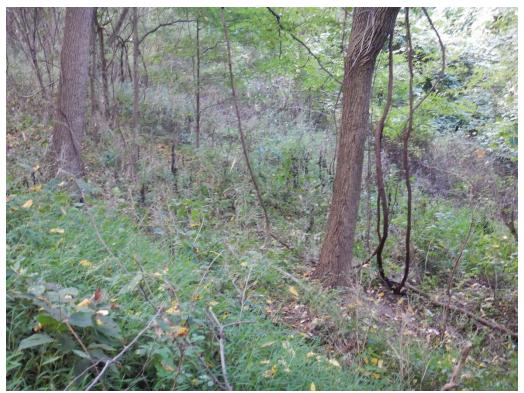
Photo 12. View northeast of the steep sloping southeastern portion of the project area.

The eastern and southern perimeters of the property slope sharply towards Bank Street (Map 2; Photo 12). The western perimeter slopes sharply towards the train station parking lot (Map 2; Photo 13).

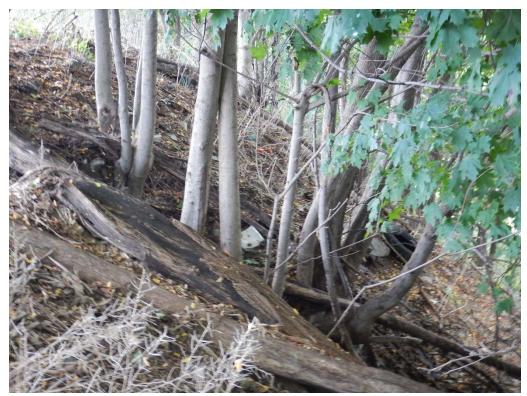
Photo 13. View north of the steep sloping western portion of the project area.

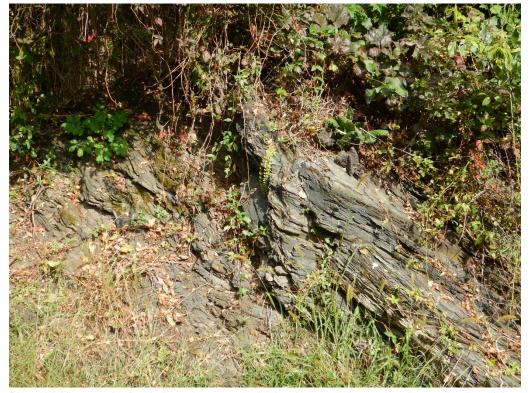
Photo 14. View north of a shale and greywacke bedrock outcrop located at the south edge of the project area along the slope. The bedrock outcrops were examined for rockshelters and chert outcrops and none were identified.

A section of exposed shale and greywacke bedrock was encountered along the southern slope (Map 2; Photo 14). The bedrock outcrops were examined for possible rockshelters and chert outcrops and none were identified.
