# HISTORIC RESOURCE INVENTORY FORM

Address or Street Location 159 Fishkill Avenue

Telephone: \_\_\_\_\_ email jclarkeplandesign@gmail.com Date June 2019

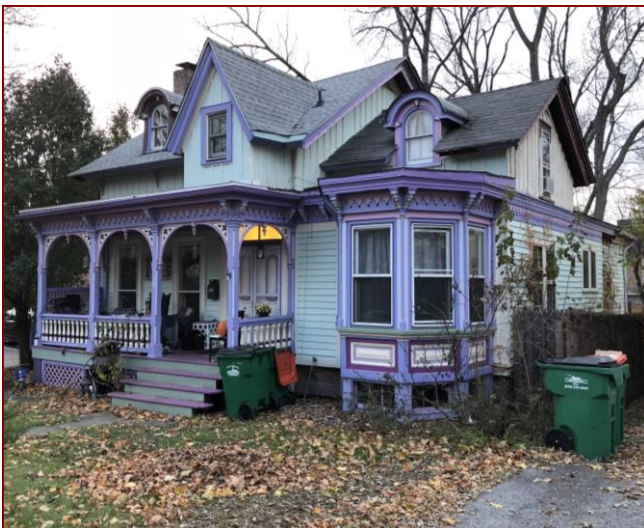
159 Fishkill Avenue

The building is located on the west side of Fishkill Avenue on a 0.2-acre lot. It is a 1½-story building with a multi-gabled roof, brick chimney, and an extraordinary level of Victorian detailing, especially for a modestly scaled house. The first story has horizontal clapboard siding and the second level has vertical board and batten siding. There are two east-facing dormers with rounded hoods.

There is a projecting one-story bay on the western corner with raised panels below the windows. The cornices over the front porch and corner bay are highly decorated with brackets and a frieze pattern that extends along the north and south walls. The chamfered porch posts have elaborate cut-out corner brackets that extend to central pendants. The heavy porch railings have turned balusters. There are two French doors onto the porch, as well as a double-door front entrance with transom window.

Front View

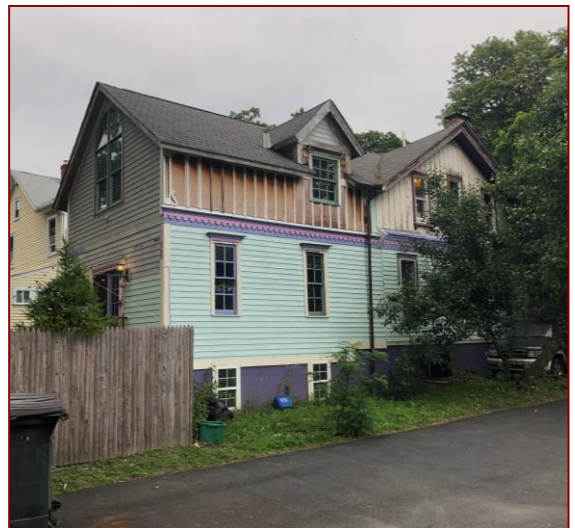
Rear View

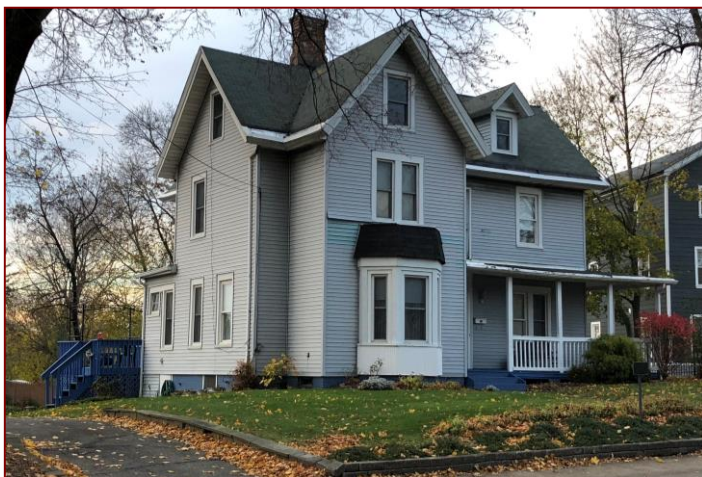
189 Fishkill Avenue

The building is located on the west side of Fishkill Avenue on a 0.3-acre lot. It is a 2½-story building with a cross gable roof, front-facing dormer, and two central brick chimneys. The 1979 Historic Survey shows a highly decorated vergeboard, bracketed bay window, and elaborately detailed front porch supports and balustrade. However, the current building has been covered over with vinyl siding and all the former architectural details are gone. The first-level bay window on the front and a wraparound porch on the north side still exist, but without any decorative elements. There is a raised deck and one-story garage to the rear.

Front View

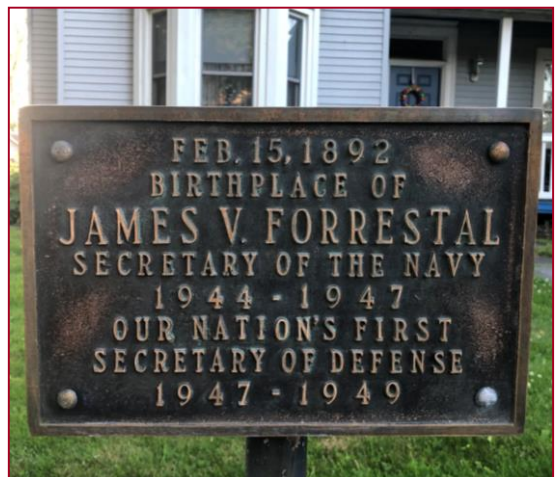
Front Plaque

Although the house has lost almost all its architectural details since the 1979 Historic Survey, the building is associated with a historic person in national history, James V. Forrestal (1892-1949). He was born here and graduated from Matteawan High School at the age of 16. A naval aviator in WWI and Wall Street executive between the wars, Forrestal's friendship with Franklin D. Roosevelt led to his appointment as Undersecretary of the Navy in 1940 and Secretary of the Navy in 1944. He is noted for his effective mobilization of the war effort, his advocacy for racial integration in the military, and, after the war, a strong national defense. Forrestal was appointed the first Secretary of Defense by President Truman in 1947, but disagreed with Truman over the military budget and other political issues and was forced to resign in 1949. He fell into depression and either fell or jumped to his death from a hospital window two months later. An aircraft carrier, a major office building in Washington DC, and an elementary school in Beacon were subsequently named after him.

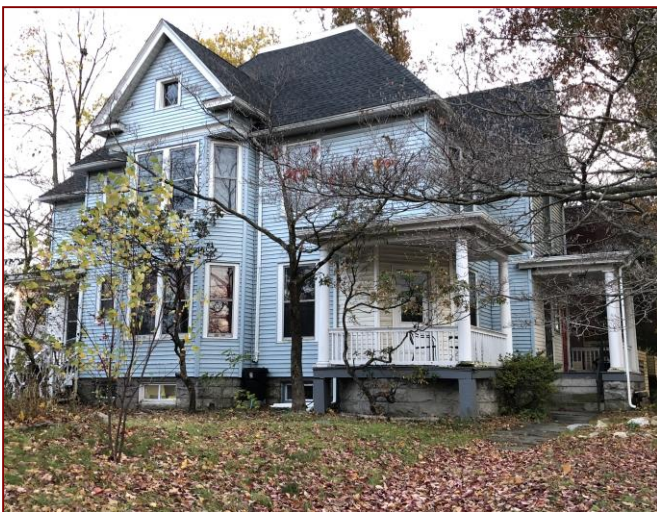
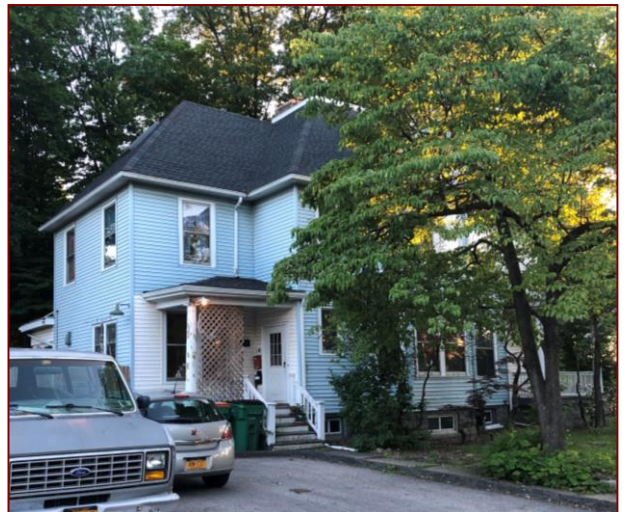
194 Fishkill Avenue

The building is located on the east side of Fishkill Avenue on a 0.23-acre corner lot. It is a 2-story building with a hip roof, two cross gables, and a central brick chimney. The basement level has a rusticated cement block foundation. There is a 2-story, three-sided bay with paired central windows facing Verplanck Avenue.

The clapboard siding and shingled gables noted in the 1979 Historic Survey have been covered over with vinyl siding. As a result, the most notable architectural features are the three street-front porches with flat roofs, Tuscan columns, and straight balusters. The porch facing the intersection has a doorway set in an angled corner.

Views from Verplanck Avenue

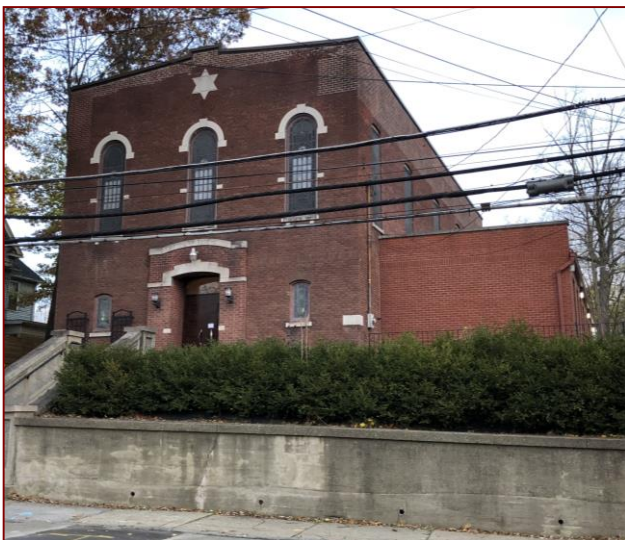
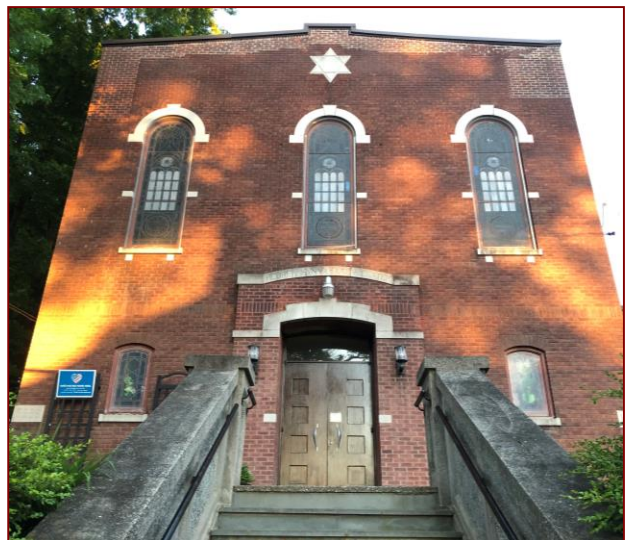
189 Fishkill Avenue

The building is located on the east side of Fishkill Avenue on a 0.19-acre lot. It is a 2-story brick structure with a flat roof. It is well above the street, accessed by central steps with a concrete retaining wall along the sidewalk.

The façade features a raised parapet roofline with a Star of David just below and three tall stained-glass windows. These windows are topped by arched stone elements with central keys and stone sills with supporting blocks below. Two smaller stained-glass windows flank the front entrance with arched brick lintels and stone sills. The brick entrance surrounds project out from the facade with a stone shallow arch above and the name of the building inscribed along the top edge. Two paneled wood doors have a transom window above and lantern lighting fixtures on both sides.

There is a modern 1-story addition on the south side and the brick under the top edge of the structure has been re-pointed with a lighter shade of mortar.

Views from Fishkill Avenue

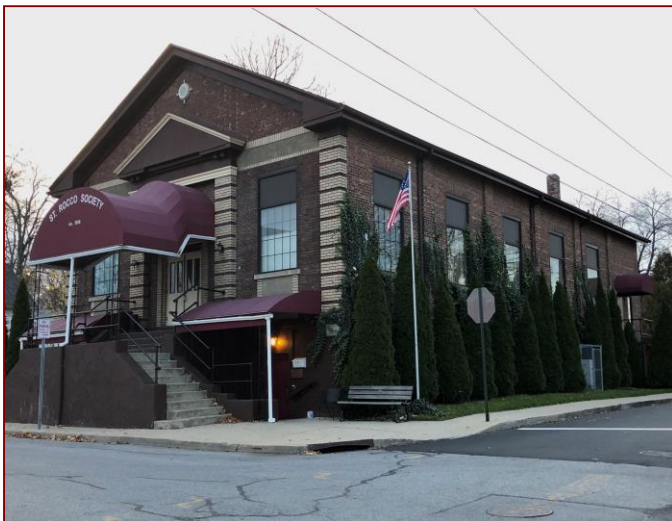
26 S. Chestnut Street

The building is located on the west side of S. Chestnut Street on a 0.17-acre corner lot. It is a 1½-story brick structure with a gable roof and rear chimney. The raised basement level has a stucco exterior.

The façade features polychrome brick that imitate quoins on the front corners. A band of light-colored soldier bricks and stucco cross under the front gable. This reinforces the projecting pediment with modillions and flanking polychrome brick columns around the front entrance. An arched stucco panel with a central key and inscribed St. Rocco Society is above the double doors. The side walls have buttresses between the windows, which have soldier brick lintels and stone sills.

Front View

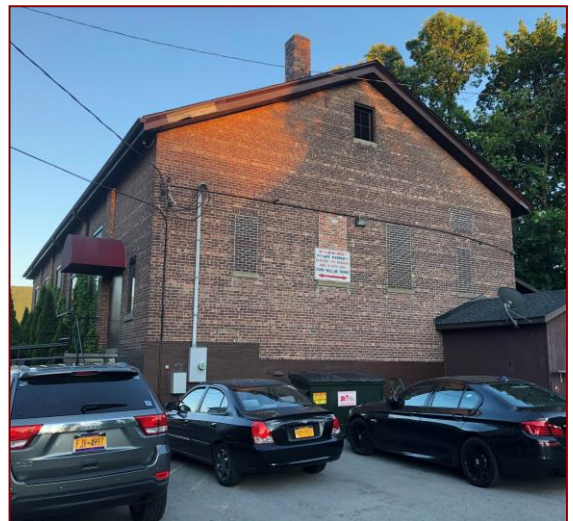
The windows appear to be modern replacements and the front stairs, metal railings, and overhead canopy are likely newer construction. Four windows on the rear wall have been bricked over. There is also a 1-story shed addition on the rear side.

Rear View

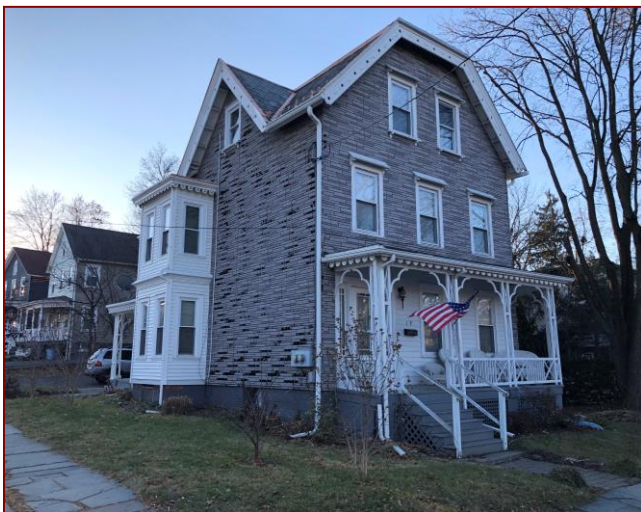
19 Commerce Street

The building is located on the south side of Commerce Street on a 0.11-acre corner lot. It is a 2½-story wood-frame structure with a cross gable roof that has an unusual flat center section and a central brick chimney. To the rear the house drops down to two stories with a flat roof. The gable ends have decorated vergeboards with applied diamonds and circular cut-outs. Parts of the existing asphalt siding have been covered over with new vinyl siding.

The rear section, front porch, side porch, and 2-story rectangular bay window facing Cliff Street all feature the same repetitive cutwork pattern along the top edges. The porch posts have lightweight crosshatching and double-arch brackets, while the porch railing supports have both crosshatch and straight pieces.

The front upper-floor windows have shed hoods with small corner brackets. All the window sashes appear to be modern replacements, but the front door and side lights seem to be original.

Front View

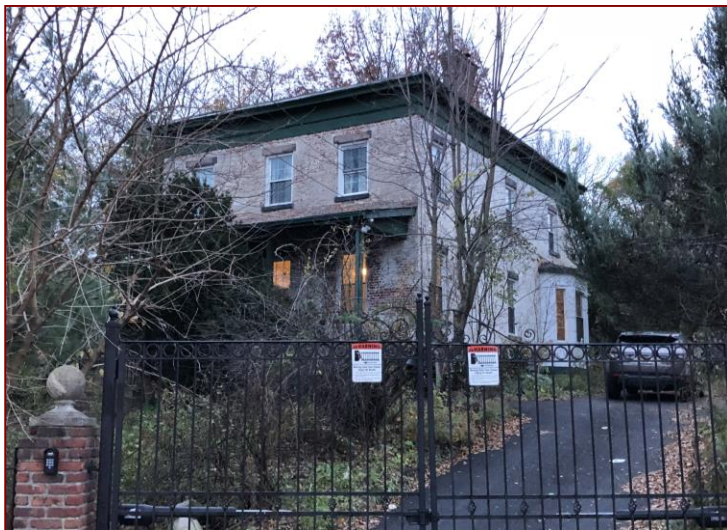
11 Commerce Street

Front View

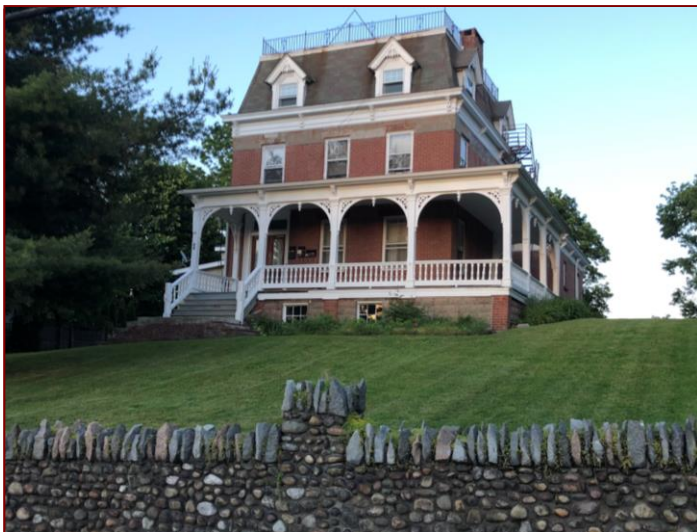
20 South Avenue

Front View

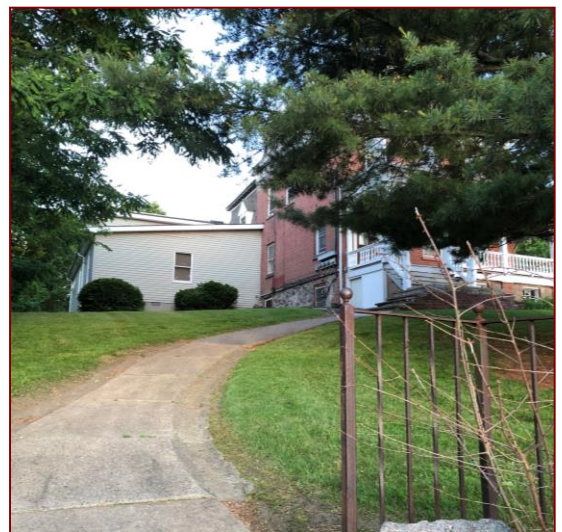
Addition on North Side

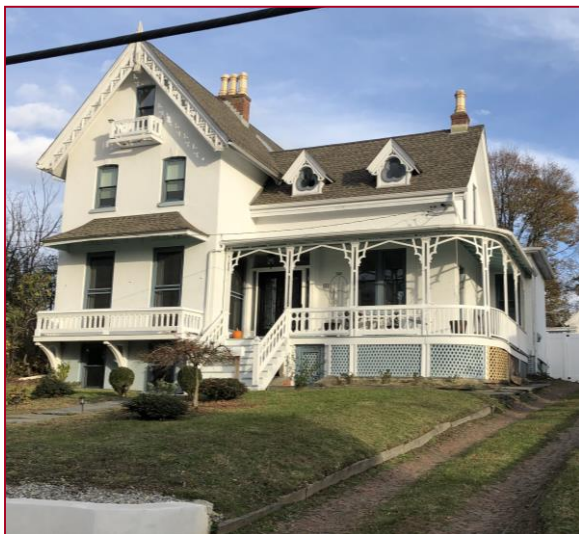
22 South Avenue

The front-facing gable has a wide vergeboard with elaborate cut-outs, pinnacle above, and a window and balcony below. The first floor in front has a canopy roof, two French doors, and an elevated porch with large projecting supports. There is a one-story bay window on the north side. The porch curving around the southern section of the house has lightweight columns and bracketed supports. Parts of the original balusters have been replaced. The double front doors have glass panels and a transom window.

Front View

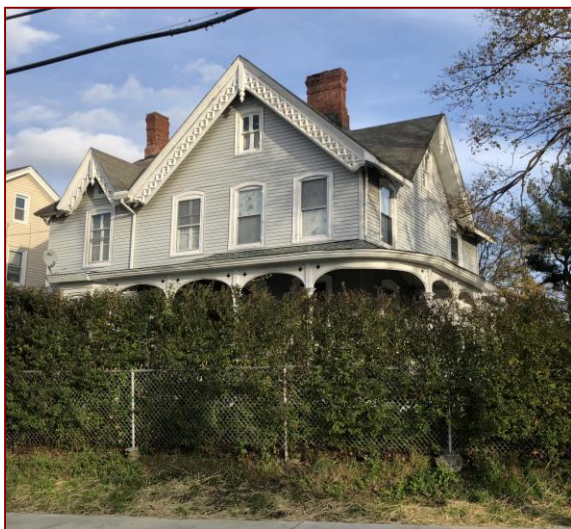
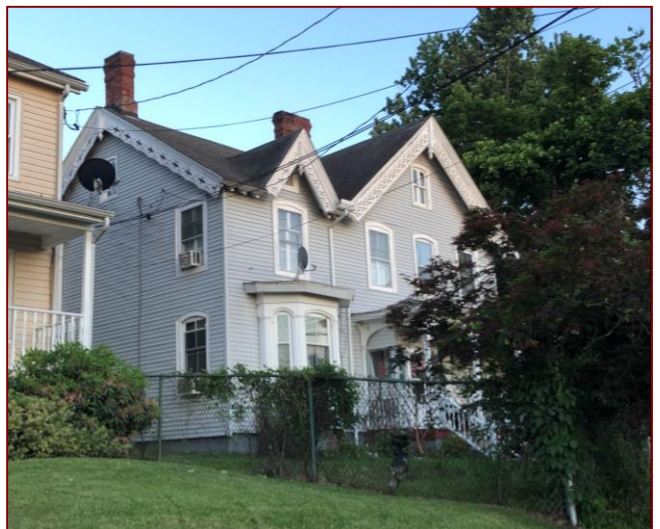
26 South Avenue

There are 1-story bay windows on the south and west sides and a 2-story bay on the north side. The cornice brackets remain on the northern bay. The windows have arched wood frames, but some of the 2 over 2 sashes have been replaced.

The front porch curves around to the south side. It has chamfered columns and arched supports with corner cut-outs. The front doorway appears to be a modern replacement.

Front Views

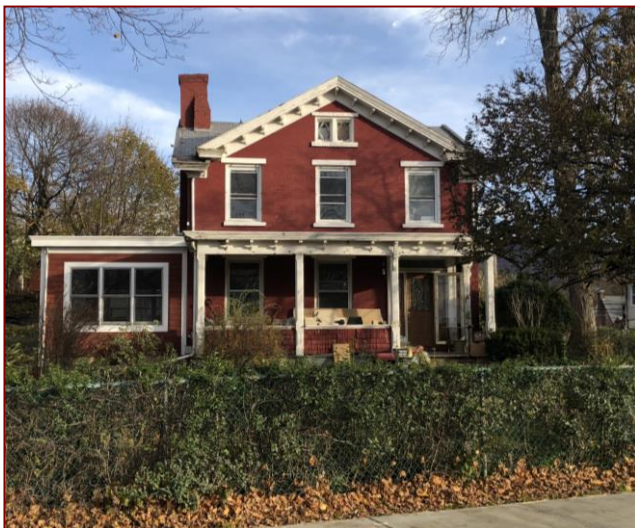
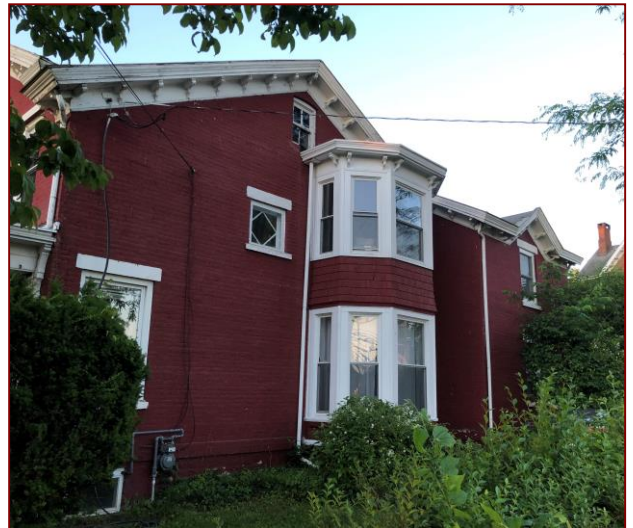
30 South Avenue

The windows have stone lintels and sills, but appear to have replacement sashes. A smaller set of paired windows under the western eaves has a distinctive diamond glazing pattern. A small, similarly shaped window with a diamond glass pattern also exists on the southern wall next to the bay.

Beacon Street View

South Avenue View
