Re: Infiltration and Inflow Investigation

177 Main Street

City of Beacon, New York Tax ID: 5954-27-791947

1&I INVESTIGATION

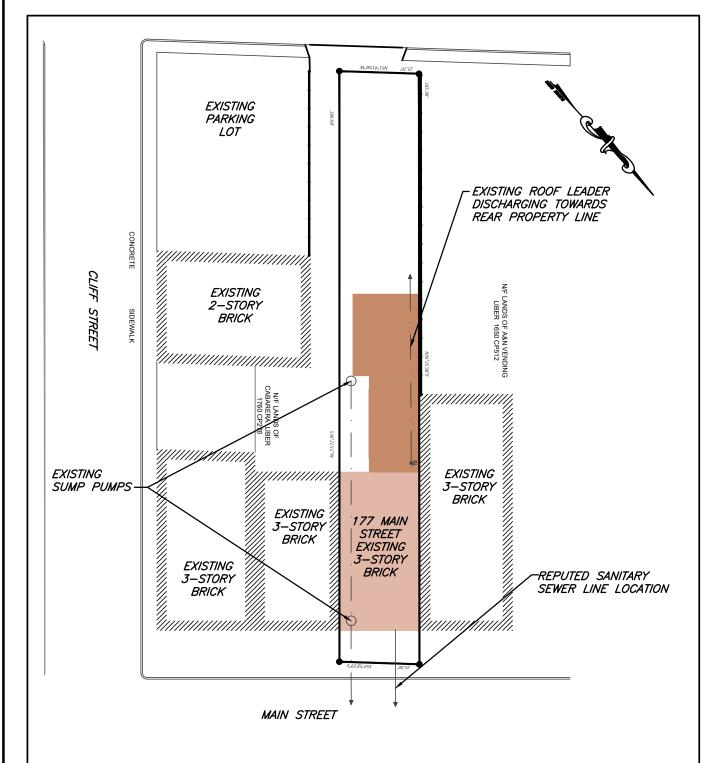
The first phase of the study consisted of an exterior inspection of the building to determine the location of roof leader discharge points. The existing three-story building has a flat roof with a roof leader in the rear of the building. Rainwater reputedly flows off the building, into the roof leader, then overland flow towards the rear property line.

Two sump pumps were observed in the basement of the existing building. One sump pump is located towards the northern foundation wall, while the second sump pump is located near the southern foundation wall. Both sump pumps reputedly discharge to the City of Beacon's sanitary sewer system.

NOTE: ROOF LEADER (RL)

The proposed expansion of the building will reroute the roof leaders towards the rear of the building and discharge into a stormwater planter box. The sump pumps will be rerouted towards the rear of the building expansion, into stormwater planter boxes located in the proposed garden area. The reputed sanitary sewer line is proposed to remain connected to the sanitary sewer system located in Main Street.
