## **Beacon Station Micro Supplemental Communications Facility Zoning Analysis Prepared on November 28, 2018**

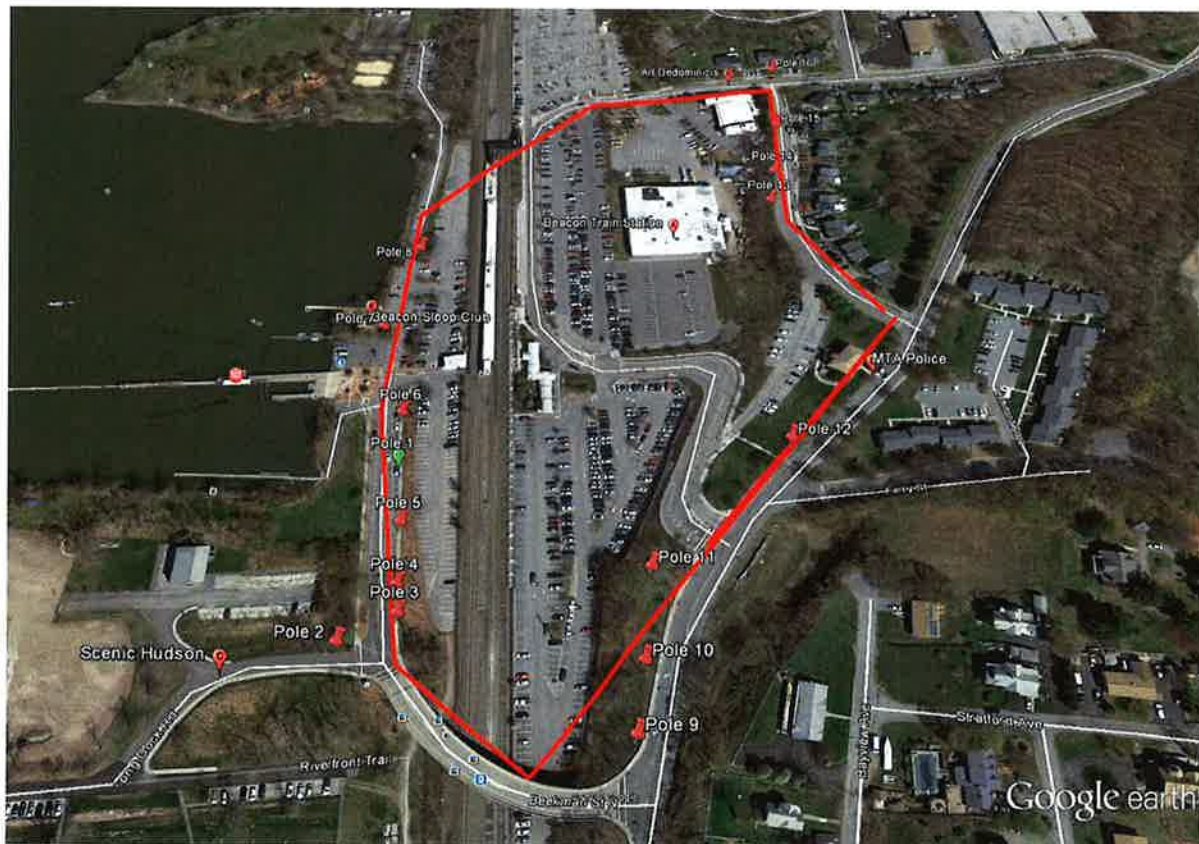
The Search Area Map for the proposed small cell is shown above. Candidates within the Search Area have been pinned. Within the Search Area Map, there are five (5) existing structures and one (16) existing utility pole in the right of way. There are no municipal buildings or structures (light poles, flag poles, etc.) within the Search Area.

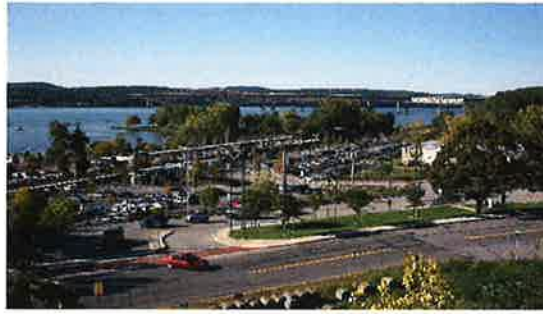
<b>Candidate A:</b>	<b>Beacon Train Station</b>
Address:	8 Long Dock Road Beacon, NY 12508
Owner Interest:	This property is owned by the MTA. Verizon Wireless contacted the Real Estate Division to determine whether the MTA had any interest in lease space to Verizon Wireless for a small cell facility. The MTA stated that they do not have interest in pursuing a small cell for this location.
RF Review:	This location would adequately serve the targeted coverage and capacity objective

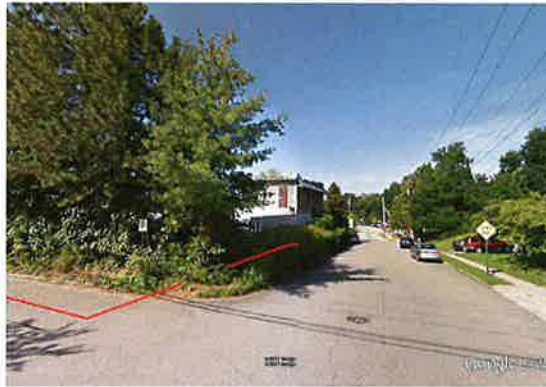
**Candidate B:**

This location would not adequately serve the targeted coverage and capacity objective due to the location of tall trees (which can be seen in the picture below) that would obstruct the antenna signals.

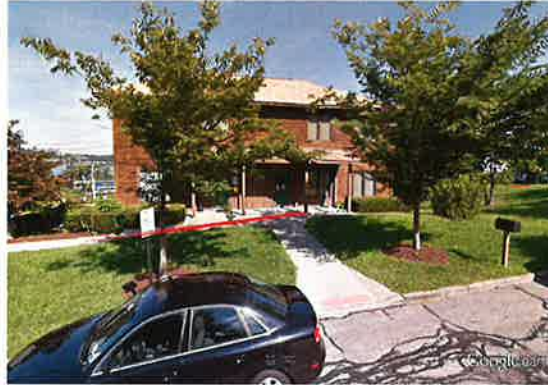
**Candidate D:****MTA Police Department**

This property is owned by the MTA. The MTA confirmed that it was not interested in pursuing a small cell for this location.

This location would adequately serve the targeted coverage and capacity objective

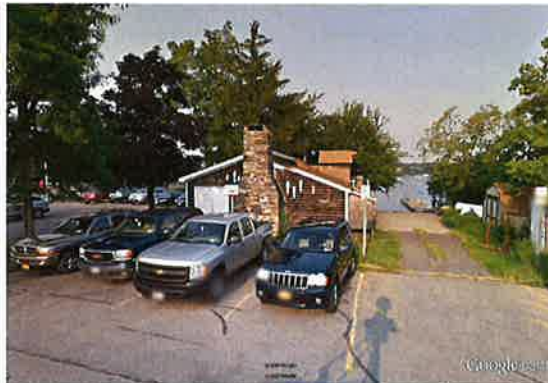
**Candidate E:****Beacon Sloop Club**

This location would not adequately serve the targeted coverage and capacity objective. Desired antenna height cannot be achieved on this roof structure.

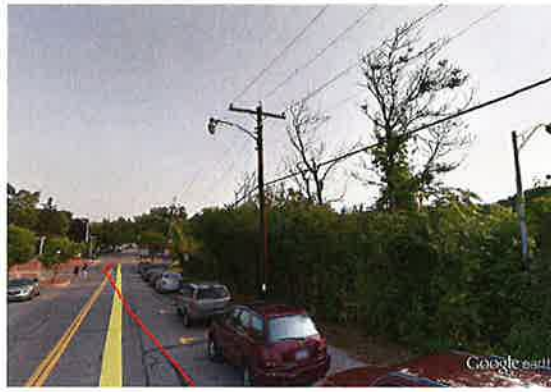
**Candidate Pole 1:****Central Hudson Utility Pole in the Right of Way**

This pole location meets RF requirements as it is 1) located in the SR, and 2) the RF antenna height / location meets the RF coverage objective. This existing pole also meets construction requirements as the equipment can be mounted on the pole, making it accessible.

☐ Conduit ☐ Double primary wire ☐ Transformer ☐ Issues getting power/telco  
☐ Trees/obstruction to radio frequency ☐ Utility company rejected pole use ☒ Pole meets requirements

Verizon Wireless is proposing to install one antenna with related equipment on an existing utility pole (i.e. Pole 1). This micro cell is intended to provide "hotspot" type wireless telecommunications coverage in an area where Verizon Wireless' existing macro cell network is overburdened by exploding demand on its 4th Generation LTE network.

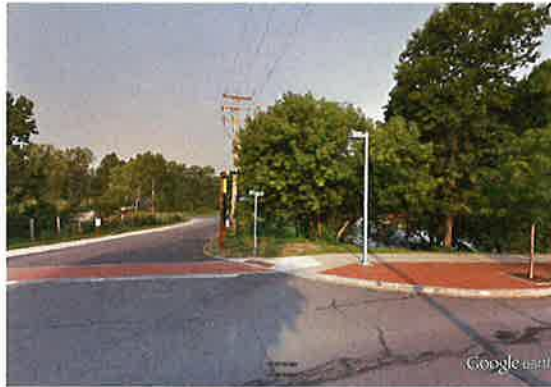
**Candidate Pole 2:**

This pole does not meet construction requirements due to:

- ☒ Conduit 
 ☒ Double primary wire 
 ☐ Transformer 
 ☐ Issues getting power/telco  
☐ Trees/obstruction to radio frequency 
 ☐ Utility company rejected pole use 
 ☐ Pole meets requirements

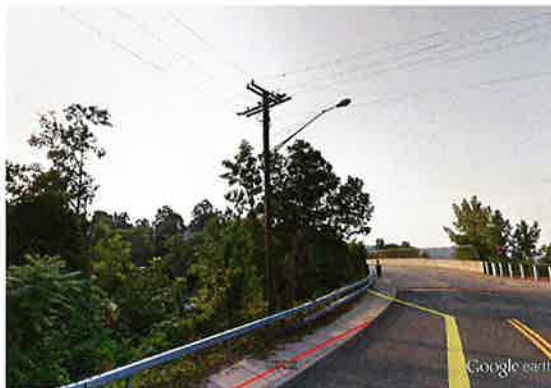
**Candidate Pole 3:**

This pole does not meet construction requirements due to:

- ☐ Conduit 
 ☒ Double primary wire 
 ☐ Transformer 
 ☐ Issues getting power/telco  
☐ Trees/obstruction to radio frequency 
 ☐ Utility company rejected pole use 
 ☐ Pole meets requirements

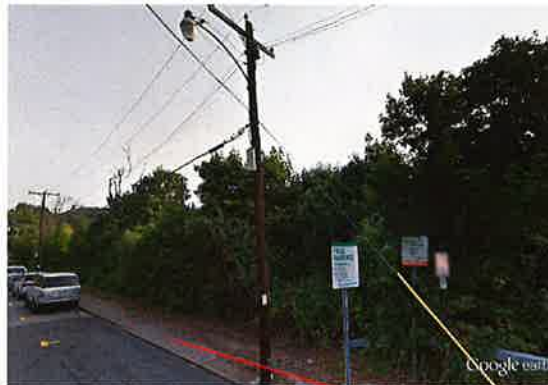
**Candidate Pole 4:**

This pole does not meet construction requirements due to:

- ☐ Conduit ☐ Double primary wire ☒ Transformer ☐ Issues getting power/telco  
☐ Trees/obstruction to radio frequency ☐ Utility company rejected pole use ☐ Pole meets requirements

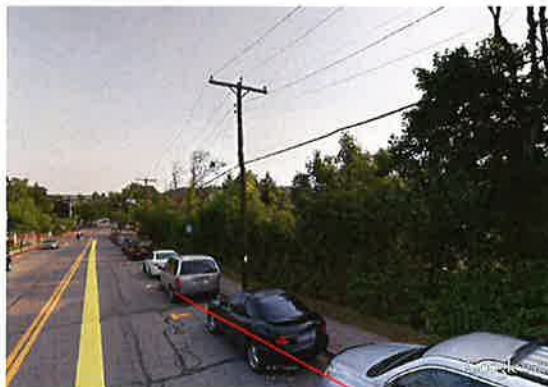
**Candidate Pole 5:**

- ☐ Conduit ☐ Double primary wire ☐ Transformer ☐ Issues getting power/telco  
☐ Trees/obstruction to radio frequency ☐ Utility company rejected pole use ☒ Pole meets requirements

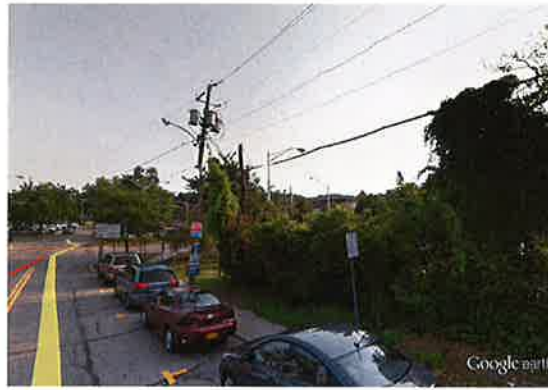
**Candidate Pole 6:**

This pole does not meet construction requirements due to:

- ☐ Conduit ☐ Double primary wire ☒ Transformer ☐ Issues getting power/telco  
☐ Trees/obstruction to radio frequency ☐ Utility company rejected pole use ☐ Pole meets requirements

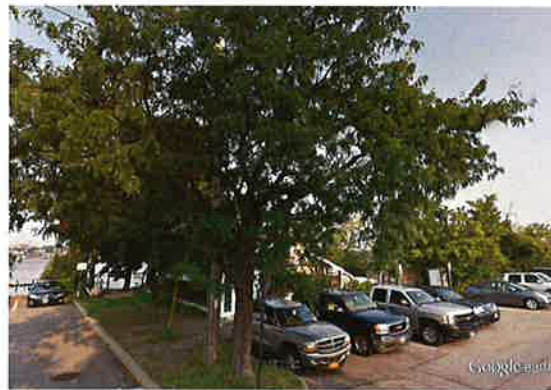
**Candidate Pole 7:**

This pole does not meet construction requirements due to:

- ☒ Conduit ☐ Double primary wire ☐ Transformer ☐ Issues getting power/telco  
☒ Trees/obstruction to radio frequency ☐ Utility company rejected pole use ☐ Pole meets requirements

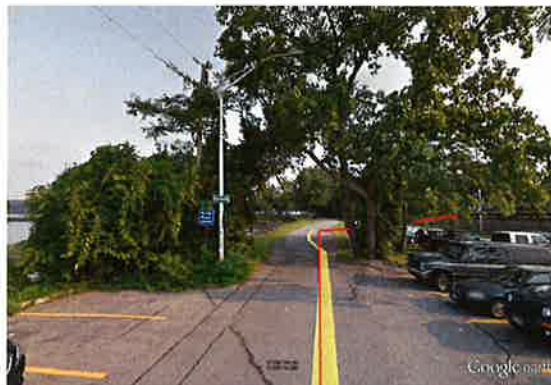
**Candidate Pole 8:**

This pole does not meet construction requirements due to:

- ☐ Conduit ☐ Double primary wire ☐ Transformer ☐ Issues getting power/telco  
☒ Trees/obstruction to radio frequency ☐ Utility company rejected pole use ☐ Pole meets requirements

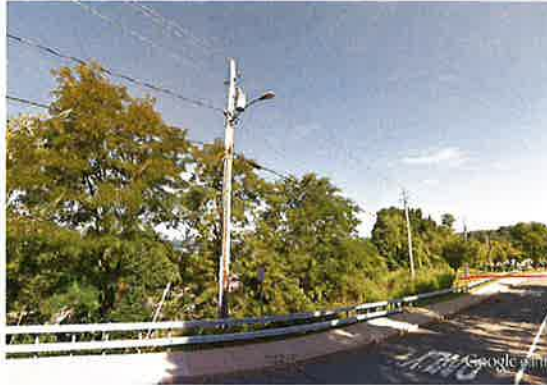
**Candidate Pole 9:**

This pole does not meet construction requirements due to:

- ☒ Conduit ☐ Double primary wire ☒ Transformer ☐ Issues getting power/telco  
☐ Trees/obstruction to radio frequency ☐ Utility company rejected pole use ☐ Pole meets requirements

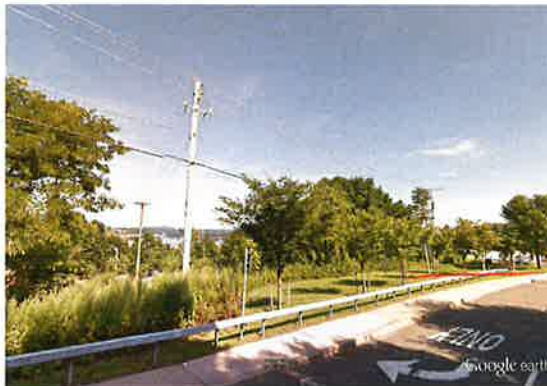
**Candidate Pole 10: Central Hudson Utility Pole in the Right of Way**

This pole does not meet construction requirements due to:

- ☐ Conduit ☒ Double primary wire ☐ Transformer ☐ Issues getting power/telco  
☐ Trees/obstruction to radio frequency ☐ Utility company rejected pole use ☐ Pole meets requirements

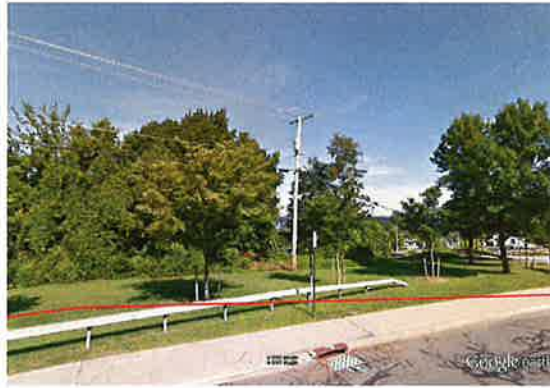
**Candidate Pole 11:**

This pole does not meet construction requirements due to:

- ☐ Conduit ☐ Double primary wire ☒ Transformer ☐ Issues getting power/telco  
☐ Trees/obstruction to radio frequency ☐ Utility company rejected pole use ☐ Pole meets requirements

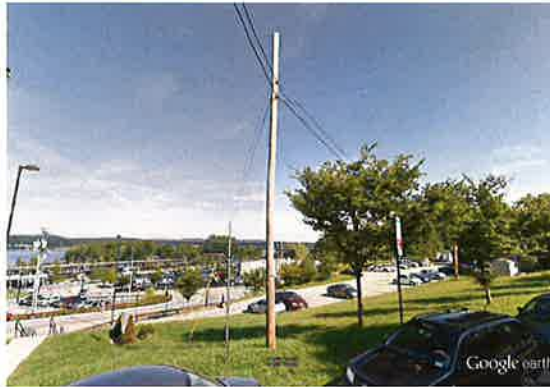
**Candidate Pole 12:**

This pole does not meet construction requirements due to:

- ☐ Conduit ☐ Double primary wire ☐ Transformer ☒ Issues getting power/telco  
☐ Trees/obstruction to radio frequency ☐ Utility company rejected pole use ☐ Pole meets requirements

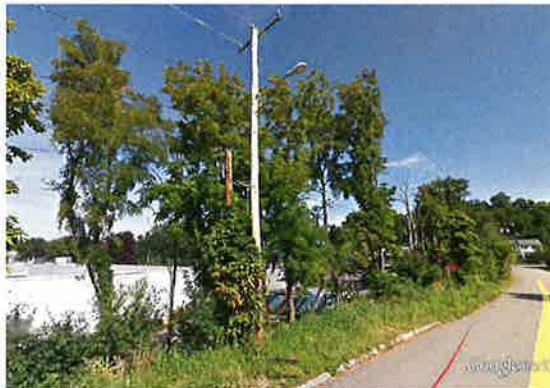
**Candidate Pole 13:**

This pole does not meet construction requirements due to:

- ☐ Conduit ☐ Double primary wire ☐ Transformer ☐ Issues getting power/telco  
☒ Trees/obstruction to radio frequency ☐ Utility company rejected pole use ☐ Pole meets requirements

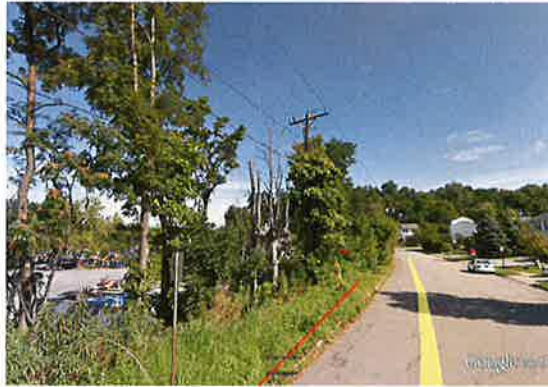
**Candidate Pole 14:**

This pole does not meet construction requirements due to:

- ☐ Conduit ☒ Double primary wire ☐ Transformer ☐ Issues getting power/telco  
☒ Trees/obstruction to radio frequency ☐ Utility company rejected pole use ☐ Pole meets requirements

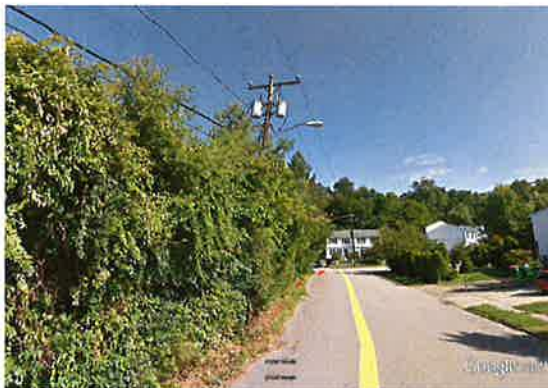
**Candidate Pole 15:**

This pole does not meet construction requirements due to:

- ☐ Conduit ☐ Double primary wire ☒ Transformer ☐ Issues getting power/telco  
☒ Trees/obstruction to radio frequency ☐ Utility company rejected pole use ☐ Pole meets requirements

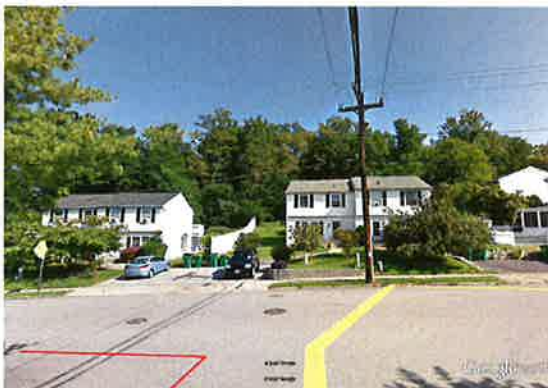
**Candidate Pole 16:**

This pole does not meet construction requirements due to:

- ☒ Conduit ☒ Double primary wire ☐ Transformer ☐ Issues getting power/telco  
☐ Trees/obstruction to radio frequency ☐ Utility company rejected pole use ☐ Pole meets requirements
